Lake County School District R-1  
Facility Assessment Report

# LAKE COUNTY INTERMEDIATE SCHOOL

October 12, 2018

## LAKE COUNTY INTERMEDIATE SCHOOL ARCHITECTURAL FACILITY ASSESSMENT

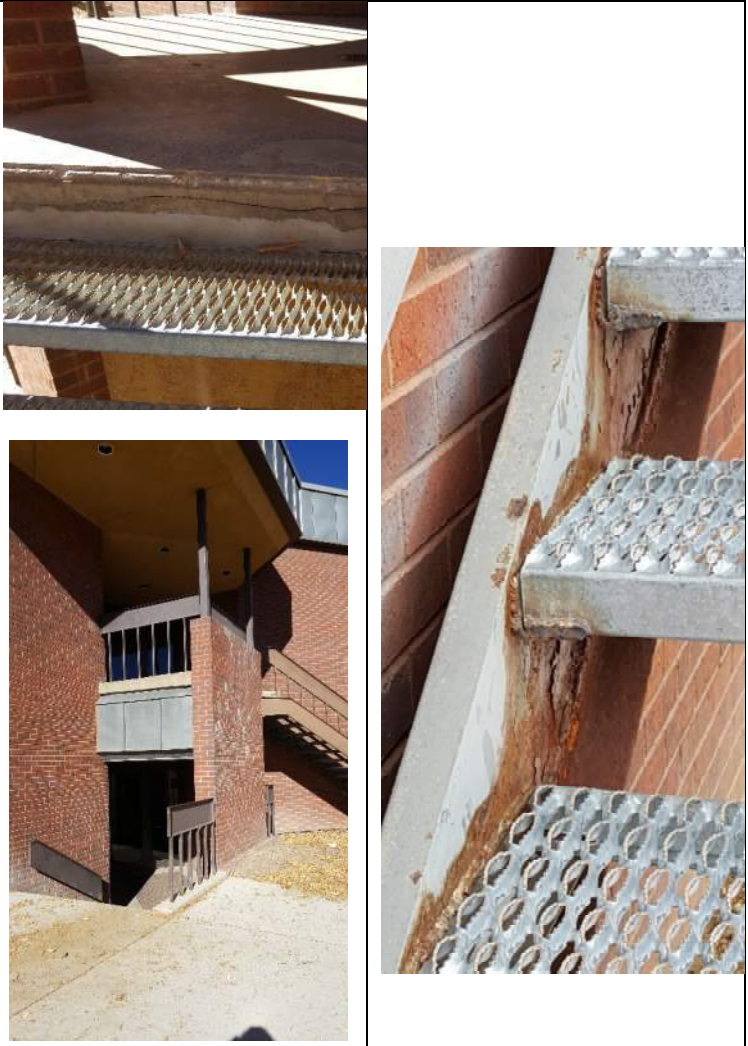
DISC. ITEM #	OBSERVATION / ISSUE / ITEM DESCRIPTION	PRIORITY LEVEL			PHOTOS
		LOW	MED	HIGH	
A-2	All exterior stairs at the building have varying levels of erosion and are in need of repair. Guardrails and handrails should also be replaced to meet current code and increase safety. See Supplemental Exhibit at end of this report for locations.

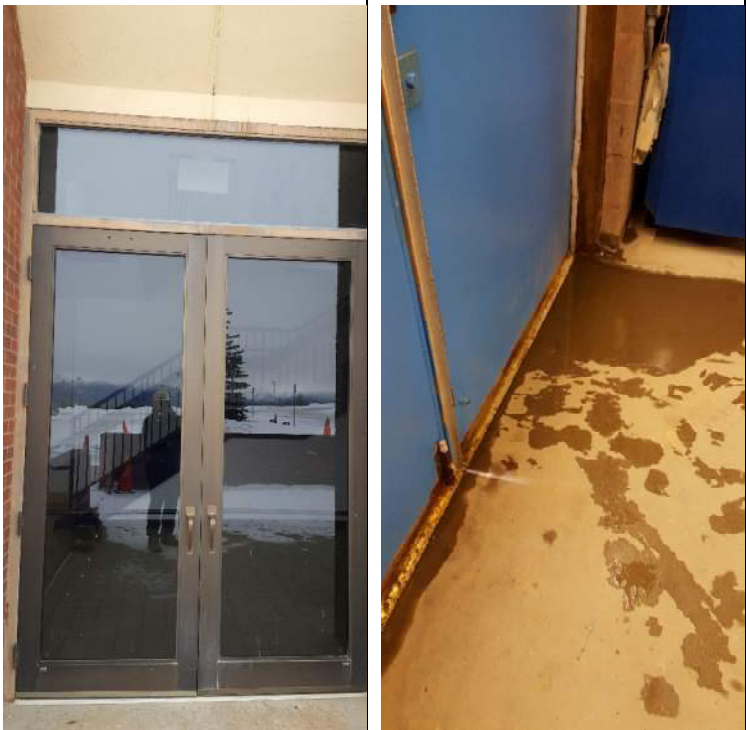
DISC. ITEM #	OBSERVATION / ISSUE / ITEM DESCRIPTION	PRIORITY LEVEL			PHOTOS
		LOW	MED	HIGH	
A-3	Exterior Windows and doors are at the end of their useful life; recommend replacement. See Supplemental Exhibit at the end of this report for door locations.

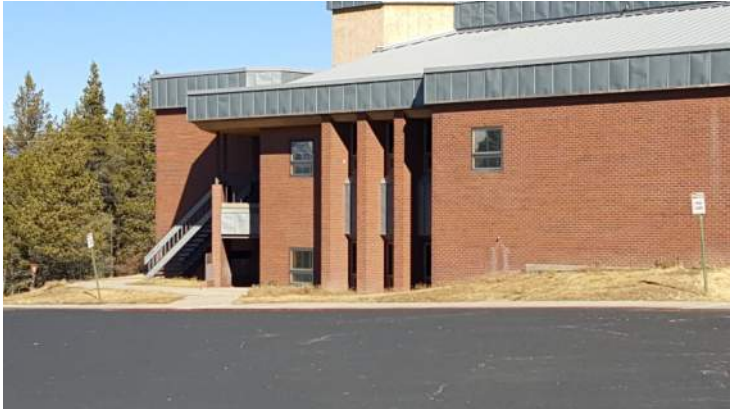
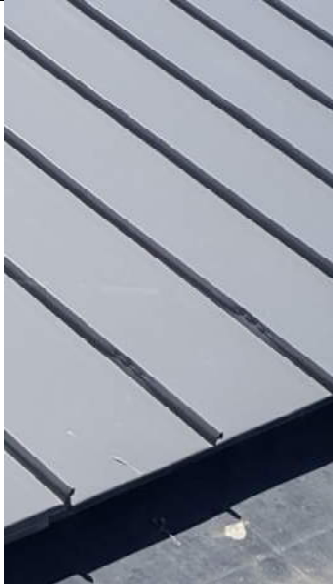
DISC. ITEM #	OBSERVATION / ISSUE / ITEM DESCRIPTION	PRIORITY LEVEL			PHOTOS
		LOW	MED	HIGH	
A-4	Standing seam roofing and exterior fascia is original to the building and at the end of its useful life. Recommend replacement.

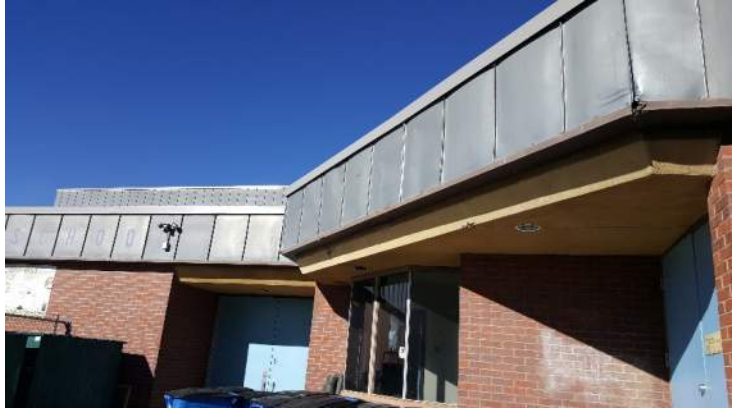
DISC. ITEM #	OBSERVATION / ISSUE / ITEM DESCRIPTION	PRIORITY LEVEL			PHOTOS
		LOW	MED	HIGH	
A-5	Exterior soffits exhibit signs of water damage due to water from adjacent fascia. Recommend replacement of these soffits in conjunction with replacement of standing seam roofing.

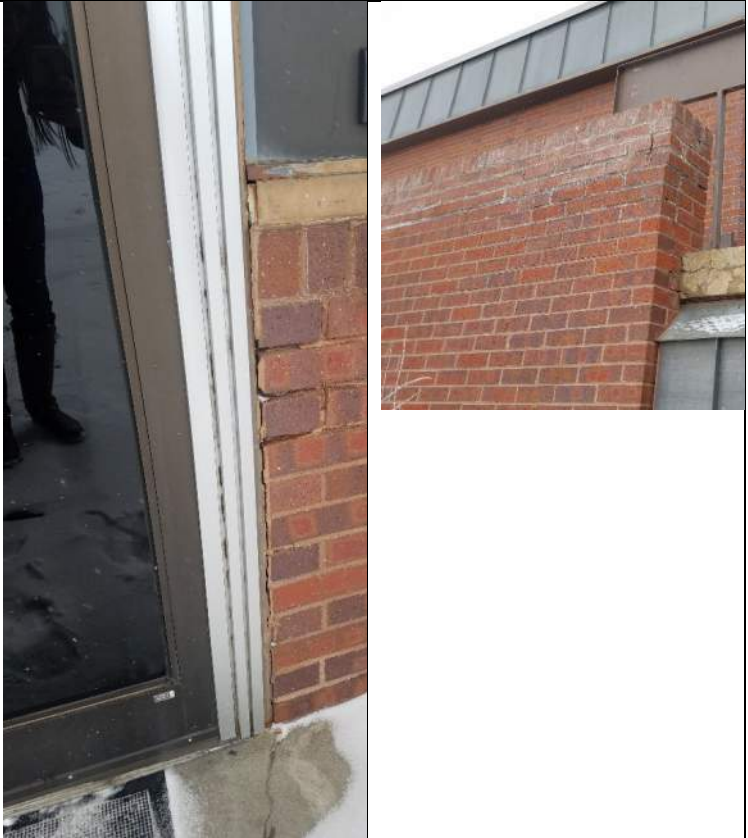
DISC. ITEM #	OBSERVATION / ISSUE / ITEM DESCRIPTION	PRIORITY LEVEL			PHOTOS
		LOW	MED	HIGH	
A-6	Some areas of damaged brick noted on exterior of building. Recommend re-tooling or replacement.

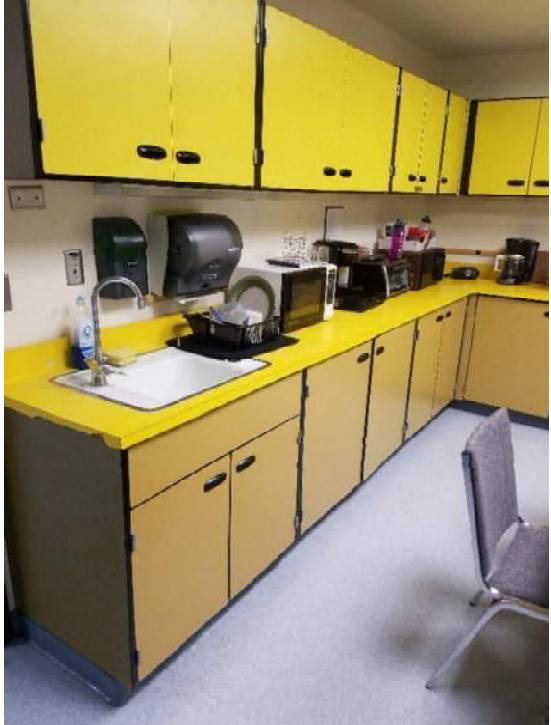
DISC. ITEM #	OBSERVATION / ISSUE / ITEM DESCRIPTION	PRIORITY LEVEL			PHOTOS
		LOW	MED	HIGH	
A-7	Casework throughout is original to the building, and in poor shape as well as non-ADA compliant. Recommend replacing all casework throughout.

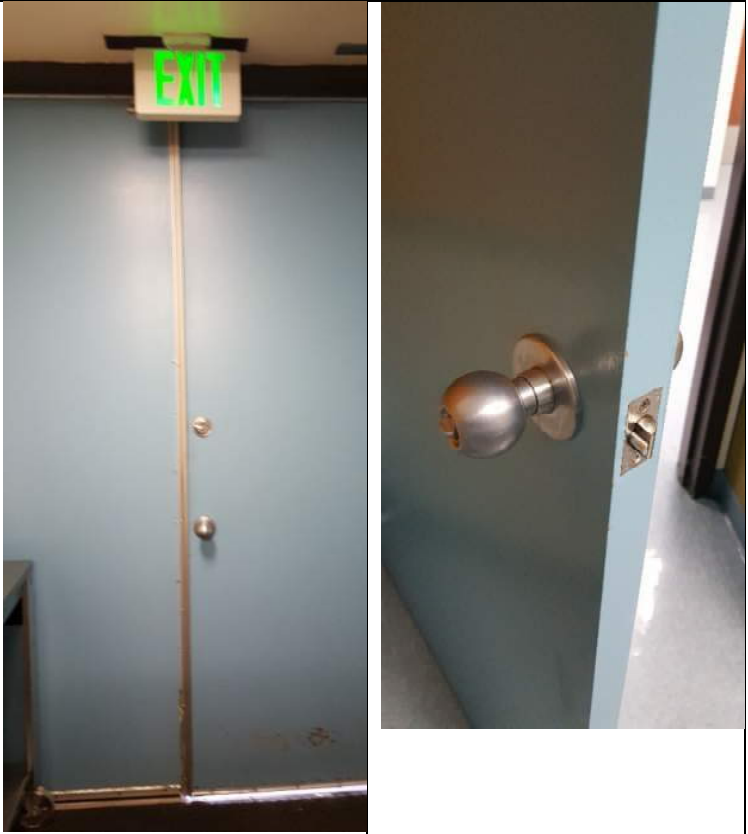
DISC. ITEM #	OBSERVATION / ISSUE / ITEM DESCRIPTION	PRIORITY LEVEL			PHOTOS
		LOW	MED	HIGH	
A-8	Doors at academic core areas, music rooms, and kitchen/gym area are in poor shape and have non-ADA compliant hardware. Recommend replacing with new doors and compliant hardware. See Supplemental Exhibit at the end of this report for locations.

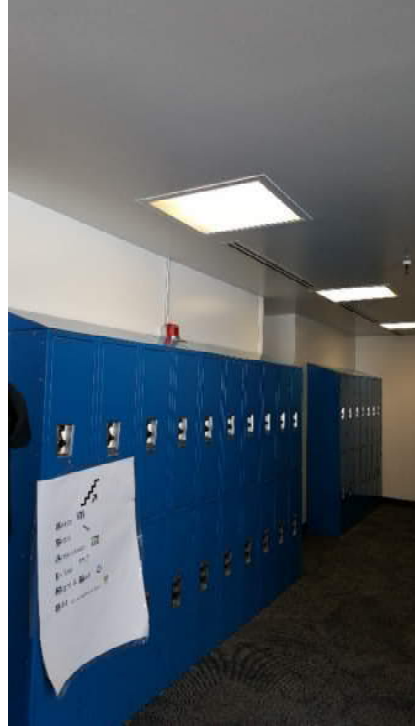
DISC. ITEM #	OBSERVATION / ISSUE / ITEM DESCRIPTION	PRIORITY LEVEL			PHOTOS
		LOW	MED	HIGH	
A-9	Doors between the swimming pool and locker rooms are not fully secured to limit access to the school. Recommend providing magnetic security locks as shown on the attached Supplemental Exhibit.				
A-10	Lockers remain in corridors of buildings from original construction but are unused. In some instances, there is conflict with the fire alarm system. Recommend removal of lockers at time of flooring replacement.

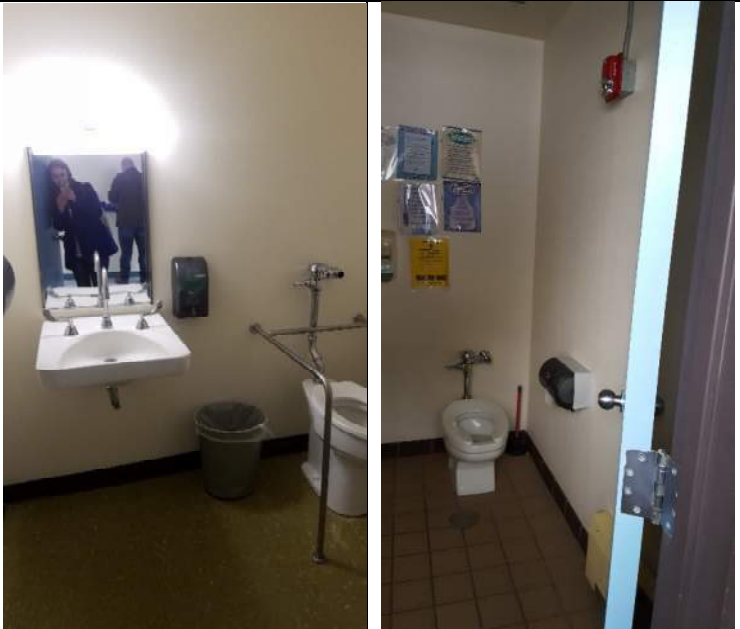
DISC. ITEM #	OBSERVATION / ISSUE / ITEM DESCRIPTION	PRIORITY LEVEL			PHOTOS
		LOW	MED	HIGH	
A-12	Single fixture restrooms throughout the building have varying levels of accessibility. Recommend making improvements to the extent feasible, including adding grab bars and replacing fixtures.

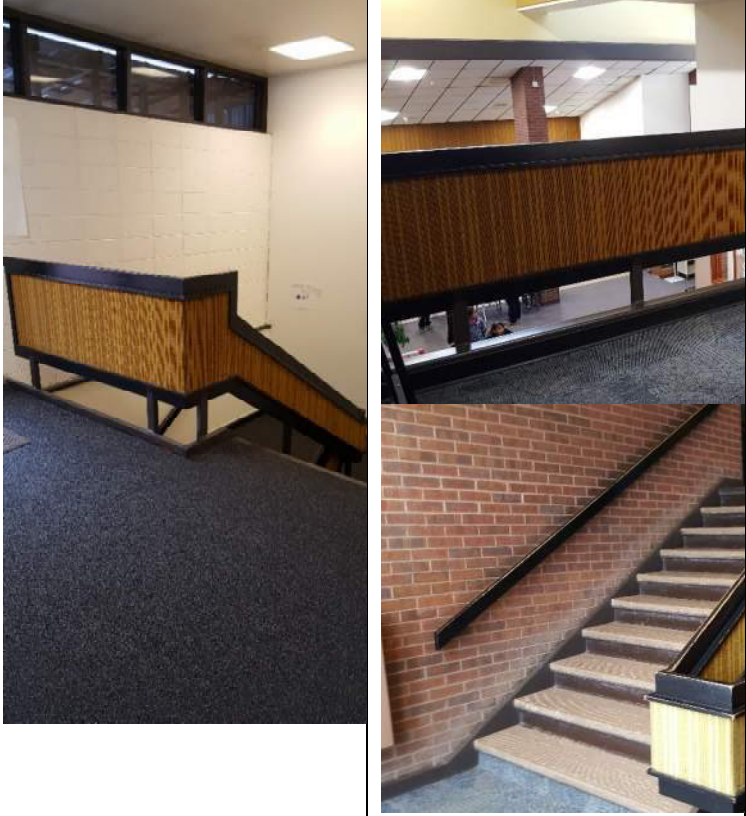
DISC. ITEM #	OBSERVATION / ISSUE / ITEM DESCRIPTION	PRIORITY LEVEL			PHOTOS
		LOW	MED	HIGH	
A-13	Interior railings and guardrails throughout the building are not compliant with current code. While not required to be replaced, it is recommended for additional student safety. See attached Supplemental Exhibit at the end of this report for locations.

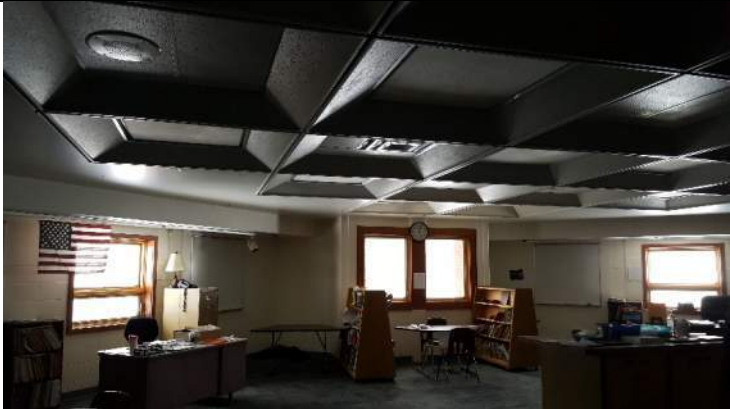
DISC. ITEM #	OBSERVATION / ISSUE / ITEM DESCRIPTION	PRIORITY LEVEL			PHOTOS
		LOW	MED	HIGH	
A-14	Many areas of ceiling in the building are original, and show signs of damage and age. Recommend new ceilings throughout for both aesthetic and acoustic improvements.

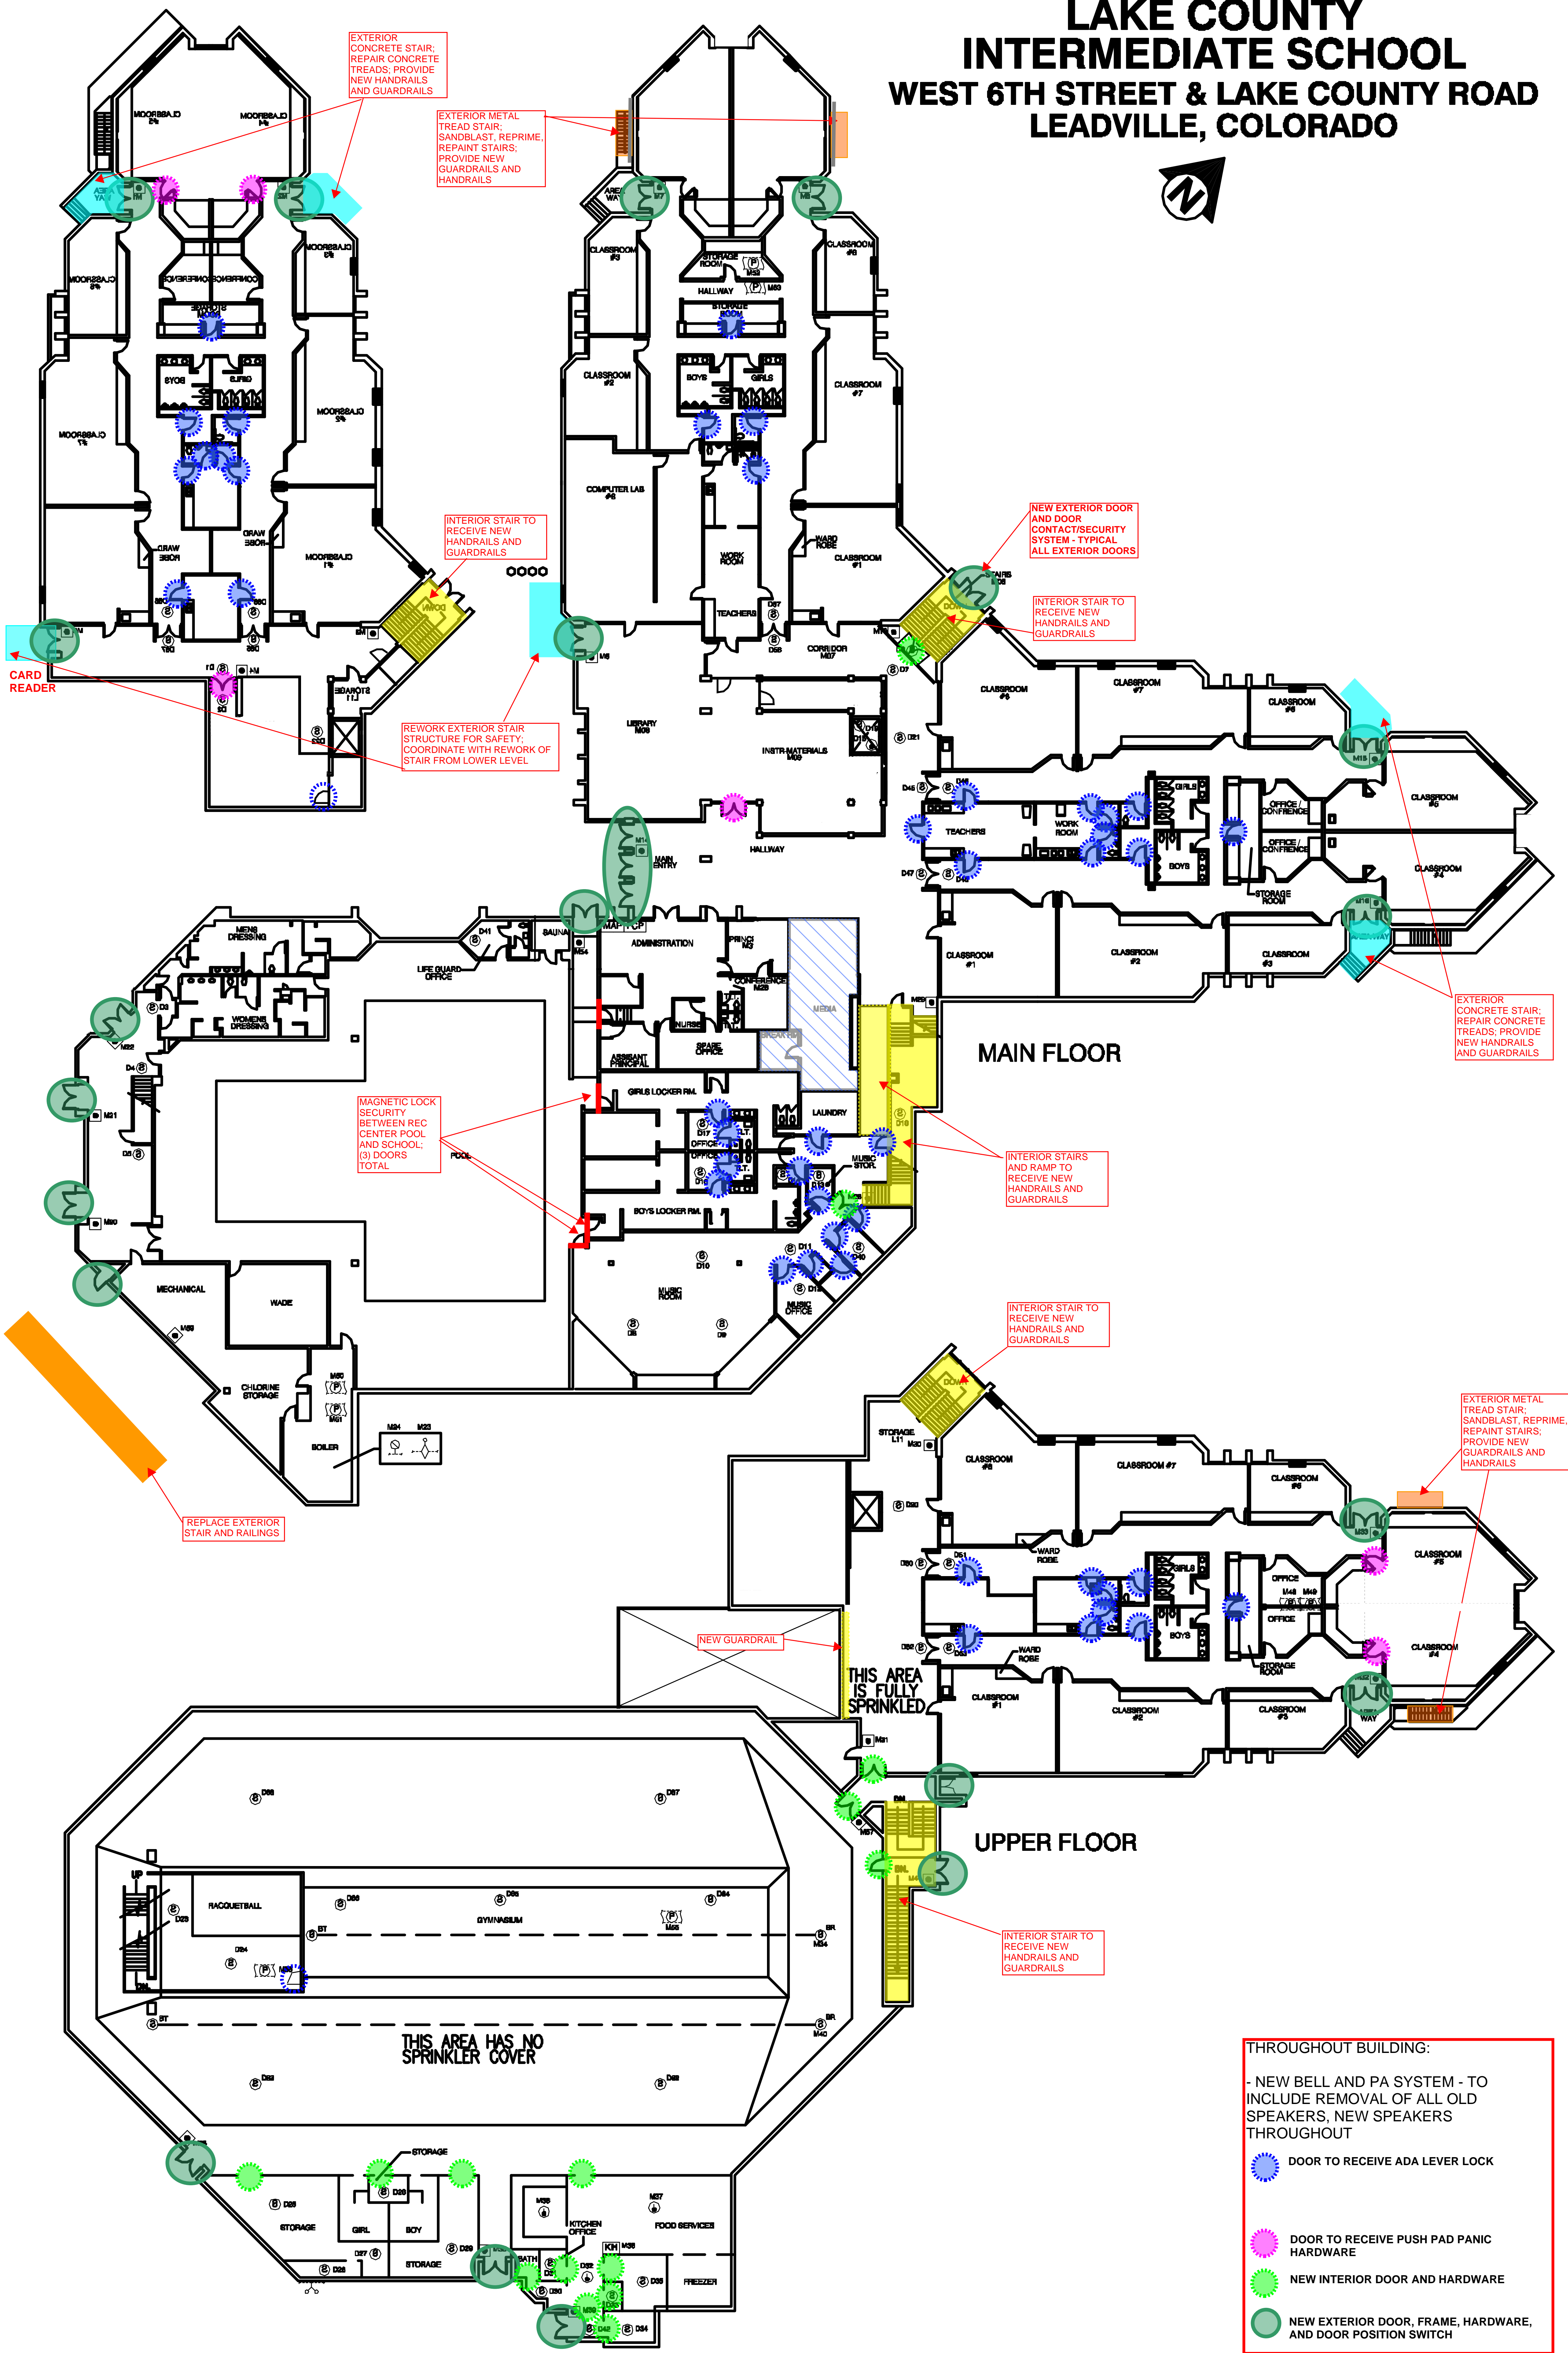
EXTERIOR CONCRETE STAIR; REPAIR CONCRETE TREADS; PROVIDE NEW HANDRAILS AND GUARDRAILS

EXTERIOR METAL TREAD STAIR; SANDBLAST, REPRIME, REPAINT STAIRS; PROVIDE NEW GUARDRAILS AND HANDRAILS

INTERIOR STAIR TO RECEIVE NEW HANDRAILS AND GUARDRAILS

NEW EXTERIOR DOOR AND DOOR CONTACT/SECURITY SYSTEM - TYPICAL ALL EXTERIOR DOORS

REPLACE EXTERIOR STAIR AND RAILINGS

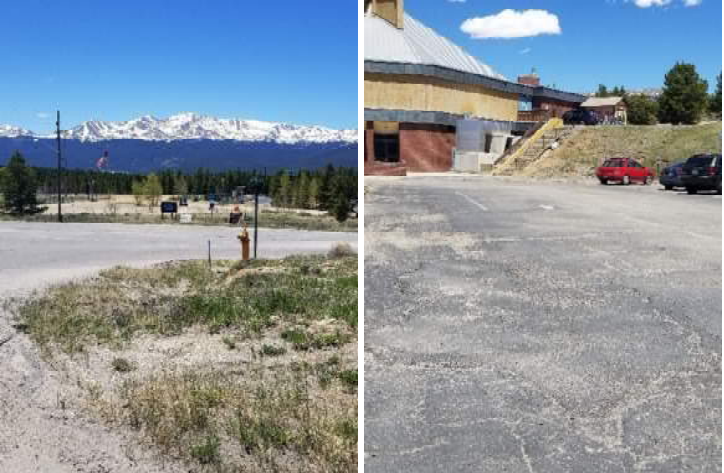
DISC. ITEM #	OBSERVATION / ISSUE / ITEM DESCRIPTION	PRIORITY LEVEL			PHOTOS
		LOW	MED	HIGH	
C-1	Asphalt drives and parking lots have reached the end of their useful life. Recommend replacement.

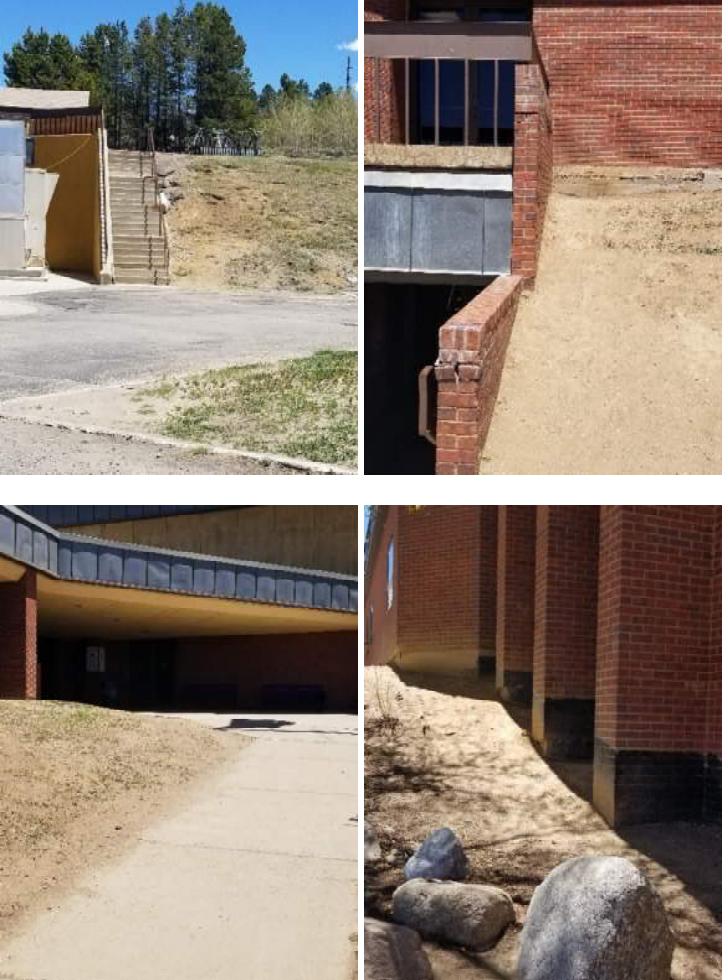
DISC. ITEM #	OBSERVATION / ISSUE / ITEM DESCRIPTION	PRIORITY LEVEL			PHOTOS
		LOW	MED	HIGH	
C-2	Several slopes across the site have evidence of experiencing erosion. Recommend erosion control measures to be installed in selective locations.

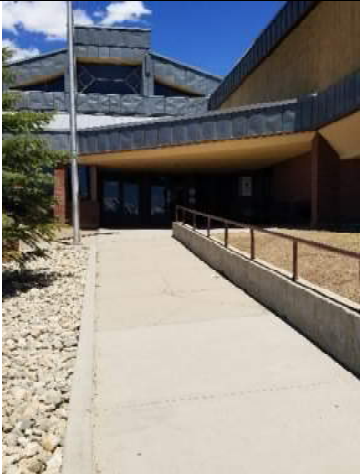
DISC. ITEM #	OBSERVATION / ISSUE / ITEM DESCRIPTION	PRIORITY LEVEL			PHOTOS
		LOW	MED	HIGH	
C-3	Site does not provide any access that conforms to ADA code. Recommend replacement at main entrance. Main entrance should connect to accessible routes that lead to ADA parking stalls and adjacent Right-of-Ways.

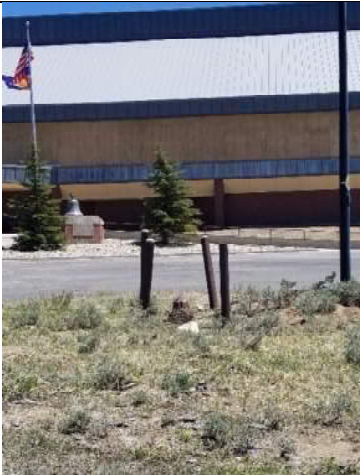
C-4	Existing ADA parking stalls to not connect to an accessible route to the building. Recommend replacement.				
C-5	Hydrants on site appear inaccessible and possibly outdated. Recommend maintenance and barrel replacement to conform to current Fire District standards.

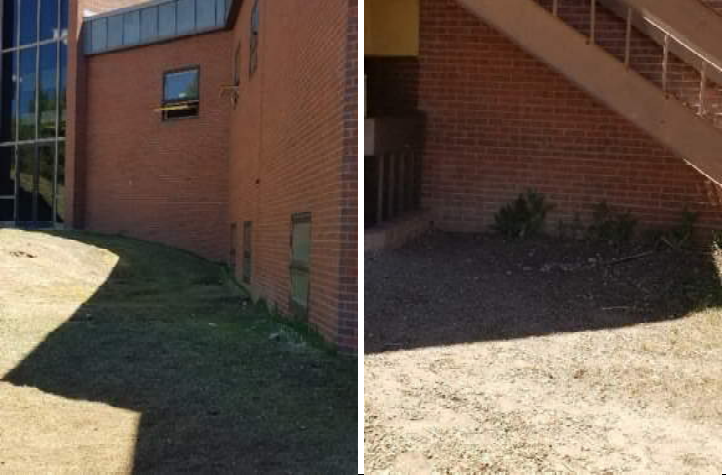
DISC. ITEM #	OBSERVATION / ISSUE / ITEM DESCRIPTION	PRIORITY LEVEL			PHOTOS
		LOW	MED	HIGH	
C-6	Some grades adjacent the building do not have adequate slope away, causing ponding near or against the building. Recommend regrading and replacement of vegetation.

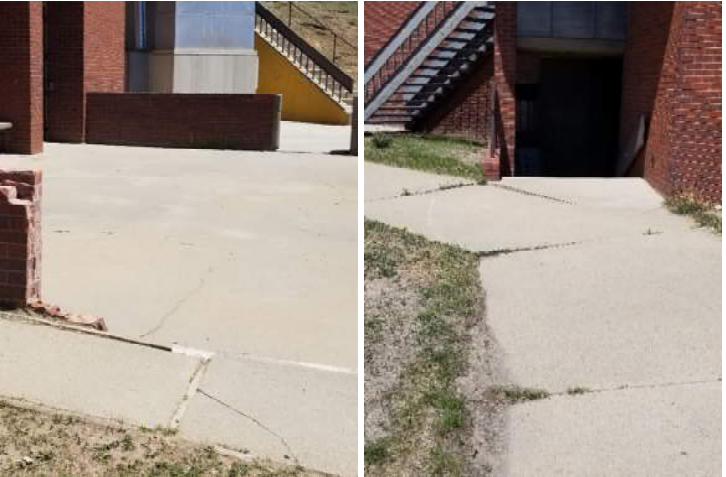
C-7	Older concrete walks on site have experienced minor cracking and slab movement. Recommend maintenance to reduce effects of freeze/thaw and remove trip hazards caused by grade differences.

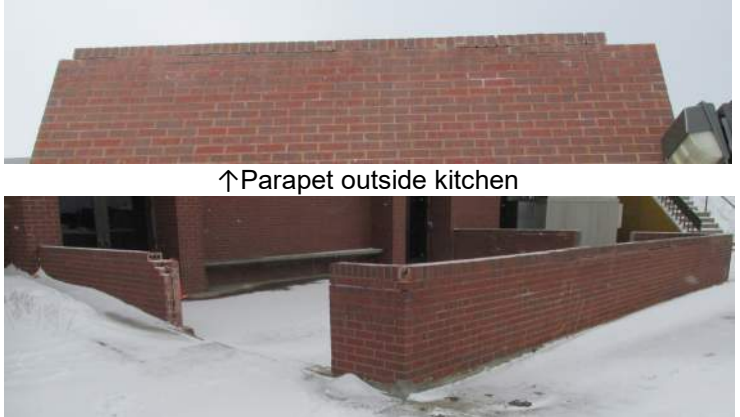
DISC. ITEM #	OBSERVATION / ISSUE / ITEM DESCRIPTION	PRIORITY LEVEL			PHOTOS
		LOW	MED	HIGH	
S-1	The exterior brick walls generally appear to be in good condition for the age of the building. There are some areas, however, where weathered mortar joints or damaged brick should be replaced and treated with a penetrating surface sealer for visual reasons and to maintain the weather-resistant characteristics of the wall system. See photos for representative locations.		X

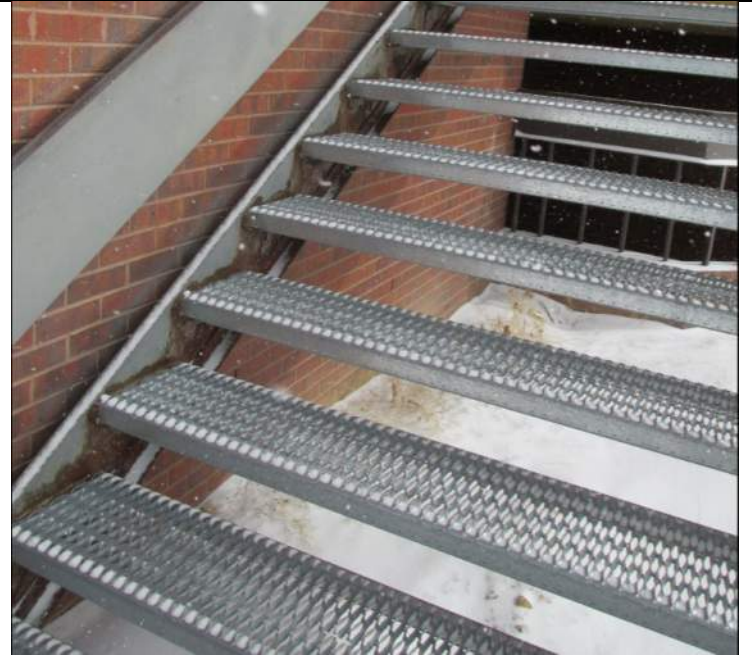
↑West wing (west side)

S-2	The stringers for the four exterior steel stairs (two at the end of the west wing and two at the end of the east wing) are severely corroded and should be replaced.			X
-----	--	--	--	---

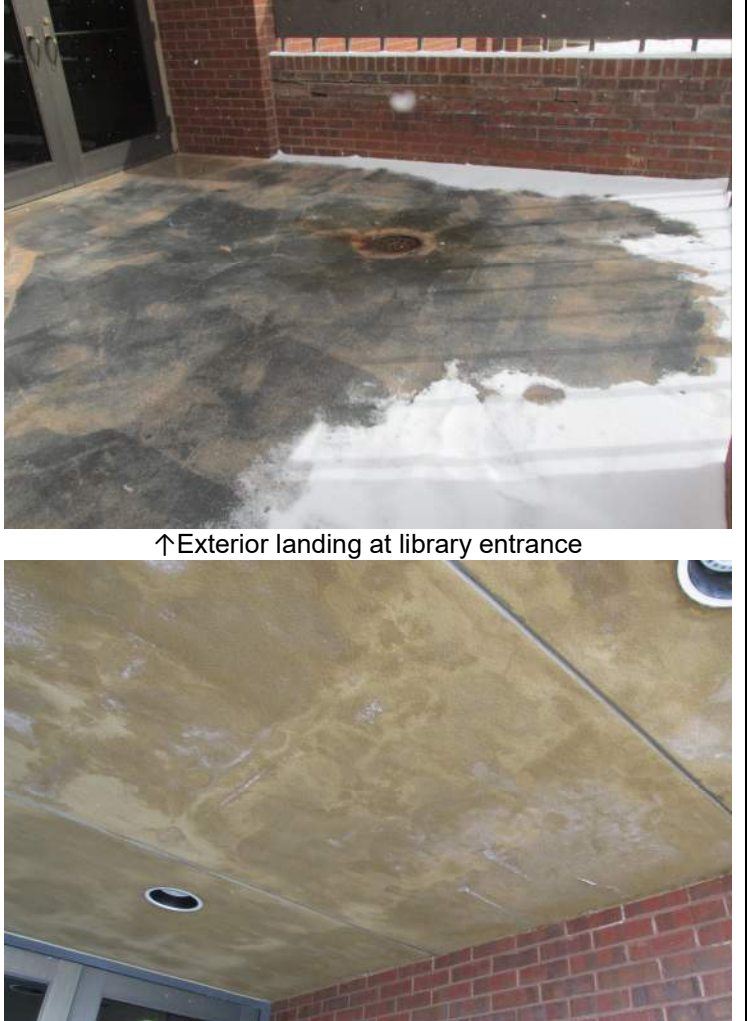
<p>↑Exterior landing at library entrance</p> <p>↑Soffit below landing at library entrance</p>
------------	--	--	--	----------	--

<p>S-3</p>	<p>The exterior landing slab at the entrance to the library has cracks in it and signs of water intrusion are evident on the surface of the soffit below. Further investigation is required to determine the condition of the landing structure and what repairs will be required.</p>			<p>X</p>

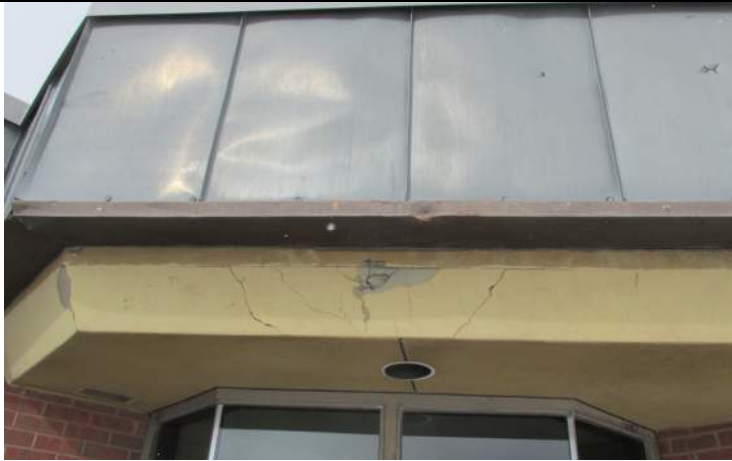
<p>S-4</p>	<p>The soffits at the loading dock area have been damaged. Repair may be necessary to prevent water intrusion.</p>	<p>X</p>

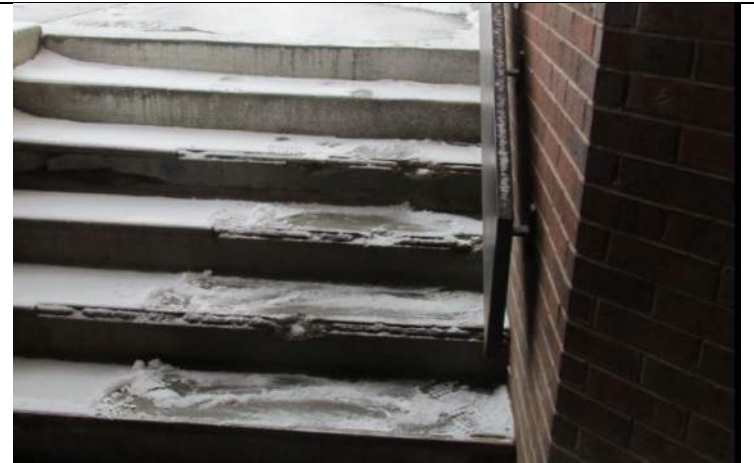
↑ Entrance steps

<p>S-5</p>	<p>Concrete at the entrances (flatwork and steps) and loading dock is deteriorating and should be replaced.</p>	<p>X</p>			  <p>↑Flatwork at main entrance</p>   <p>↑Entrance steps</p>

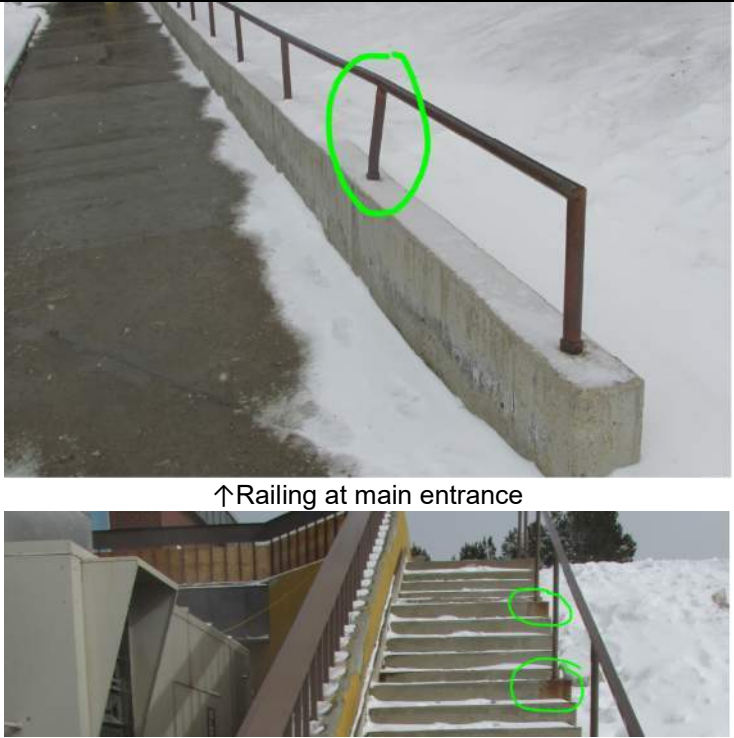
S-6	<p>The exterior steel railings appear to be in serviceable condition except that one of the railing posts at the main entrance is bent and the bases of some of the railing posts at the mechanical well stair are rusting. If the bent post is straightened for visual reasons, care should be taken to not damage the concrete wall. Removal of the rust and coating with a rust-inhibiting primer and paint is recommended. Repair of cracked concrete at the base of the rusting posts is also recommended.</p>	X

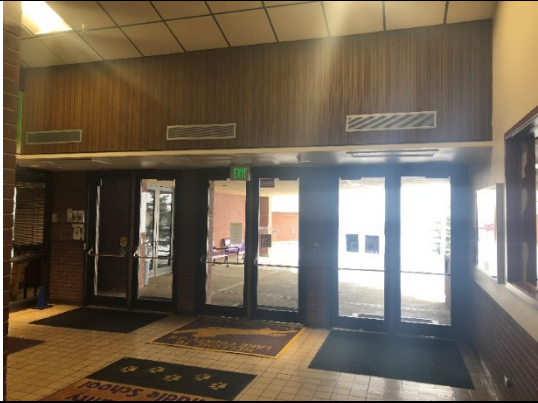
DISC. ITEM #	OBSERVATION / ISSUE / ITEM DESCRIPTION	PRIORITY LEVEL			PHOTOS
		LOW	MED	HIGH	
MP-1	Main entry- no vestibule provided.			X

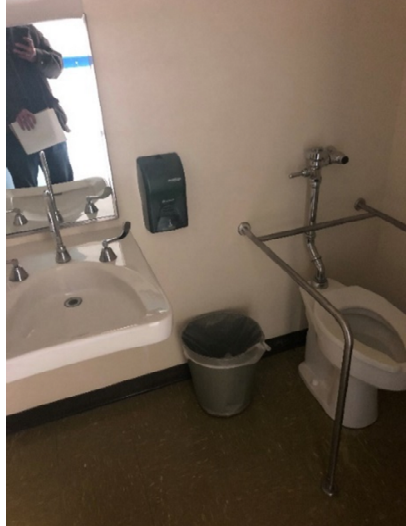
MP-2	Existing plumbing fixtures- ADA update required.			X

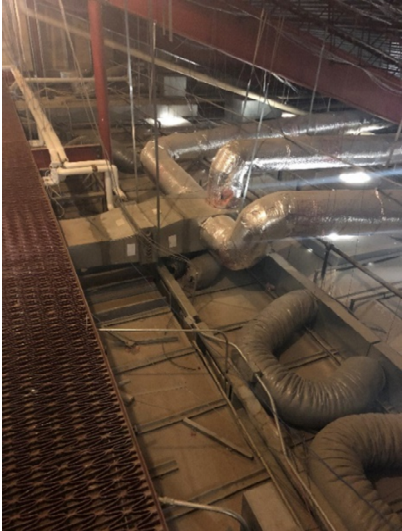
DISC. ITEM #	OBSERVATION / ISSUE / ITEM DESCRIPTION	PRIORITY LEVEL			PHOTOS
		LOW	MED	HIGH	
MP-3	Existing reheat coils with associated catwalk access.	X

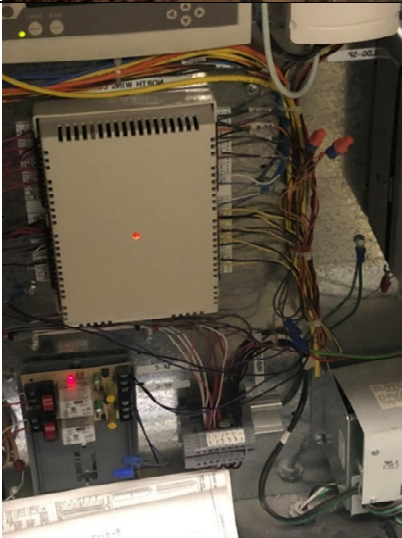
MP-4	Typical existing electronic control panel.		X

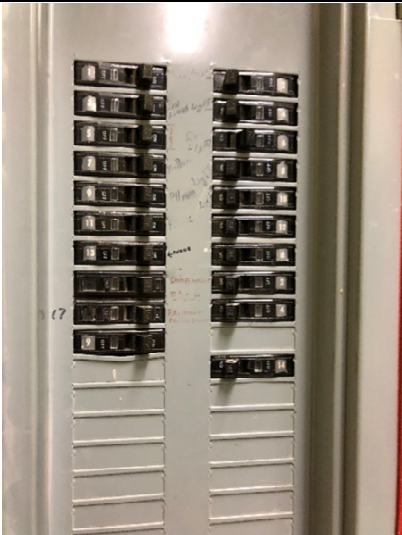
DISC. ITEM #	OBSERVATION / ISSUE / ITEM DESCRIPTION	PRIORITY LEVEL			PHOTOS
		LOW	MED	HIGH	
E-1	There are a few spare/spaces within panelboards for future expansion.		X

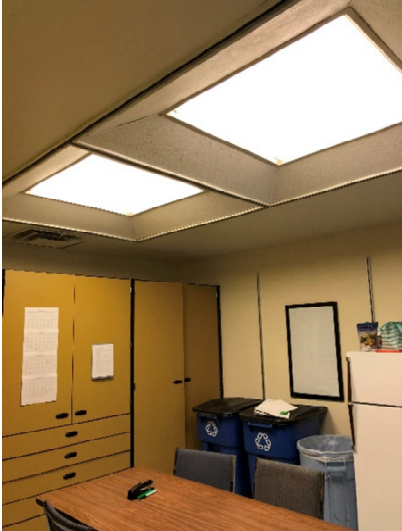
E-2	Existing linear fluorescent lighting should be replaced with LED, either with replacement lamps or new LED fixtures/modules.		X

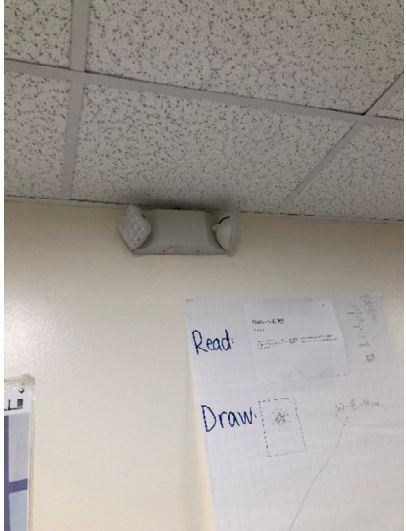
DISC. ITEM #	OBSERVATION / ISSUE / ITEM DESCRIPTION	PRIORITY LEVEL			PHOTOS
		LOW	MED	HIGH	
E-3	Existing battery packs were provided throughout interior path of egress. Exterior emergency fixtures would need to be provided on all exterior egress doors since it is required by code.		X

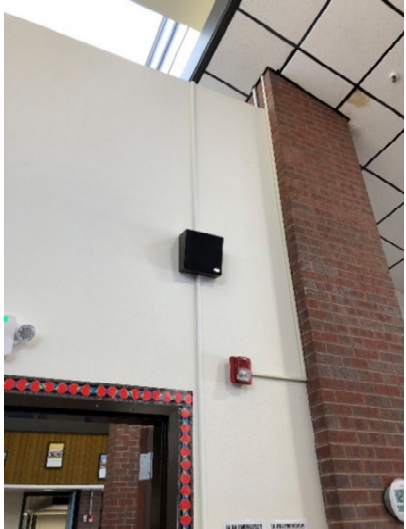
E-4	Existing horn/strobes would need to be replaced with new speaker strobes to accommodate voice evacuation system, if modification is required for fire alarm system.		X
