Lake County School District R-1  
Facility Assessment Report

# PITTS ELEMENTARY SCHOOL

October 12, 2018

## PITTS ELEMENTARY SCHOOL ARCHITECTURAL FACILITY ASSESSMENT

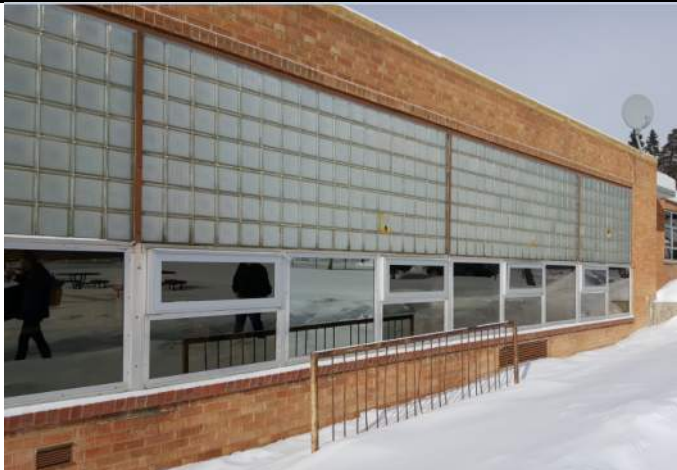
DISC. ITEM #	OBSERVATION / ISSUE / ITEM DESCRIPTION	PRIORITY LEVEL			PHOTOS
		LOW	MED	HIGH	
A-1	Glass block at exterior of building is damaged in multiple locations. Recommend replacing block with new high performance aluminum windows and glazing.

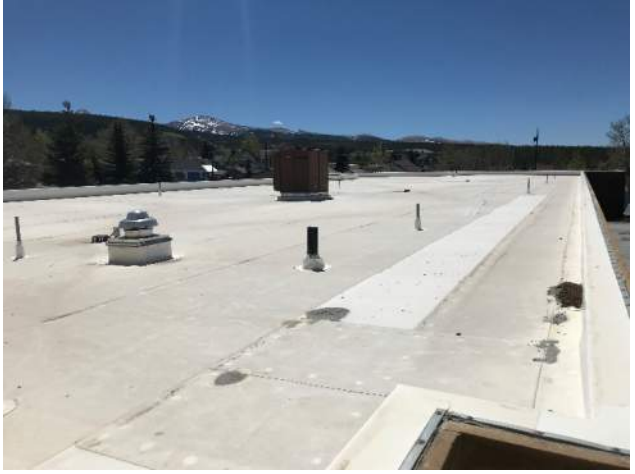
DISC. ITEM #	OBSERVATION / ISSUE / ITEM DESCRIPTION	PRIORITY LEVEL			PHOTOS
		LOW	MED	HIGH	
A-2	Some portions of the building were reroofed in 1997 with TPO membrane. This membrane has exceeded its life span, and should be replaced. Overflow scuppers or interior overflow drains should be added at time of reroof.

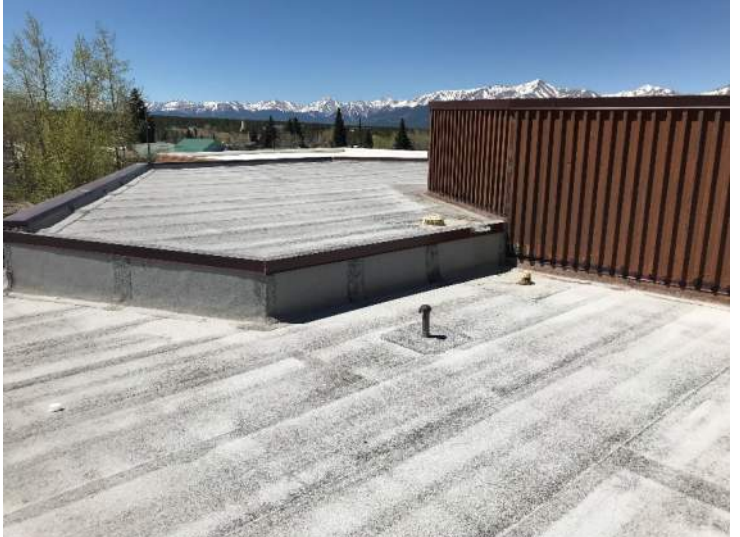
A-3	Areas of built-up roofing that were not replaced in 1997 still remain. Recommend replacement with new roofing membrane.

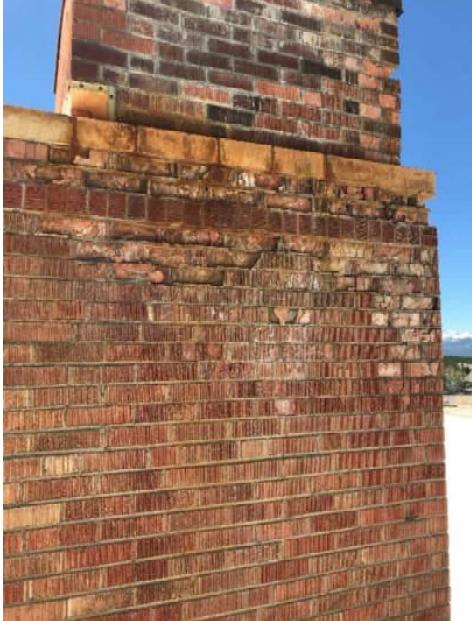
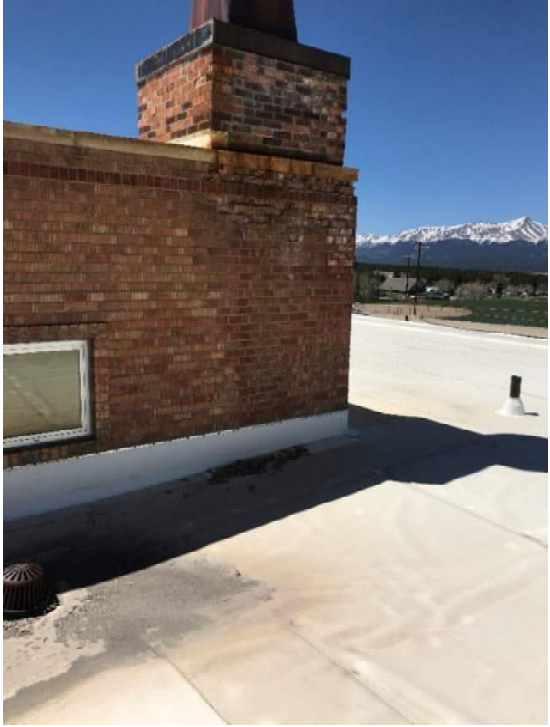
DISC. ITEM #	OBSERVATION / ISSUE / ITEM DESCRIPTION	PRIORITY LEVEL			PHOTOS
		LOW	MED	HIGH	
A-4	Masonry on existing chimney (not-in-use) is in disrepair. Recommend dismantling and capping, and replacing remaining masonry below.

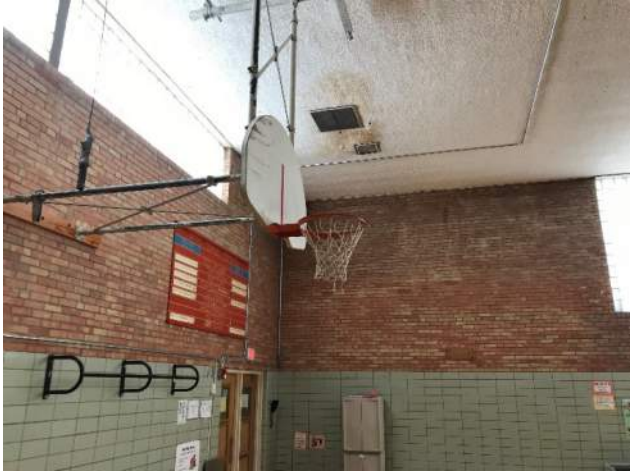
DISC. ITEM #	OBSERVATION / ISSUE / ITEM DESCRIPTION	PRIORITY LEVEL			PHOTOS
		LOW	MED	HIGH	
A-5	Water staining at the gym ceiling is evident. Reroofing may help to address; refinishing ceiling is recommended.

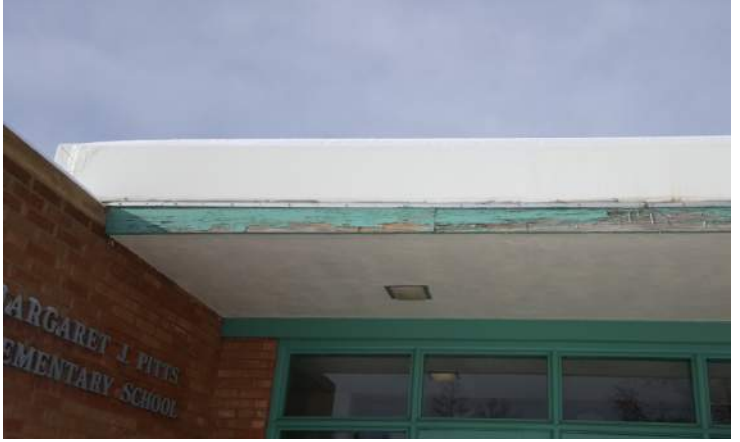
A-6	Exterior fascias have considerable deterioration and should be replaced. Recommend installation of sheet metal flashing with drip edge as part of reroof work to limit future water damage.

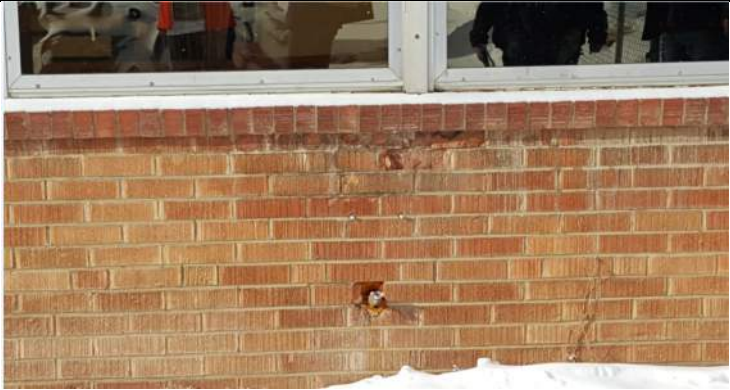
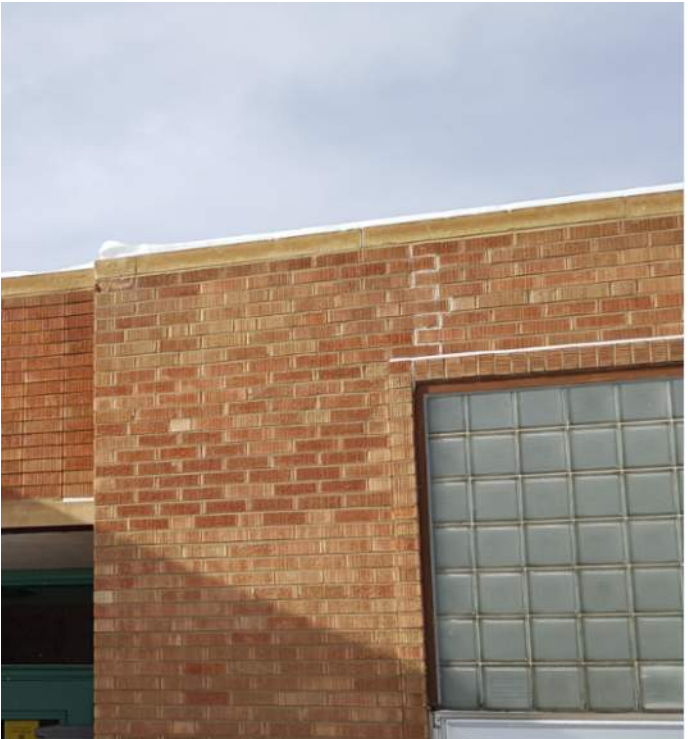
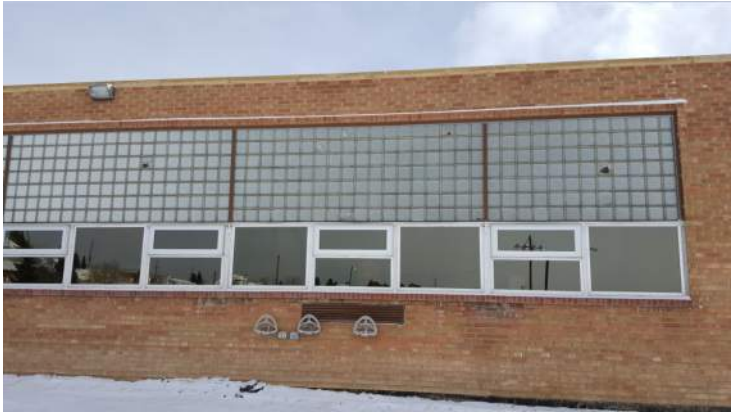
DISC. ITEM #	OBSERVATION / ISSUE / ITEM DESCRIPTION	PRIORITY LEVEL			PHOTOS
		LOW	MED	HIGH	
A-7	Areas of damage to exterior brick noted. These areas should be replaced/retooled.

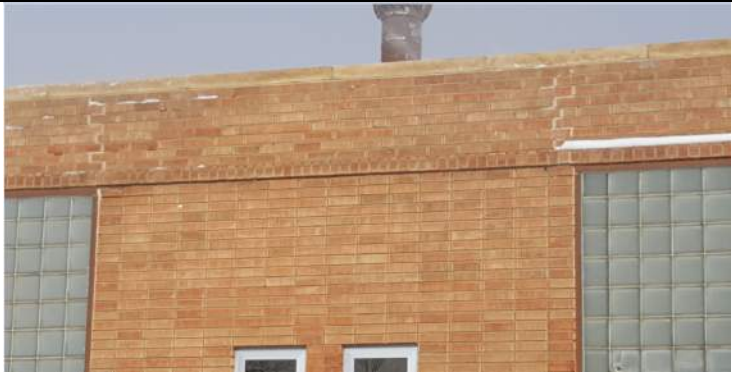
A-8	Cast stone parapet cap should be replaced with sheet metal flashing as part of reroofing.

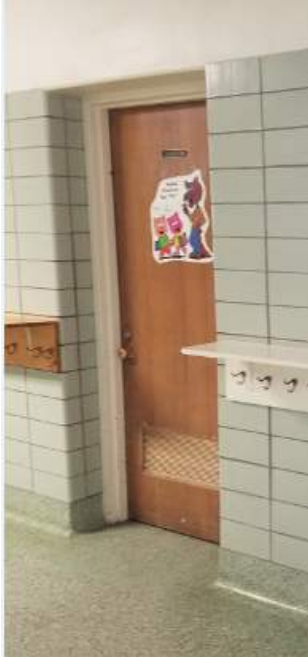
DISC. ITEM #	OBSERVATION / ISSUE / ITEM DESCRIPTION	PRIORITY LEVEL			PHOTOS
		LOW	MED	HIGH	
A-9	Interior wood doors are in poor condition and should be replaced alongside non ADA compliant hardware from knobs to levers.

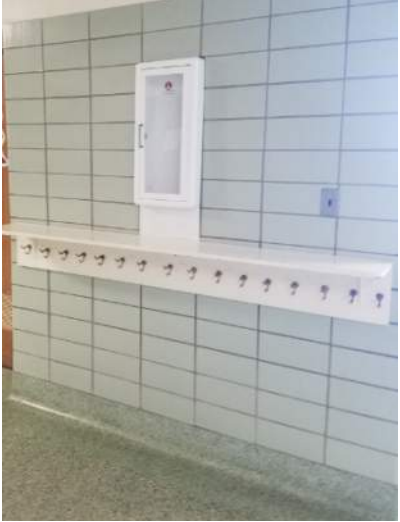
DISC. ITEM #	OBSERVATION / ISSUE / ITEM DESCRIPTION	PRIORITY LEVEL			PHOTOS
		LOW	MED	HIGH	
A-10	Fire extinguisher cabinets are not ADA accessible, and some appear to have no extinguishers. Recommend replacing and relocating cabinets, providing new extinguishers.

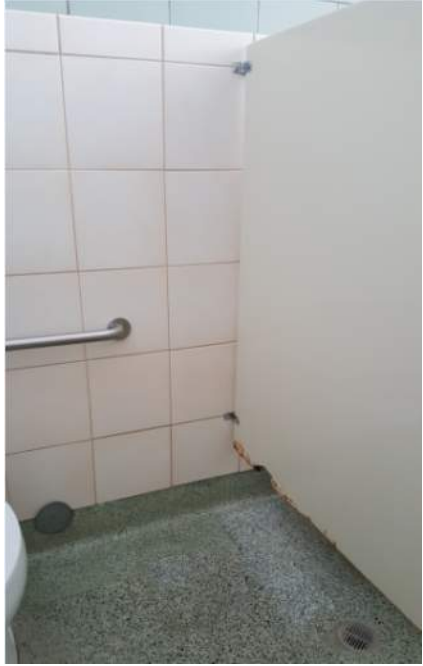
DISC. ITEM #	OBSERVATION / ISSUE / ITEM DESCRIPTION	PRIORITY LEVEL			PHOTOS
		LOW	MED	HIGH	
A-11	Toilet partitions are beyond their useful life and should be replaced.

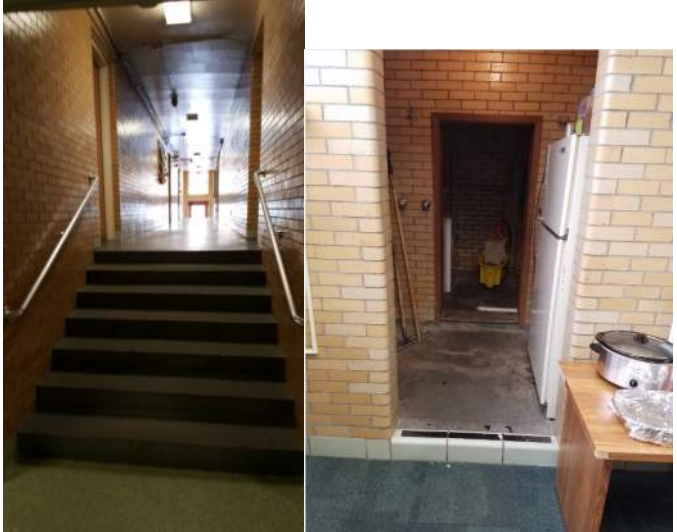
DISC. ITEM #	OBSERVATION / ISSUE / ITEM DESCRIPTION	PRIORITY LEVEL			PHOTOS
		LOW	MED	HIGH	
A-12	Limited areas of the building are not ADA accessible.

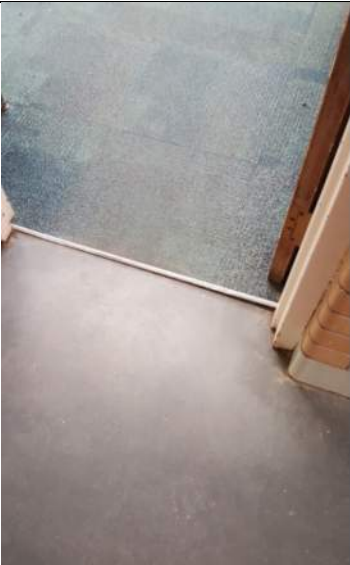
A-13	The carpeting in the building is beyond its useful life and should be replaced.

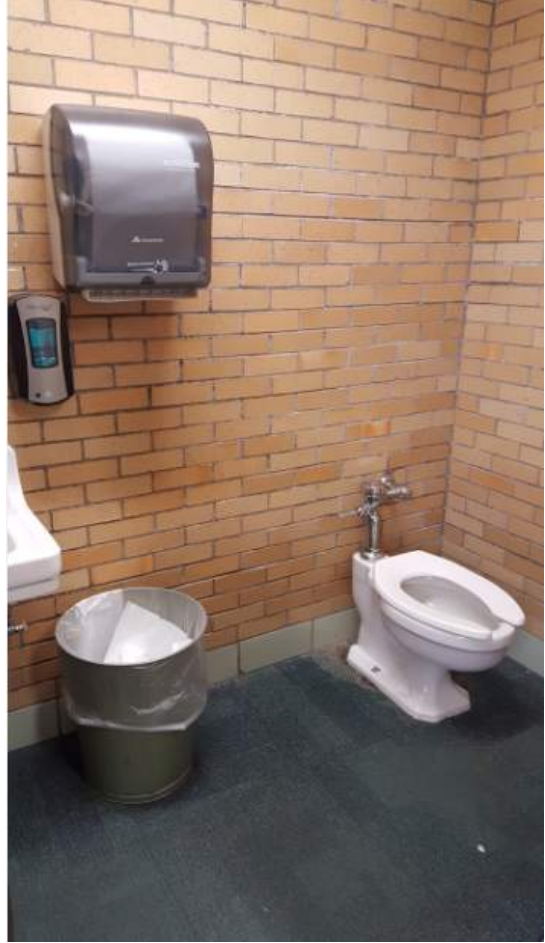
DISC. ITEM #	OBSERVATION / ISSUE / ITEM DESCRIPTION	PRIORITY LEVEL			PHOTOS
		LOW	MED	HIGH	
A-14	There are non ADA accessible restrooms that should be renovated to meet requirements. In addition, restroom flooring should be replaced as part of that work.

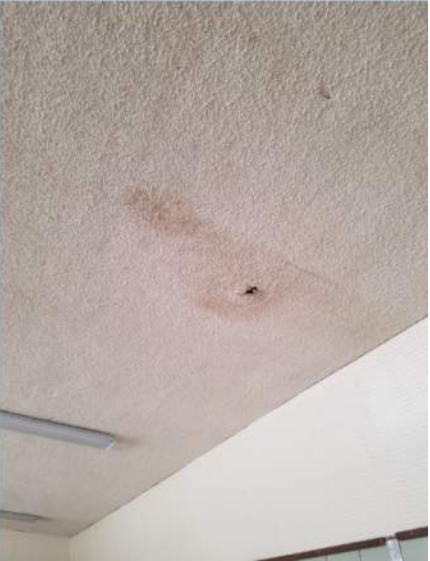
DISC. ITEM #	OBSERVATION / ISSUE / ITEM DESCRIPTION	PRIORITY LEVEL			PHOTOS
		LOW	MED	HIGH	
A-15	Areas of water damage noted at ceiling in cafeteria. Source of damage should be investigated and ceiling repaired.

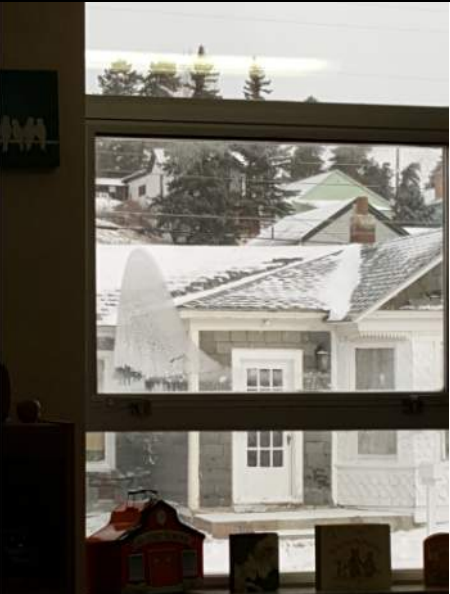
A-16	Aluminum windows are beyond their useful life, and various areas of condensation were noted. Recommend all windows be replaced with new high performance aluminum windows and glazing.

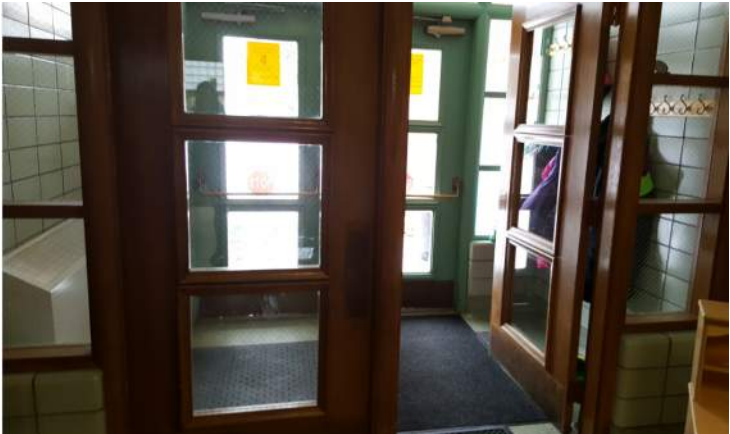
DISC. ITEM #	OBSERVATION / ISSUE / ITEM DESCRIPTION	PRIORITY LEVEL			PHOTOS
		LOW	MED	HIGH	
A-17	Exterior doors are damaged, and hardware needs to be replaced. Recommend all exterior doors and hardware be replaced.

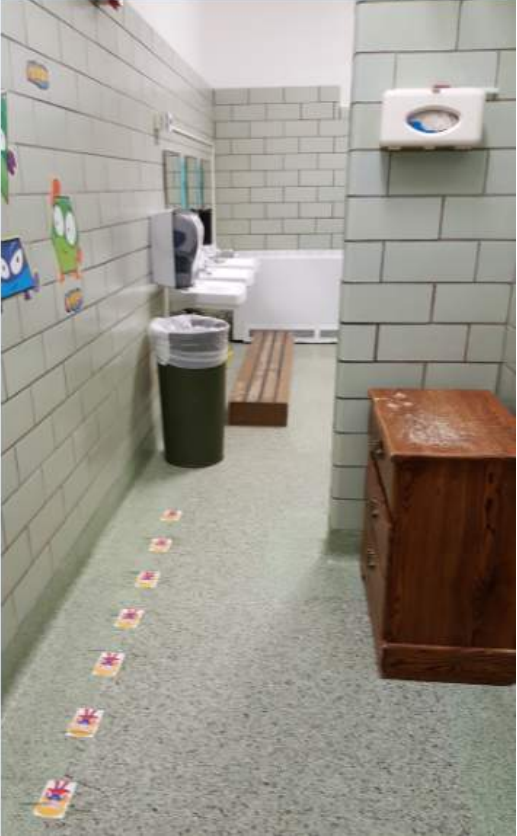
DISC. ITEM #	OBSERVATION / ISSUE / ITEM DESCRIPTION	PRIORITY LEVEL			PHOTOS
		LOW	MED	HIGH	
A-18	Multi fixture restrooms are not fully ADA accessible or appropriately sized for the age groups served. Recommend renovation of these restrooms.

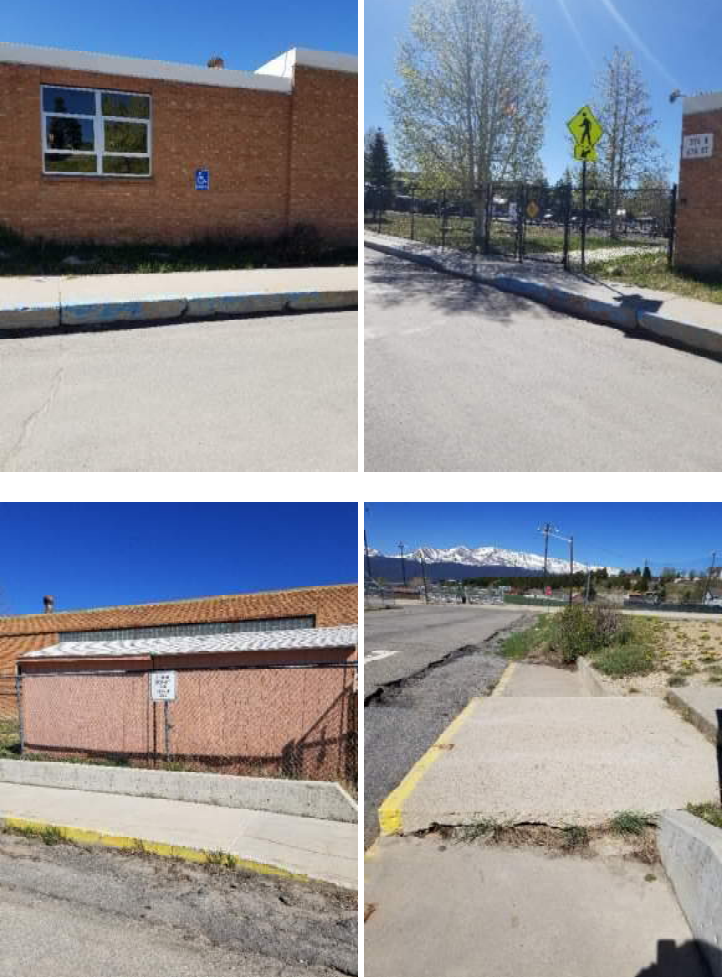
DISC. ITEM #	OBSERVATION / ISSUE / ITEM DESCRIPTION	PRIORITY LEVEL			PHOTOS
		LOW	MED	HIGH	
C-2	The building has no ADA accessible parking, drop-off, or accessible routes to the right-of-way that conform with current codes. Existing parking stalls have no accessible ramps. Existing routes have gates without ADA door openers. Recommend replacing site walks.

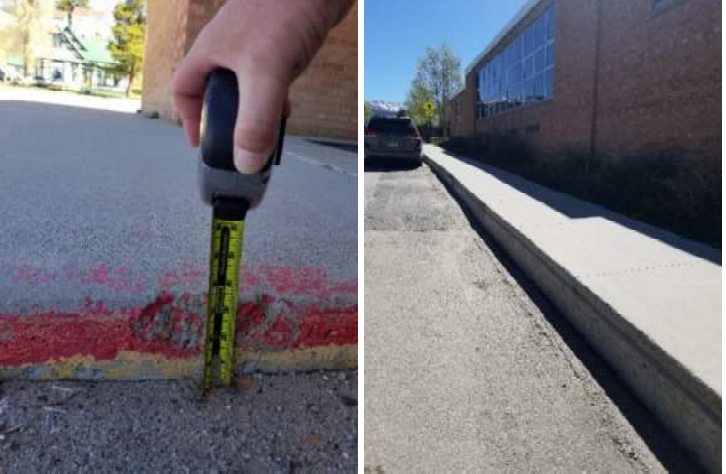
DISC. ITEM #	OBSERVATION / ISSUE / ITEM DESCRIPTION	PRIORITY LEVEL			PHOTOS
		LOW	MED	HIGH	
C-3	Atypical curb/riser heights across the site don't conform to ADA codes and create trip hazards. Recommend full replacement.

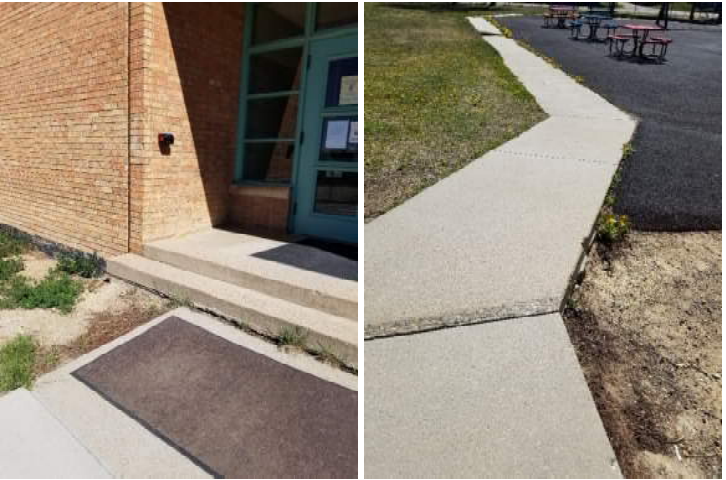
C-4	A large portion of site walks have experienced substantial damage or movement. Recommend selective replacement.

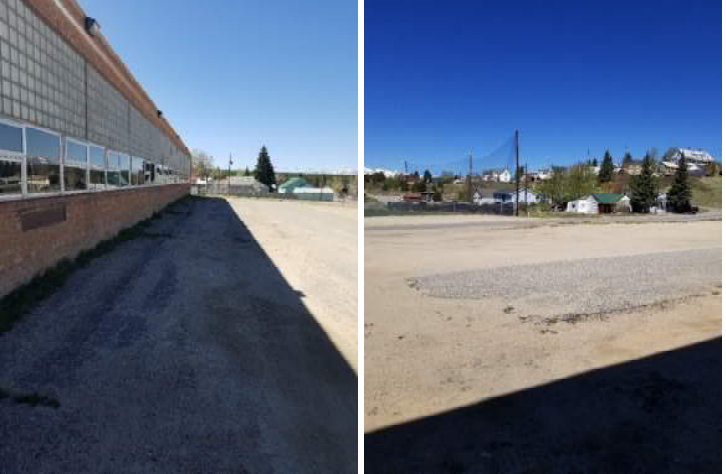
DISC. ITEM #	OBSERVATION / ISSUE / ITEM DESCRIPTION	PRIORITY LEVEL			PHOTOS
		LOW	MED	HIGH	
C-5	Asphalt portion of parking lot is at end of useful life. Recommend full replacement.

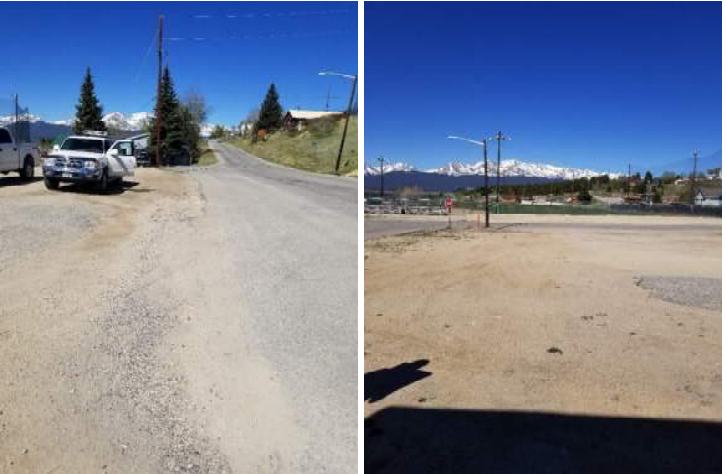
C-6	Existing gravel parking lot is not stabilized and causes erosion and tracking onto Town roads. Recommend regrading and routine maintenance.

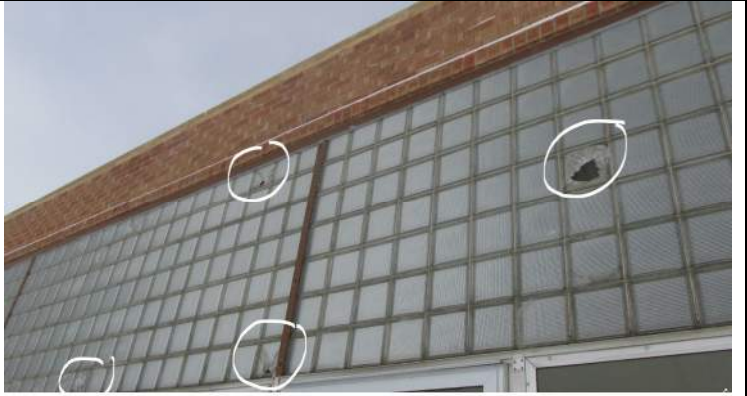
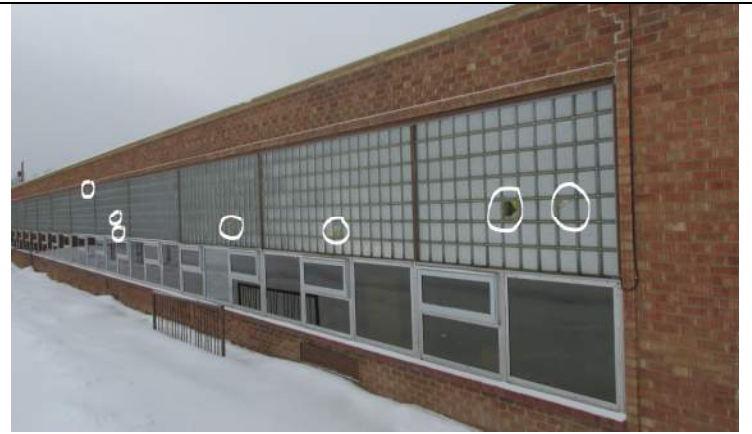
DISC. ITEM #		PRIORITY LEVEL			PHOTOS
		LOW	MED	HIGH	
S-1	The exterior walls have large areas of glass block above the classroom windows and the face shells have been cracked or knocked out in multiple locations. It is evident that damaged glass block units have been replaced in the past since the replacement units do not quite match the originals. Multiple closely-spaced damaged glass block units would be a structural concern; however, the damaged units appear to be isolated and widely spaced so repairs would be for visual and weatherproofing/insulation reasons.	X

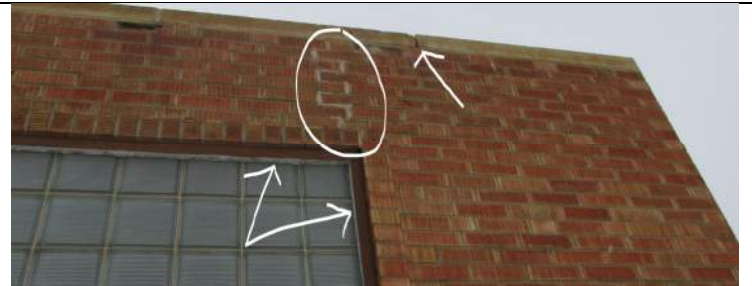
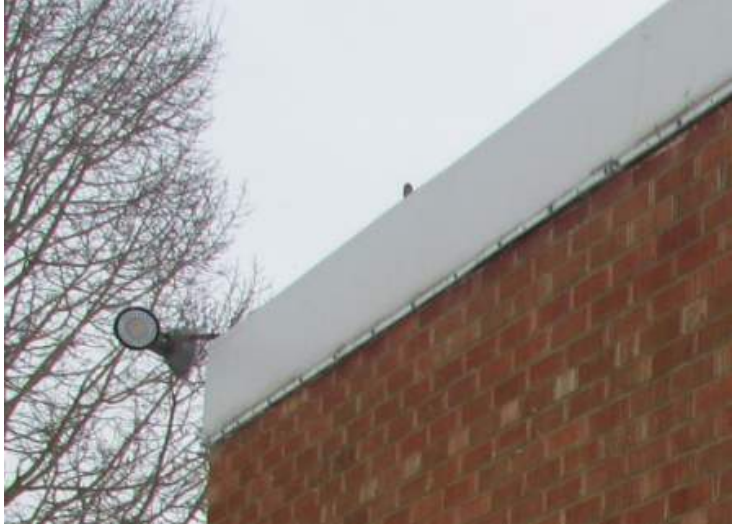
S-2 The sealant around the windows has deteriorated in some locations. Removal and replacement of the deteriorated sealant may be necessary to prevent water intrusion. The exterior brick walls do not have any control joints and stair step cracks occur commonly in the corners above the glass block areas. It is evident that the cracks have been repaired in the past; however, some of the repairs appear to have deteriorated and should be refreshed with repointing or re-caulking and applying a sealer to prevent water intrusion. The stone parapet cap is weathered and the mortar joints between sections have deteriorated. Repairs should occur to prevent moisture intrusion. In some areas, the roof membrane has been wrapped over the top of the parapet and attached to the brick wall with an exposed termination bar.

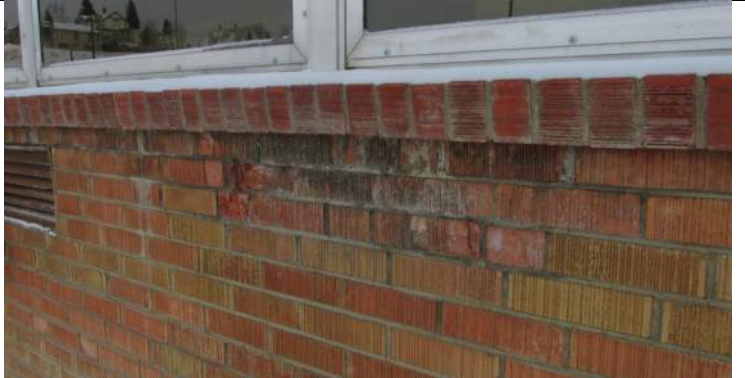
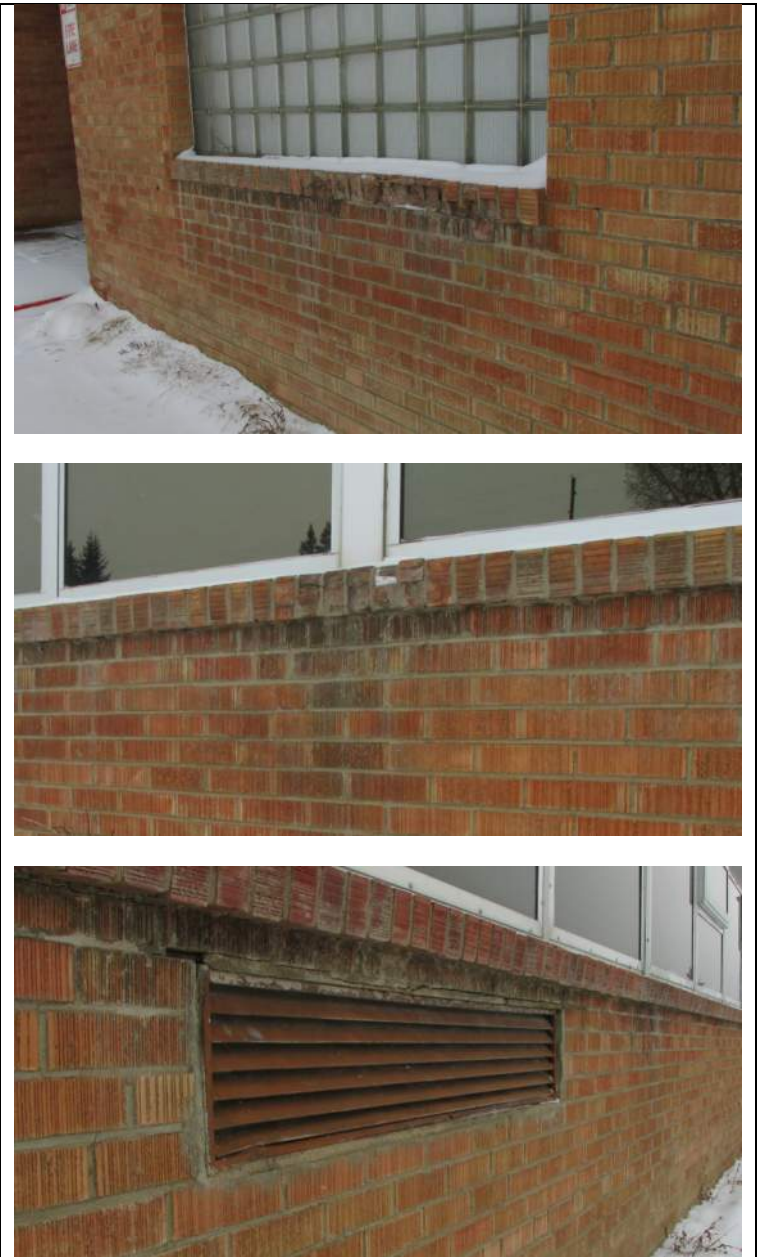
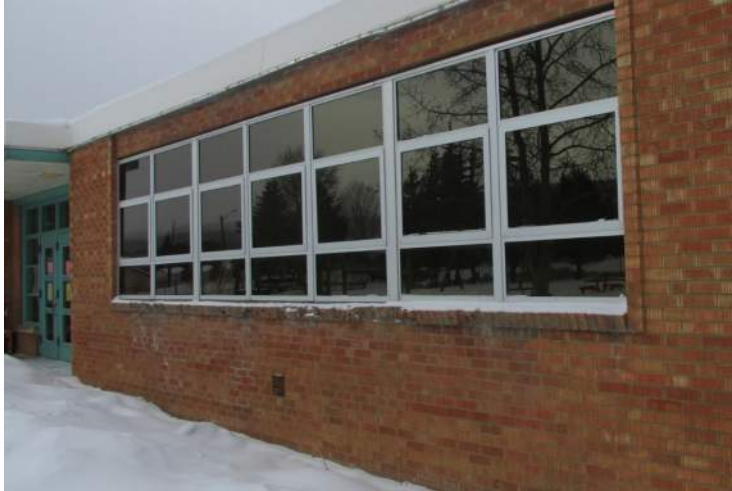
S-3	<p>The exterior brick walls have deteriorated and even eroded extensively around the building, especially below the windows. Removal and replacement of deteriorated brick and mortar followed by application of a sealer is recommended to prevent further deterioration of the walls and possible loss of structural integrity.</p>		X

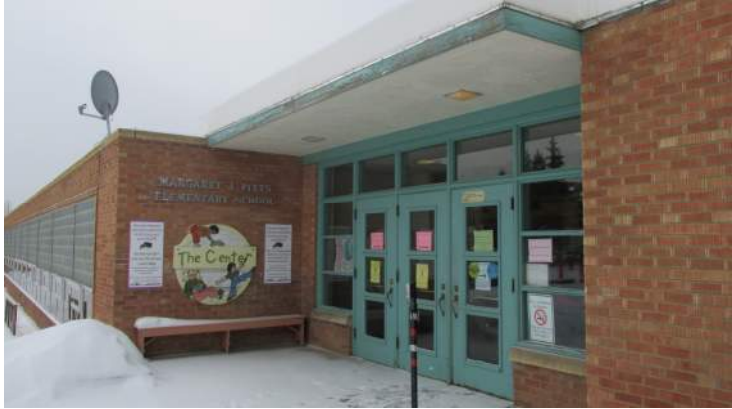
S-4	<p>The roof membrane has been wrapped down onto the fascia above the main entrance; however, the paint is wearing off of the portion of the wood fascia not covered by the membrane. Repainting is recommended to prevent the wood fascia from deteriorating.</p>		X

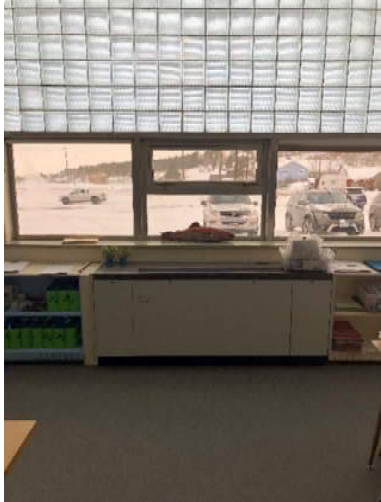
DISC. ITEM #	OBSERVATION / ISSUE / ITEM DESCRIPTION	PRIORITY LEVEL			PHOTOS
		LOW	MED	HIGH	
MP-1	Newer unit ventilator installation	X

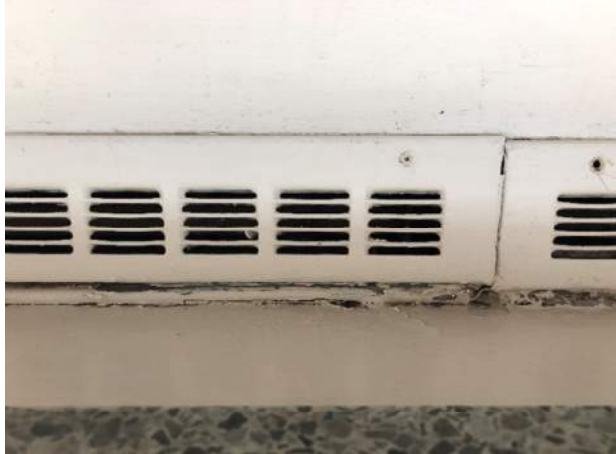
DISC. ITEM #	OBSERVATION / ISSUE / ITEM DESCRIPTION	PRIORITY LEVEL			PHOTOS
		LOW	MED	HIGH	
MP-2	Abandoned baseboard in millwork.			X

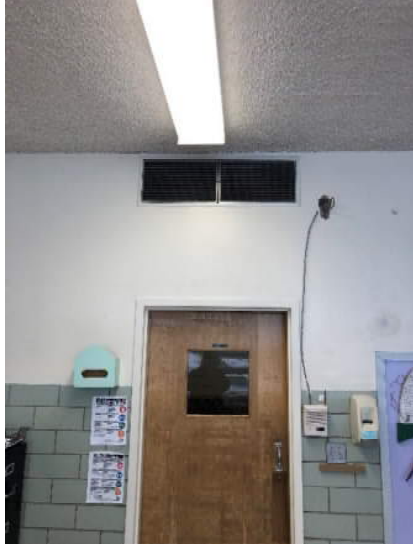
MP-3	Ventilation relief through soffit exhaust system.		X

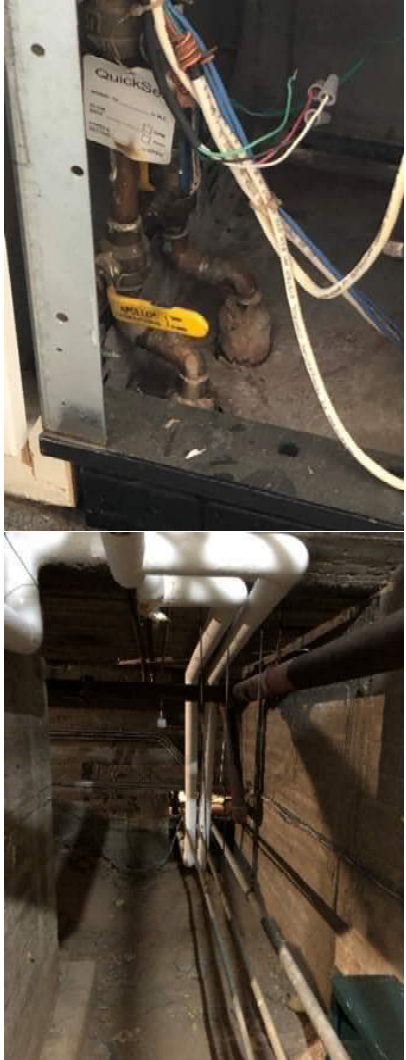
DISC. ITEM #	OBSERVATION / ISSUE / ITEM DESCRIPTION	PRIORITY LEVEL			PHOTOS
		LOW	MED	HIGH	
MP-4	Existing under slab mechanical piping still in service.			X

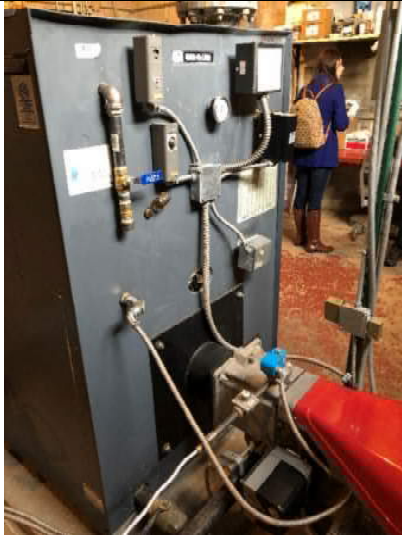
DISC. ITEM #	OBSERVATION / ISSUE / ITEM DESCRIPTION	PRIORITY LEVEL			PHOTOS
		LOW	MED	HIGH	
MP-5	Original hvac boilers with burner retrofit.		X

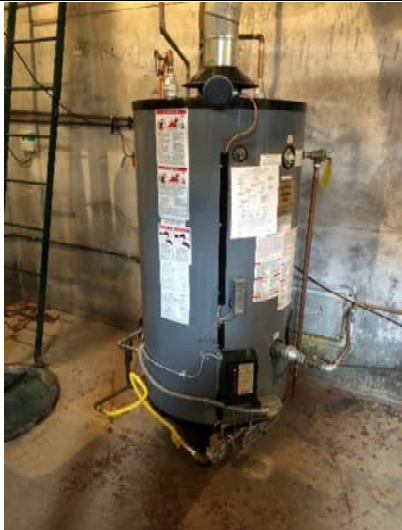
MP-6	New domestic water heater installation.	X

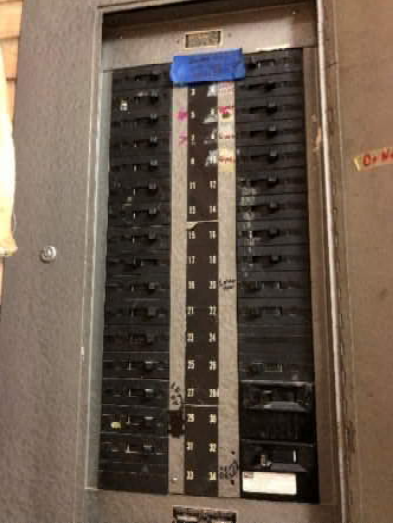
DISC. ITEM #	OBSERVATION / ISSUE / ITEM DESCRIPTION	PRIORITY LEVEL			PHOTOS
		LOW	MED	HIGH	
E-1	Original panelboard were provided with Federal Electric with not many spares/spaces available for additional loads. We recommend that existing single phase service is upgraded and panelboard to be replaced with new.		X

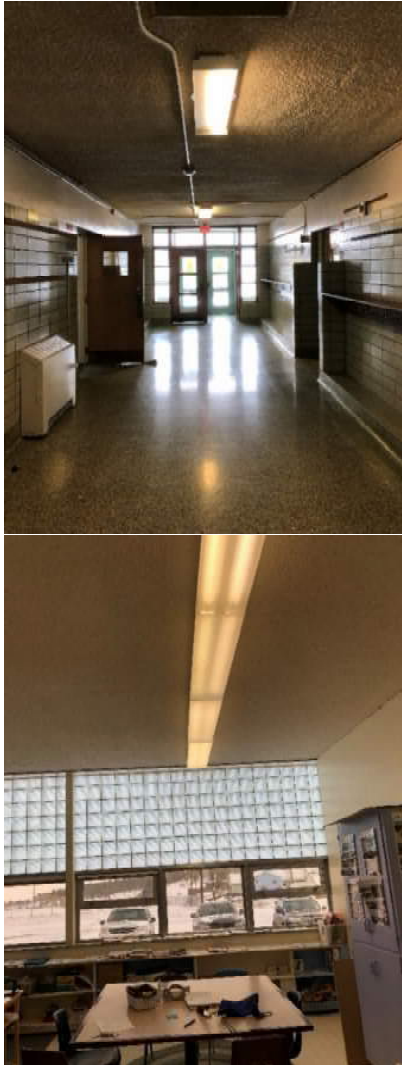
DISC. ITEM #	OBSERVATION / ISSUE / ITEM DESCRIPTION	PRIORITY LEVEL			PHOTOS
		LOW	MED	HIGH	
E-2	Existing linear fluorescent lighting. Corridors seems to be a bit dark. We recommend on replacing fixtures with LED (2x2 or linear).	X

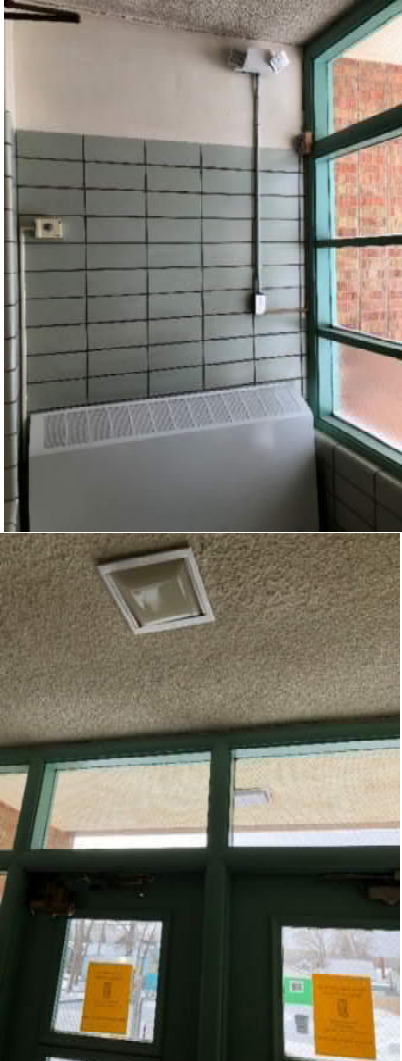
DISC. ITEM #	OBSERVATION / ISSUE / ITEM DESCRIPTION	PRIORITY LEVEL			PHOTOS
		LOW	MED	HIGH	
E-3	Existing battery packs were added throughout interior path of egress. Exterior emergency fixtures would need to be provided on all exterior egress doors since it is required by code.			X

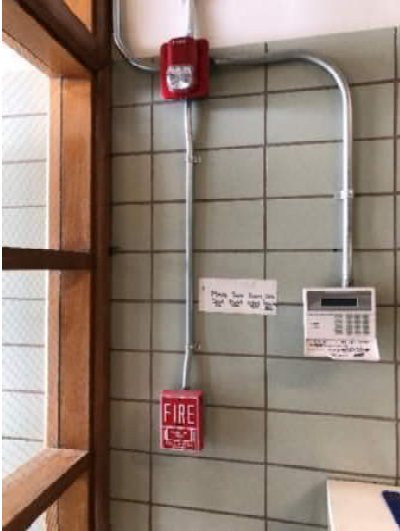
DISC. ITEM #	OBSERVATION / ISSUE / ITEM DESCRIPTION	PRIORITY LEVEL			PHOTOS
		LOW	MED	HIGH	
E-4	Existing horn/strobes would need to be replaced with new speaker strobes to accommodate voice evacuation system, if modification is required for fire alarm system.			X

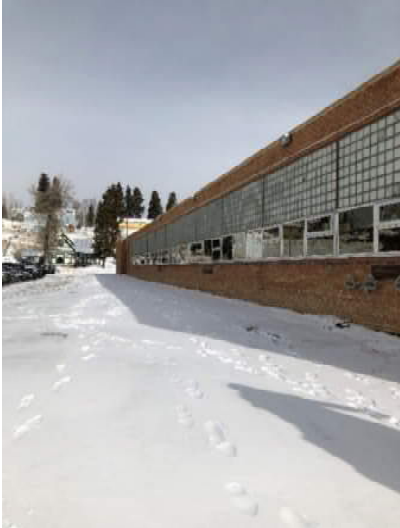
E-5	Existing area lighting is provided along building for both walkways and parking lot lighting. We recommend on providing forward throw wall mounted light or pole mounted light.		X
