Lake County School District R-1  
Facility Assessment Report

# WEST PARK ELEMENTARY SCHOOL

October 12, 2018

## WEST PARK ELEMENTARY SCHOOL ARCHITECTURAL FACILITY ASSESSMENT

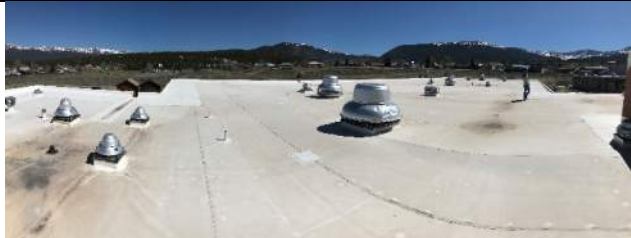
DISC. ITEM #	OBSERVATION / ISSUE / ITEM DESCRIPTION	PRIORITY LEVEL			PHOTOS
		LOW	MED	HIGH	
A-1	The existing TPO membrane roof has exceeded its 20 year life span, and should be replaced.

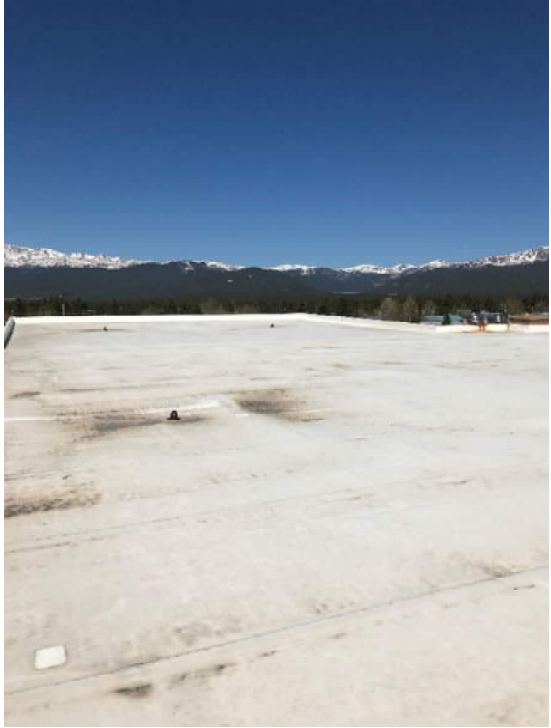
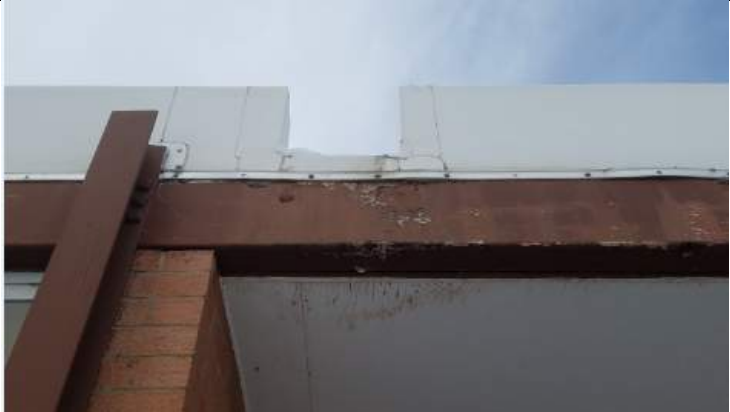
A-2	Roof scuppers along the perimeter of the building lack proper metal flashing drip edges, and as such have contributed to water damage at fascias and soffits. It is recommended that metal flashing be installed as part of the re-roofing, and fascias and soffits repaired or replaced.		X

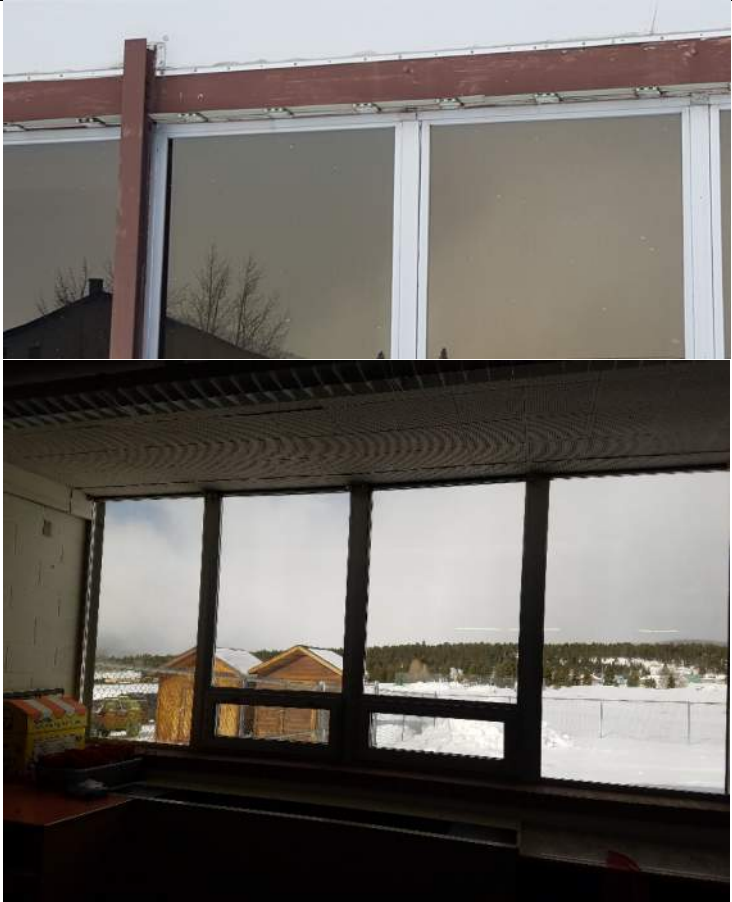
DISC. ITEM #	OBSERVATION / ISSUE / ITEM DESCRIPTION	PRIORITY LEVEL			PHOTOS
		LOW	MED	HIGH	
A-3	Aluminum windows appear to be original to the building, with areas of condensation noted. It is recommended that all windows are replaced with new high performance aluminum windows and glazing.			X

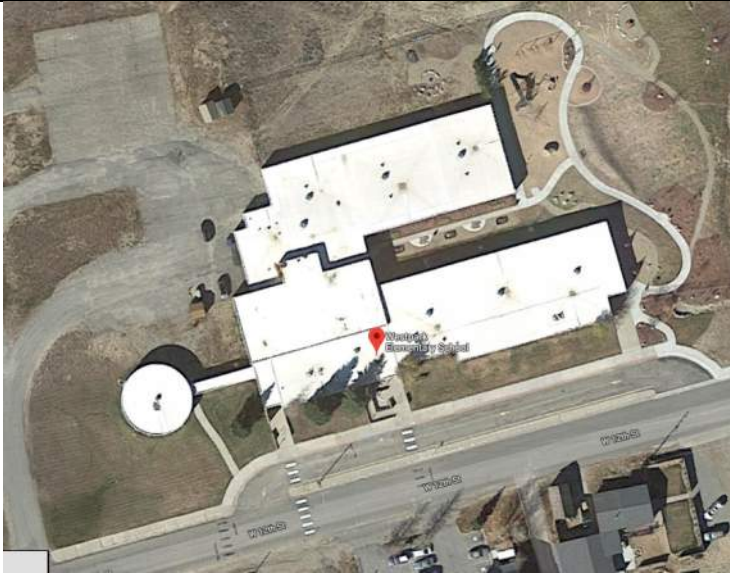
DISC. ITEM #	OBSERVATION / ISSUE / ITEM DESCRIPTION	PRIORITY LEVEL			PHOTOS
		LOW	MED	HIGH	
A-4	There is no ADA signed parking and paths on site. Recommend installation of a minimum of 2 ADA parking stalls adjacent to the main entry.		X

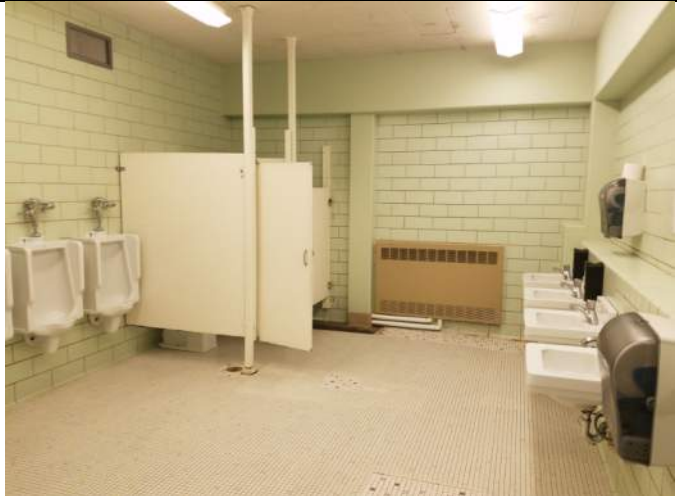
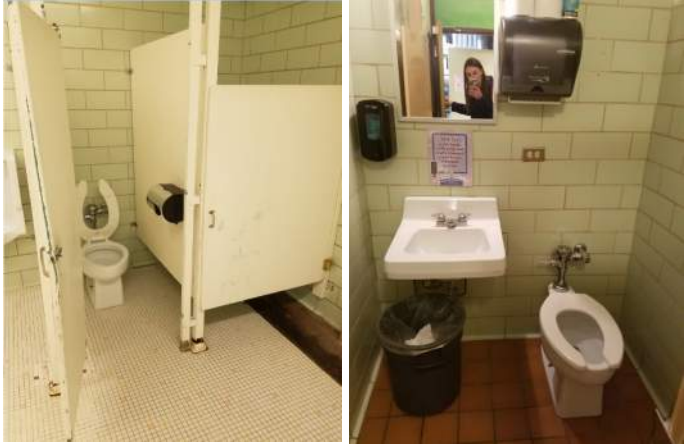
A-5	Multi fixture restrooms in the building are not ADA accessible. In addition, the fixtures and partitions are beyond their useful life. It is recommended that the restrooms are remodeled to incorporate full accessibility requirements.		X

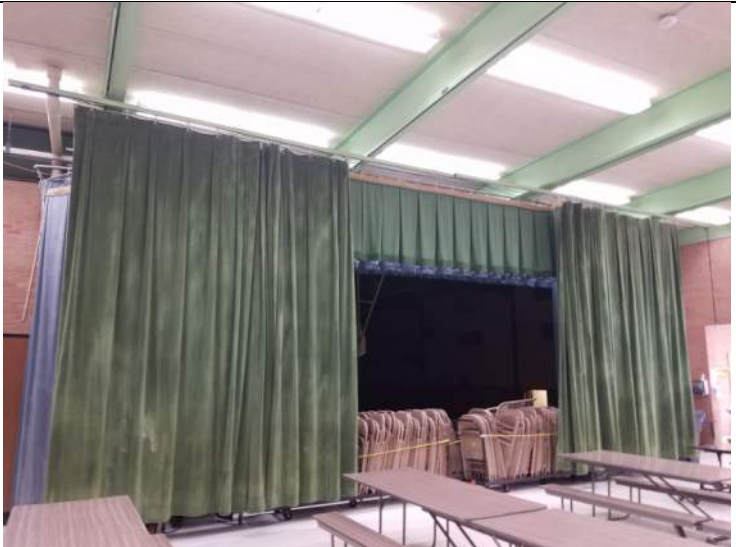
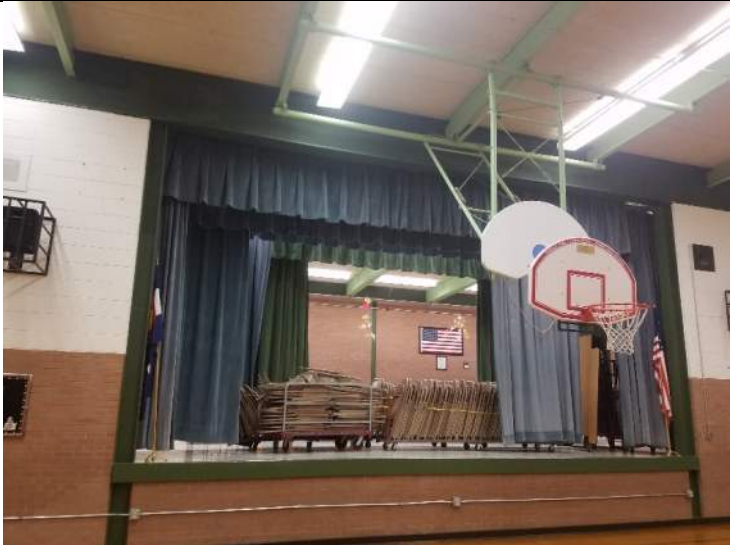
A-6	The stage curtains show signs of wear and tear, and are beyond their useful life and should be replaced. In addition, no safety barrier exists between the cafeteria and the edge of stage. Recommend providing a folding acoustic partition between the stage and gym.		X

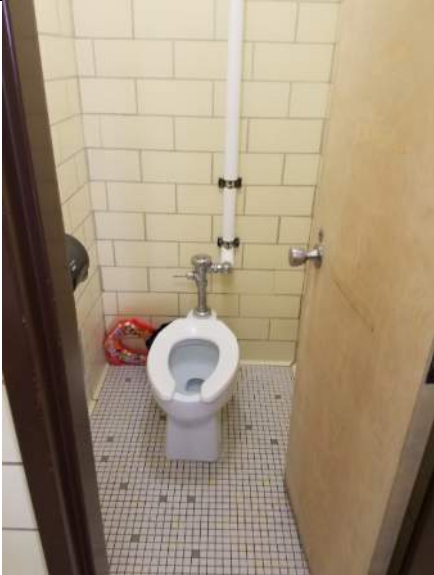
A-7	All classrooms appear to have the proper panic function lever type locks; however, other areas existing where non ADA hardware is in use. Recommend replacing all door knobs with levers.		X

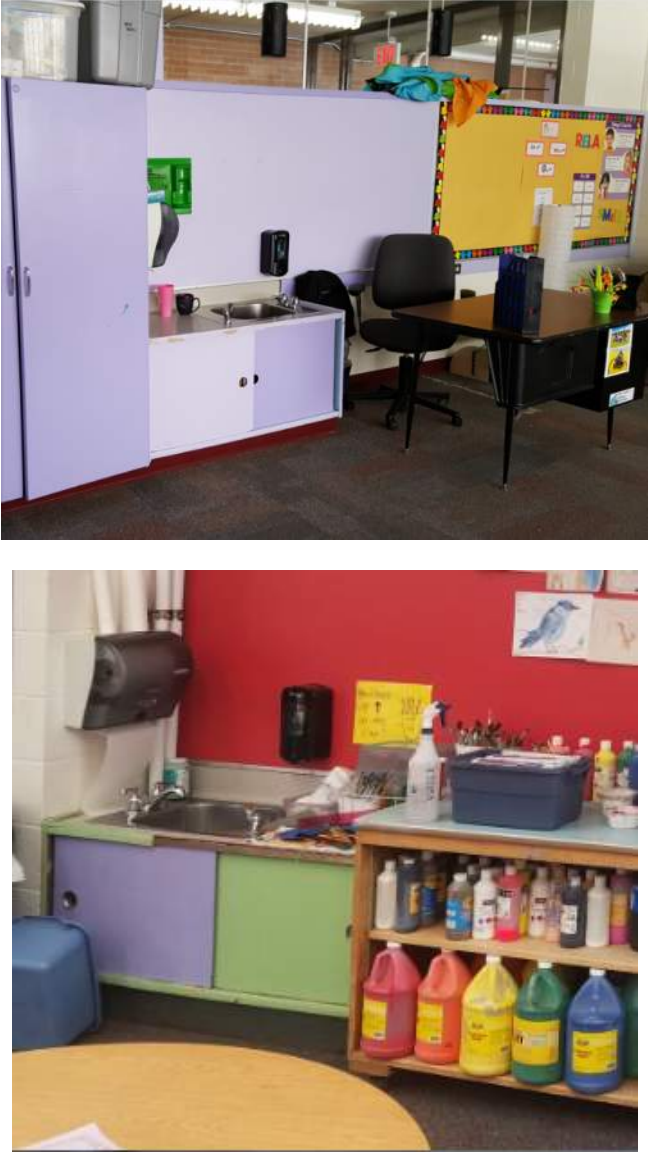
DISC. ITEM #	OBSERVATION / ISSUE / ITEM DESCRIPTION	PRIORITY LEVEL			PHOTOS
		LOW	MED	HIGH	
A-8	Casework is original to the building, and there are several areas where the plastic laminate is damaged. In addition, there are many areas where it is not ADA accessible. It is recommended that all casework in the building is replaced.			X

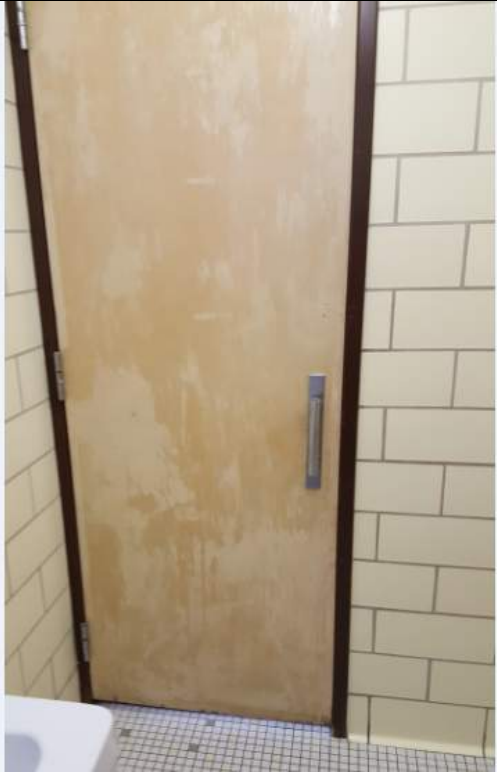
DISC. ITEM #	OBSERVATION / ISSUE / ITEM DESCRIPTION	PRIORITY LEVEL			PHOTOS
		LOW	MED	HIGH	
A-9	Many wood doors show signs of damage, wear and tear. It is recommended that all interior doors in the building are replaced.		X

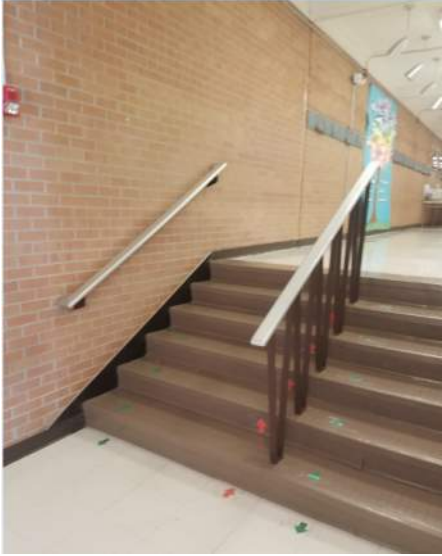
DISC. ITEM #	OBSERVATION / ISSUE / ITEM DESCRIPTION	PRIORITY LEVEL			PHOTOS
		LOW	MED	HIGH	
A-10	Handrails do not meet current accessibility requirements. It is recommended that these be replaced.		X

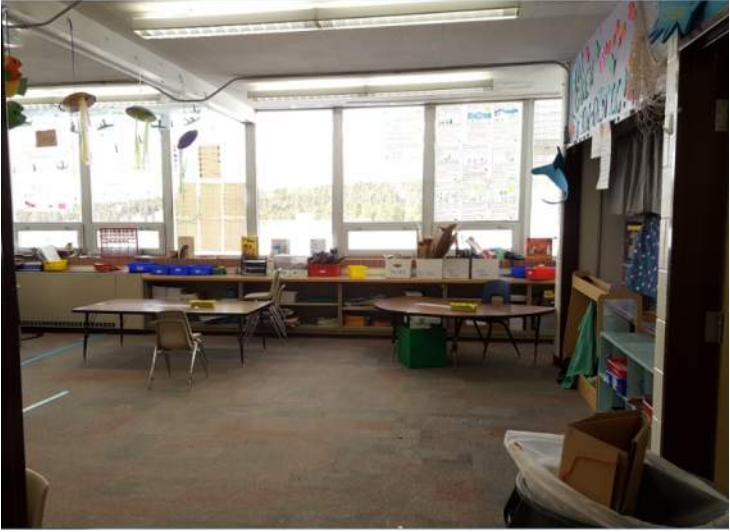
A-11	Carpeting throughout building is still in serviceable condition, however it is nearing the end of its life cycle. Replacement throughout recommended.		X

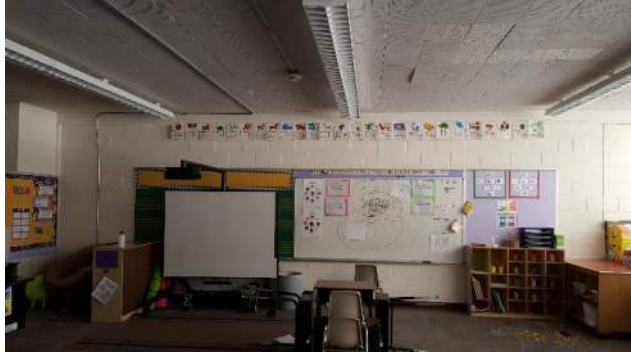
DISC. ITEM #	OBSERVATION / ISSUE / ITEM DESCRIPTION	PRIORITY LEVEL			PHOTOS
		LOW	MED	HIGH	
A-12	Ceilings throughout are original 12"x12" tile, with some areas missing tiles or with damaged tiles. Recommend providing new dropped acoustical ceiling tile system throughout for improved acoustics and appearance.

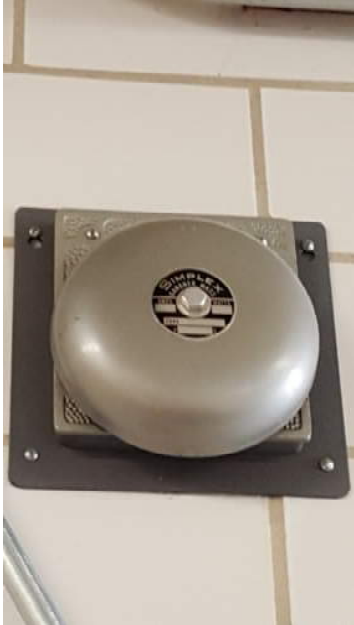
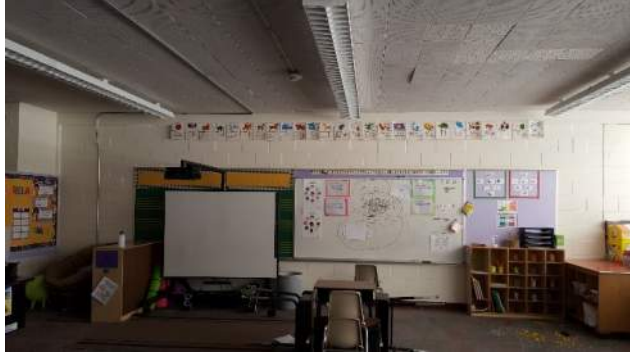
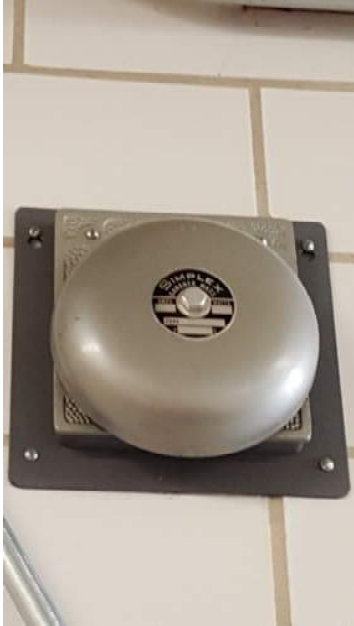
A-13	Bell system is original to school. Recommend replacing with new Bell and PA system.

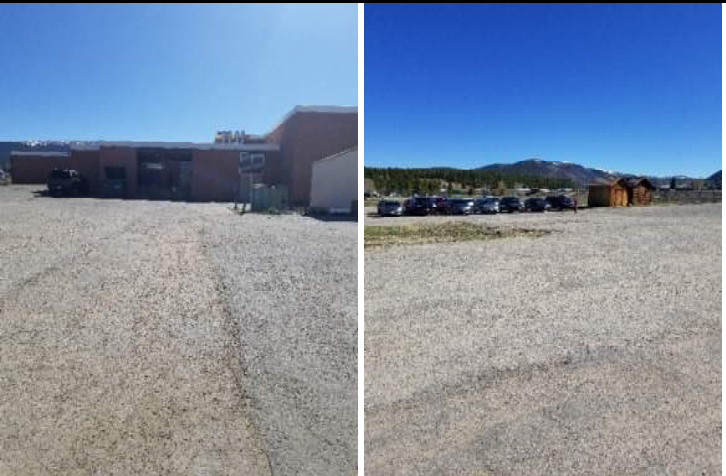
DISC. ITEM #	OBSERVATION / ISSUE / ITEM DESCRIPTION	PRIORITY LEVEL			PHOTOS
		LOW	MED	HIGH	
C-1	Asphalt in northwest parking lot and associated drives is at end of useful life. Recommend replacement.

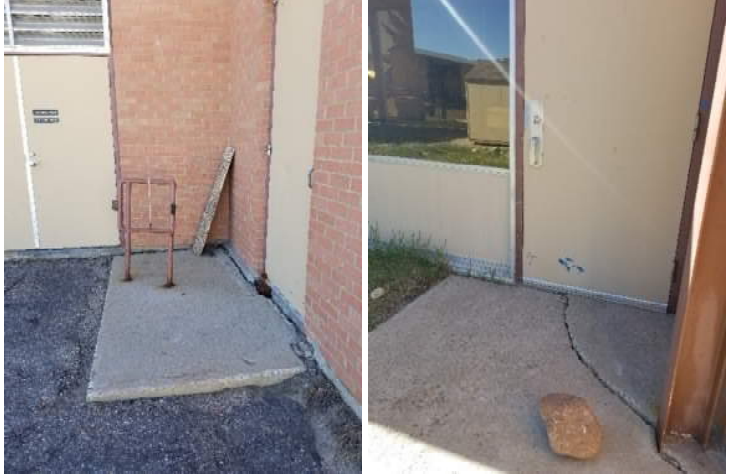
DISC. ITEM #	OBSERVATION / ISSUE / ITEM DESCRIPTION	PRIORITY LEVEL			PHOTOS
		LOW	MED	HIGH	
C-3	Concrete stoops at several doors have experienced movement or damage and are out of conformance with current code. Recommend selective replacement.

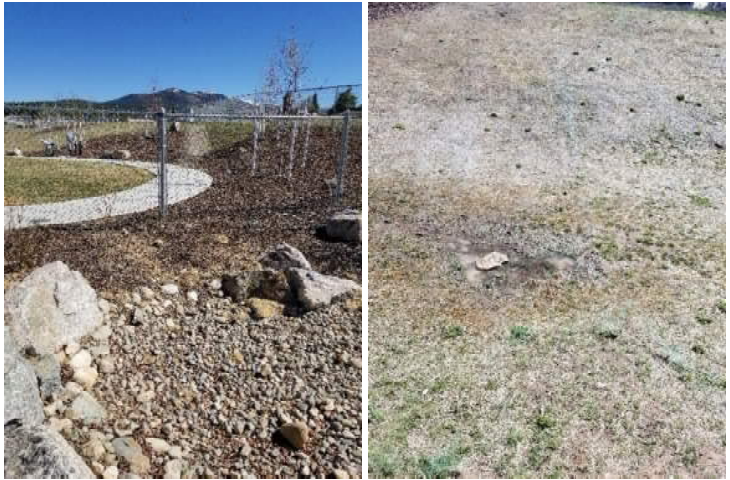
C-4	Playground drainage was noted to not function as intended. Small ponding occurs in softscape and at the installed dry well. Recommend remove and replace with positive drainage away from low points.

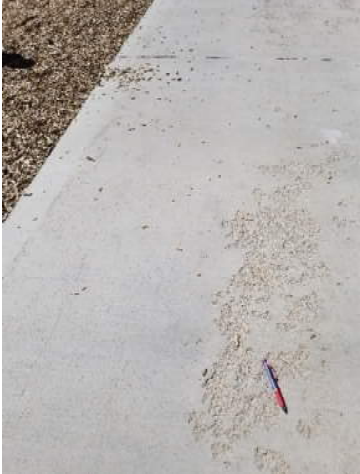
DISC. ITEM #	OBSERVATION / ISSUE / ITEM DESCRIPTION	PRIORITY LEVEL			PHOTOS
		LOW	MED	HIGH	
C-5	Concrete walks at playground are experiencing spalling. Recommend routine maintenance to extend service life.

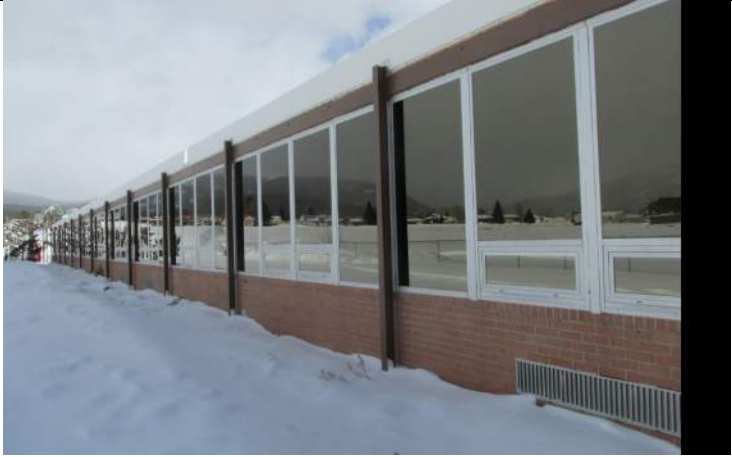
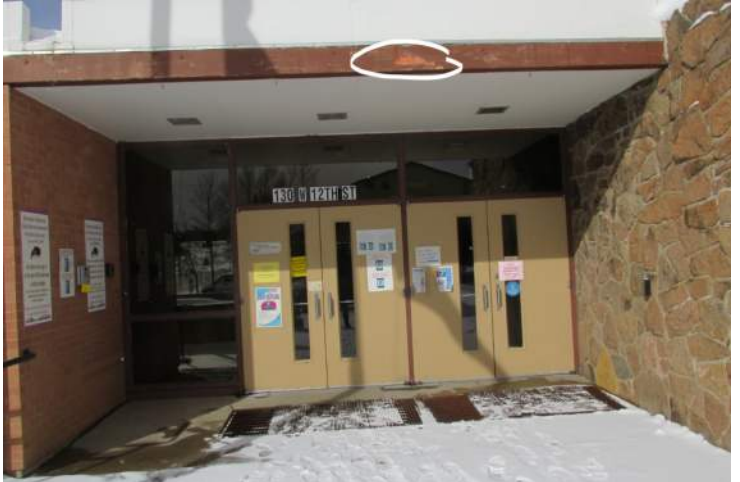
DISC. ITEM #	OBSERVATION / ISSUE / ITEM DESCRIPTION	PRIORITY LEVEL			PHOTOS
		LOW	MED	HIGH	
S-1	The exterior steel columns and metal fascia around the perimeter appear to have been painted fairly recently. The paint is streaked but corrosion does not appear to be present. The roof membrane has been wrapped down onto the metal fascia and partially covers it. The exposed steel should be periodically inspected for signs of corrosion.	X

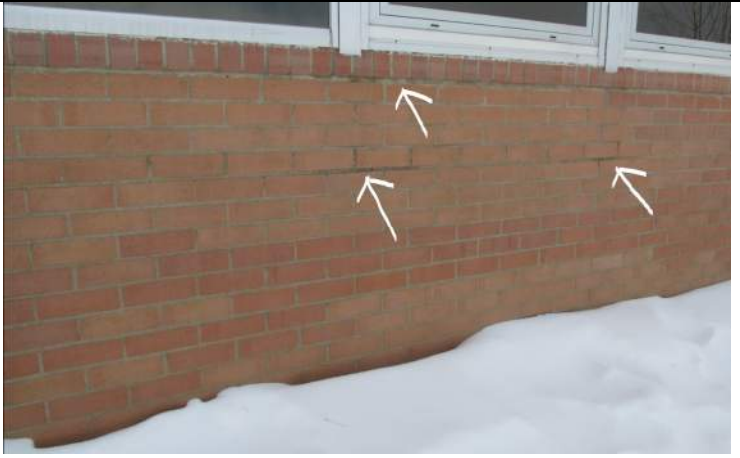
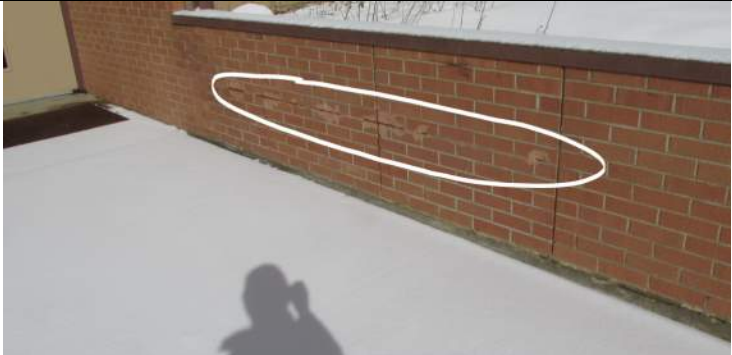
S-2	The exterior brick walls generally appear to be in good condition for the age of the building. There are a few isolated areas where weathered mortar joints or damaged brick could be repaired for visual reasons and to maintain the weather-resistant characteristics of the wall system.	X

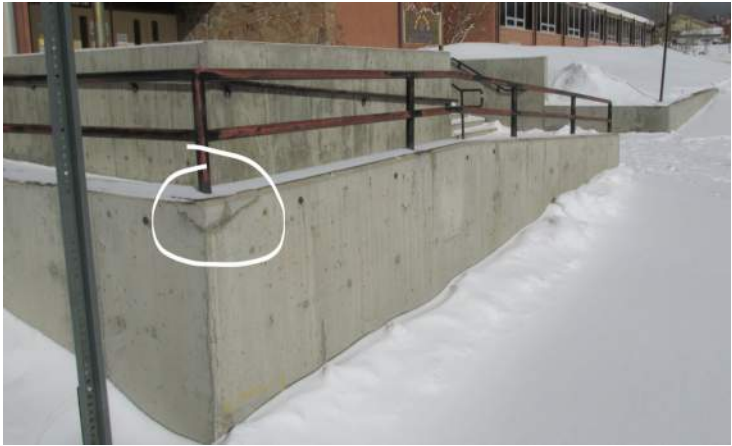
S-3	The concrete retaining walls at the main entrance appear to be in good condition with only minor cosmetic cracking in isolated locations. The steel rails appear to have been painted fairly recently. The paint is streaked but corrosion does not appear to be present.	X

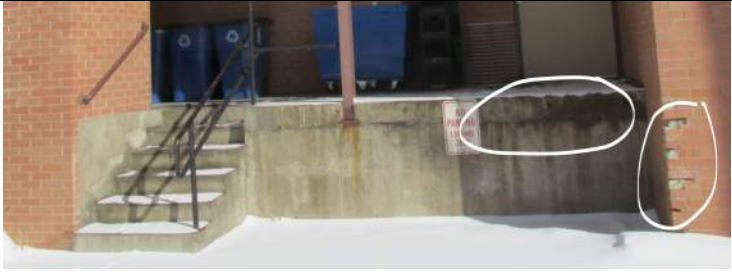
S-4	Signs of wear and tear are evident at the loading dock. Repairs would be primarily for visual reasons and to maintain the weather-resistant characteristics of the walls.	X

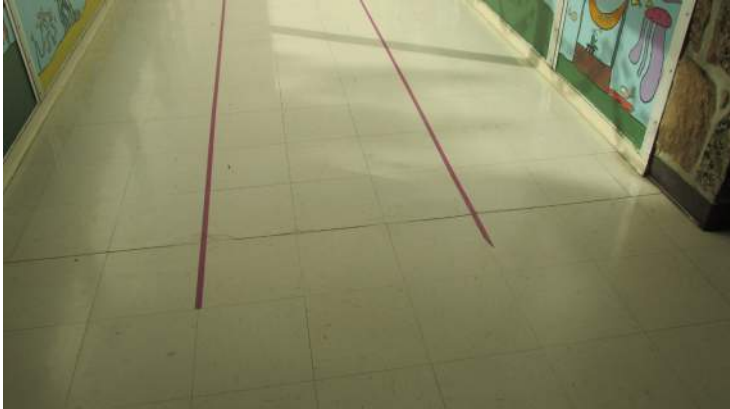
DISC. ITEM #	OBSERVATION / ISSUE / ITEM DESCRIPTION	PRIORITY LEVEL			PHOTOS
		LOW	MED	HIGH	
S-5	Signs of interior slab-on-grade movement were not observed except for some minor separation of the vinyl floor covering in a few isolated locations, possibly due to slab contraction.	X

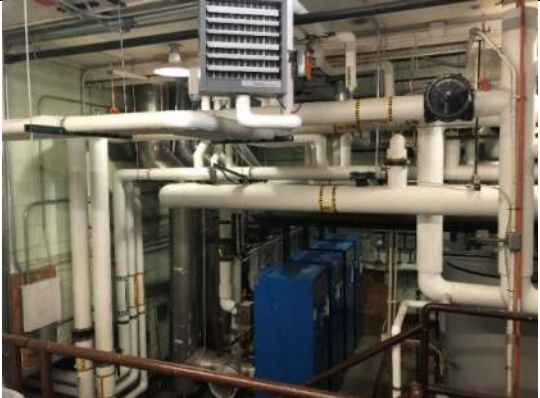
DISC. ITEM #	OBSERVATION / ISSUE / ITEM DESCRIPTION	PRIORITY LEVEL			PHOTOS
		LOW	MED	HIGH	
MP-1	Newer boiler installation.	X

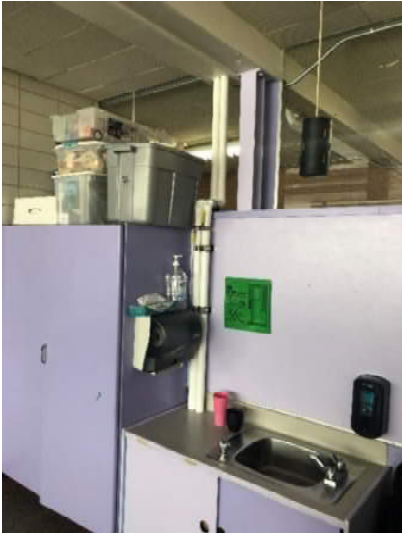
DISC. ITEM #	OBSERVATION / ISSUE / ITEM DESCRIPTION	PRIORITY LEVEL			PHOTOS
		LOW	MED	HIGH	
MP-2	Piping replacement, note overhead soffited distribution to replace previously installed underslab piping. (Ref. Pitts Elementary.)

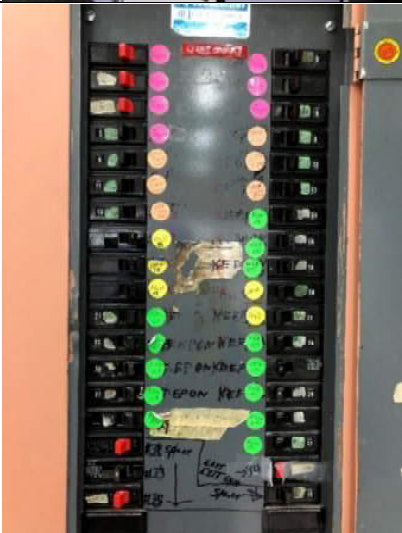
E-1	Original panelboard were provided with ITE with not many spares/spaces available for additional loads. We recommend that existing panelboard to be replaced with new.	X

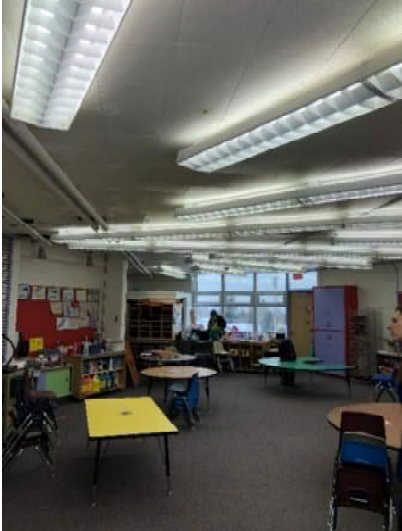
DISC. ITEM #	OBSERVATION / ISSUE / ITEM DESCRIPTION	PRIORITY LEVEL			PHOTOS
		LOW	MED	HIGH	
E-2	Existing fluorescent lighting in art/music classroom seems to be a bit excessive. We recommend replacing it with LED and less fixture quantity.	X

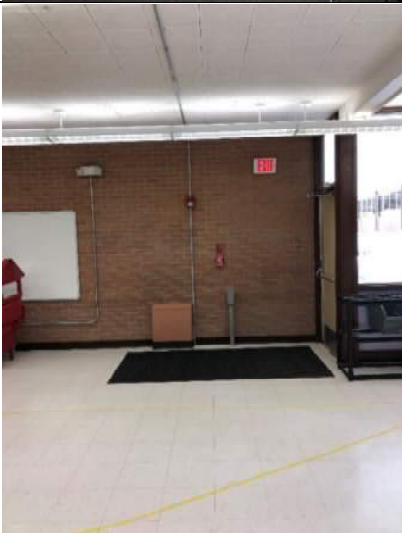
E-3	Existing battery packs were added throughout interior path of egress. Exterior emergency fixtures would need to be provided on all exterior egress doors since it is required by code.			X

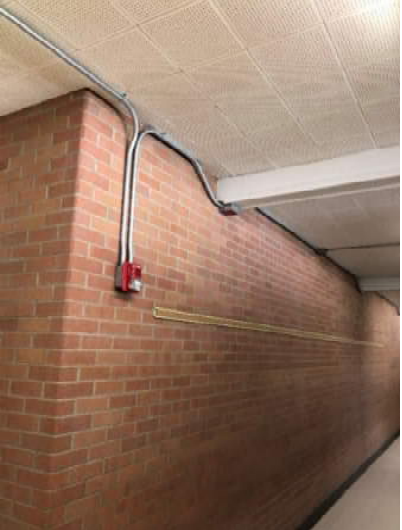
DISC. ITEM #	OBSERVATION / ISSUE / ITEM DESCRIPTION	PRIORITY LEVEL			PHOTOS
		LOW	MED	HIGH	
E-4	Existing horn/strobes would need to be replaced with new speaker strobes to accommodate voice evacuation system, if modification is required for fire alarm system.			X

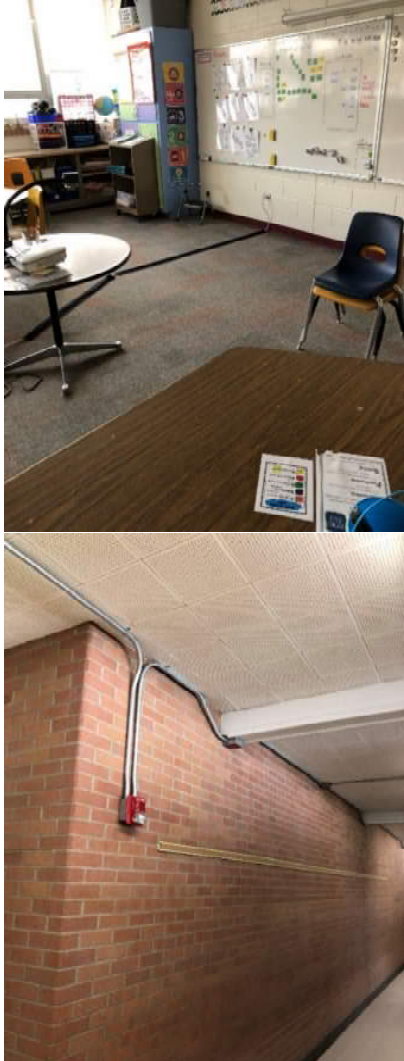
DISC. ITEM #	OBSERVATION / ISSUE / ITEM DESCRIPTION	PRIORITY LEVEL			PHOTOS
		LOW	MED	HIGH	
E-5	Existing power strips were provided to serve additional power requirement in classrooms, etc. We recommend providing additional outlets in each classroom.		X
