Lake County School District  
Learning Beyond Walls

# 2019 MASTER PLAN

FEBRUARY 15, 2019

## 2019 MASTER PLAN

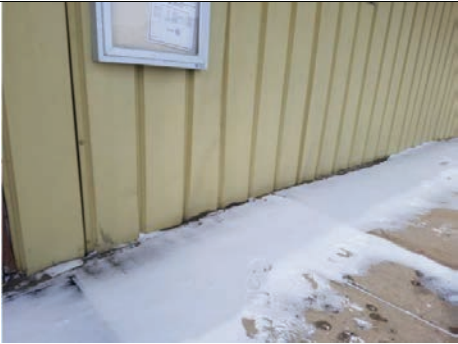
A-3	Exterior damage to building envelope potentially contributing to water intrusion. Recommend repair or replacement of siding.		X

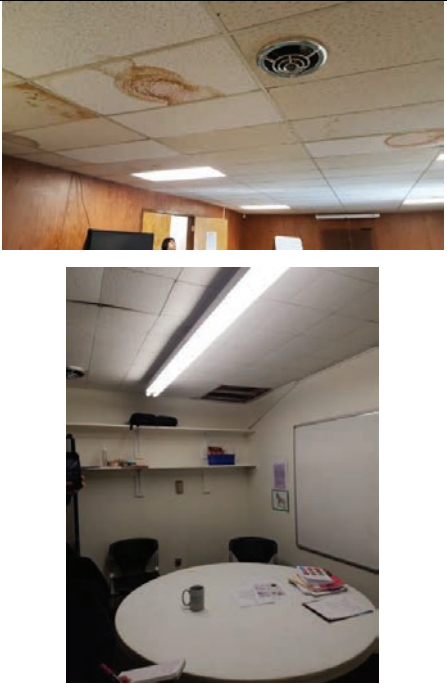
TREANORHL					
Page 7 of 12 Lake County School District Architectural Facility Assessment – DISTRICT ADMINISTRATION OFFICES Project #: ED0480.0003.00 Issue Date: 10/12/2018					
A-7	Water staining observed in multiple locations at ceiling tile. Further investigation into integrity of roofing and structure recommended; followed by roofing and ceiling replacement.			X

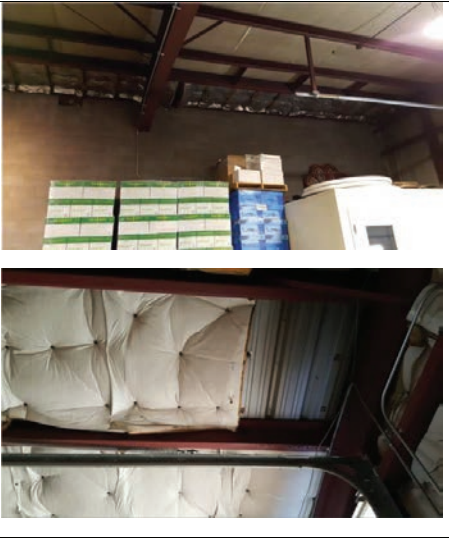
A-10	Miscellaneous area of insulation in garage area is in disrepair or falling from ceiling. Recommend replacement and resecurement. Note that if the roof is required to be replaced, all insulation (existing and new) will need to meet the current energy code.	X

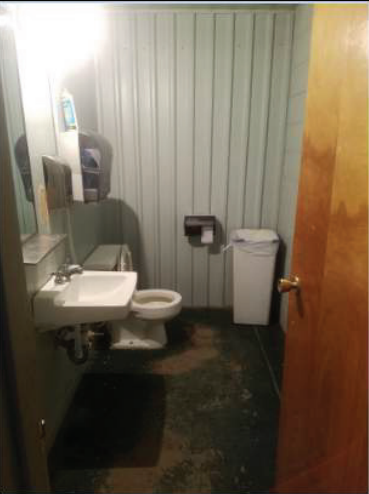
A-11	No ADA accessible toilet facility is available in the garage portion of the building. Recommend modification of existing facility, if possible, to create accessible restroom.	X

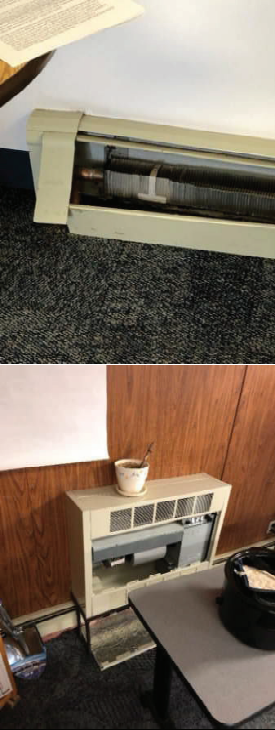
DISC. ITEM #	OBSERVATION / ISSUE / ITEM DESCRIPTION	PRIORITY LEVEL			PHOTOS
		LOW	MED	HIGH	
MP-1	Existing baseboard and cabinet unit heaters in poor condition and in need of replacement.			X

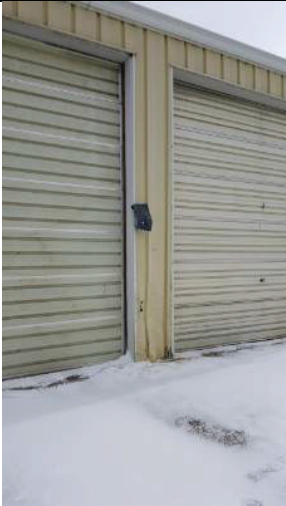
DISC. ITEM #	OBSERVATION / ISSUE / ITEM DESCRIPTION	PRIORITY LEVEL			PHOTOS
		LOW	MED	HIGH	
A-2	Some areas of damage to the building, primarily at the garage door entries, noted. Recommend repair of the panels and the installation of steel bollards for building protection.

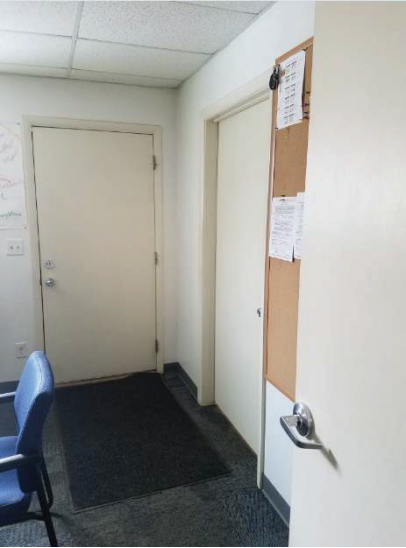
DISC. ITEM #	OBSERVATION / ISSUE / ITEM DESCRIPTION	PRIORITY LEVEL			PHOTOS
		LOW	MED	HIGH	
A-7	Some door hardware within building is not ADA compliant; recommend replacing non-compliant knobs with levers.

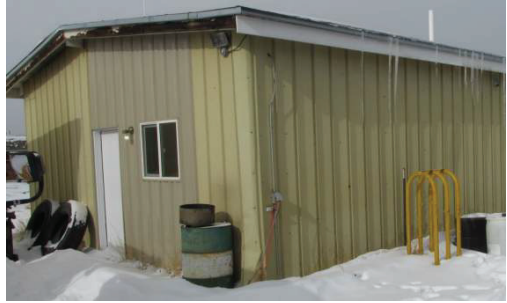
DISC. ITEM #	OBSERVATION / ISSUE / ITEM DESCRIPTION	PRIORITY LEVEL			PHOTOS
		LOW	MED	HIGH	
S-2	The paint has worn off of the wood fascia at the south wall of the office bumpout leaving it exposed to the elements. Repair is recommended to prevent further deterioration.	X

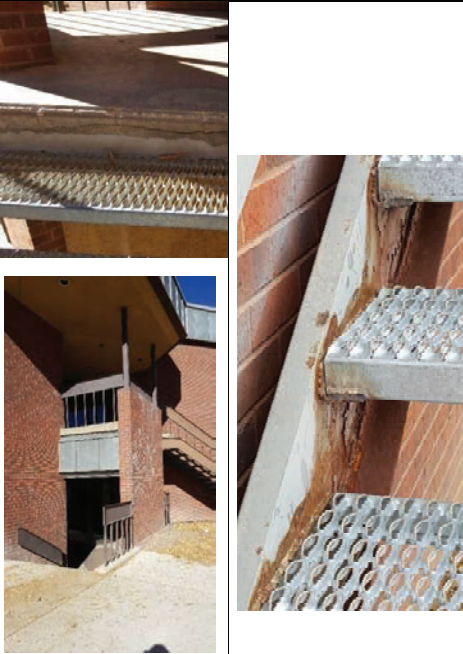
DISC. ITEM #	OBSERVATION / ISSUE / ITEM DESCRIPTION	PRIORITY LEVEL			PHOTOS
		LOW	MED	HIGH	
A-2	All exterior stairs at the building have varying levels of erosion and are in need of repair. Guardrails and handrails should also be replaced to meet current code and increase safety. See Supplemental Exhibit at end of this report for locations.

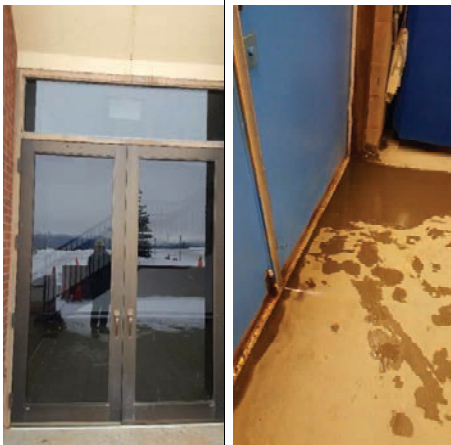
DISC. ITEM #	OBSERVATION / ISSUE / ITEM DESCRIPTION	PRIORITY LEVEL			PHOTOS
		LOW	MED	HIGH	
A-3	Exterior Windows and doors are at the end of their useful life; recommend replacement. See Supplemental Exhibit at the end of this report for door locations.

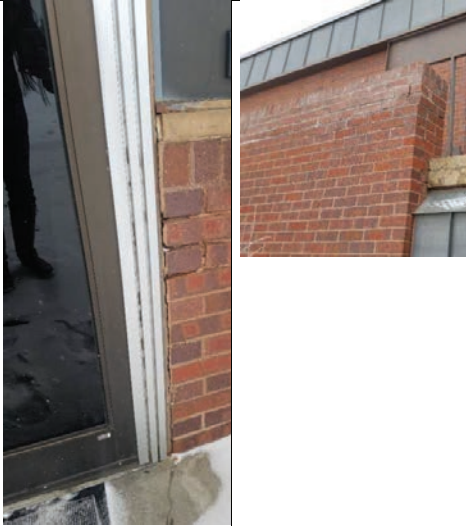
DISC. ITEM #	OBSERVATION / ISSUE / ITEM DESCRIPTION	PRIORITY LEVEL			PHOTOS
		LOW	MED	HIGH	
A-6	Some areas of damaged brick noted on exterior of building. Recommend re-tooling or replacement.

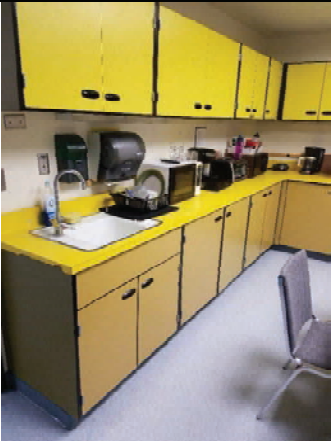
DISC. ITEM #	OBSERVATION / ISSUE / ITEM DESCRIPTION	PRIORITY LEVEL			PHOTOS
		LOW	MED	HIGH	
A-7	Casework throughout is original to the building, and in poor shape as well as non-ADA compliant. Recommend replacing all casework throughout.

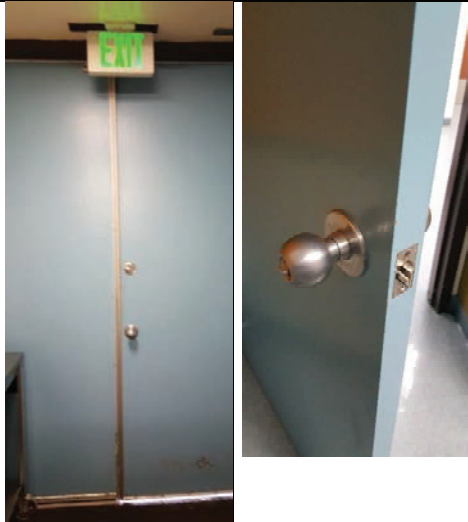
DISC. ITEM #	OBSERVATION / ISSUE / ITEM DESCRIPTION	PRIORITY LEVEL			PHOTOS
		LOW	MED	HIGH	
A-8	Doors at academic core areas, music rooms, and kitchen/gym area are in poor shape and have non-ADA compliant hardware. Recommend replacing with new doors and compliant hardware. See Supplemental Exhibit at the end of this report for locations.

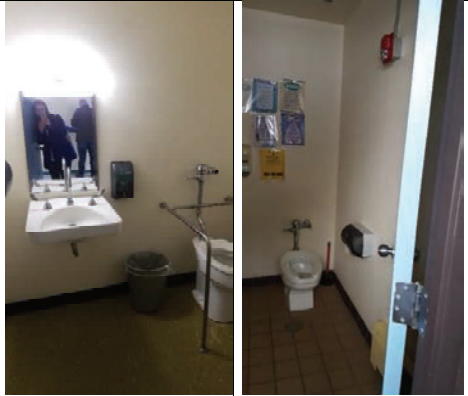
DISC. ITEM #	OBSERVATION / ISSUE / ITEM DESCRIPTION	PRIORITY LEVEL			PHOTOS
		LOW	MED	HIGH	
A-12	Single fixture restrooms throughout the building have varying levels of accessibility. Recommend making improvements to the extent feasible, including adding grab bars and replacing fixtures.

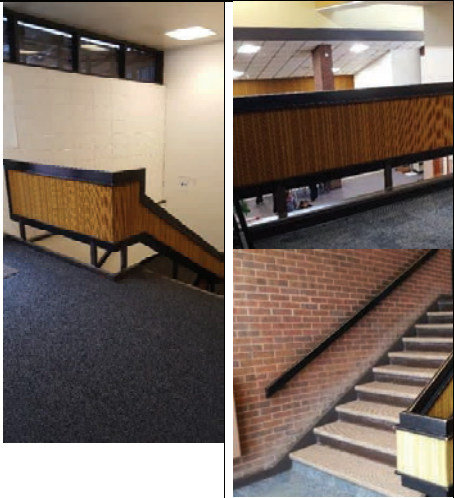
DISC. ITEM #	OBSERVATION / ISSUE / ITEM DESCRIPTION	PRIORITY LEVEL			PHOTOS
		LOW	MED	HIGH	
A-13	Interior railings and guardrails throughout the building are not compliant with current code. While not required to be replaced, it is recommended for additional student safety. See attached Supplemental Exhibit at the end of this report for locations.

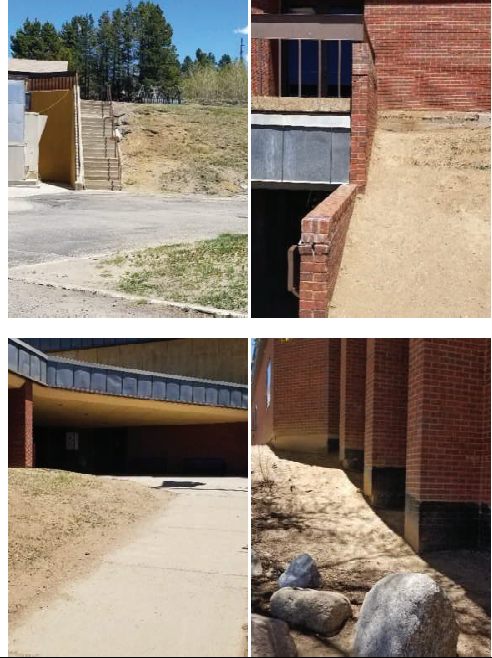
DISC. ITEM #	OBSERVATION / ISSUE / ITEM DESCRIPTION	PRIORITY LEVEL			PHOTOS
		LOW	MED	HIGH	
C-2	Several slopes across the site have evidence of experiencing erosion. Recommend erosion control measures to be installed in selective locations.

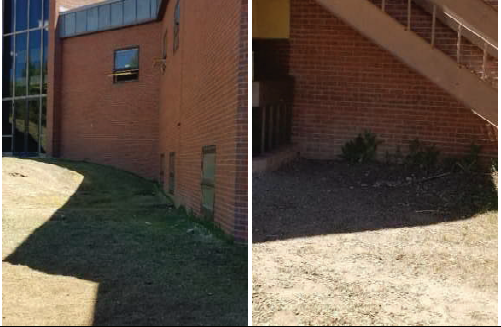
DISC. ITEM #	OBSERVATION / ISSUE / ITEM DESCRIPTION	PRIORITY LEVEL			PHOTOS
		LOW	MED	HIGH	
C-6	Some grades adjacent the building do not have adequate slope away, causing ponding near or against the building. Recommend regrading and replacement of vegetation.

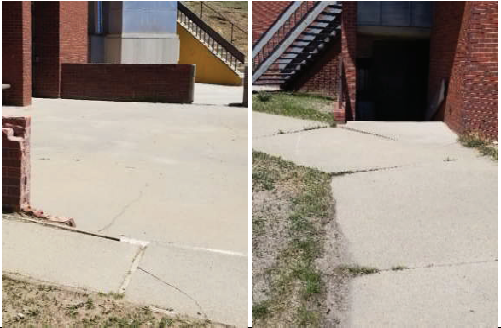
C-7	Older concrete walks on site have experienced minor cracking and slab movement. Recommend maintenance to reduce effects of freeze/thaw and remove trip hazards caused by grade differences.

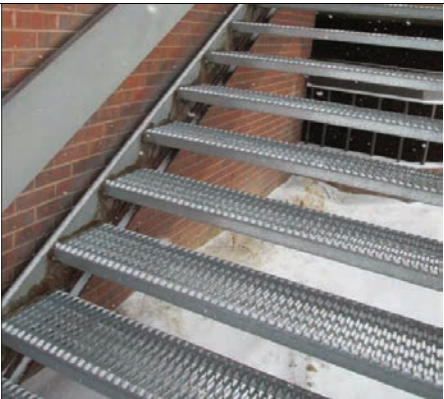
<p>↑West wing (west side)</p>

S-2	The stringers for the four exterior steel stairs (two at the end of the west wing and two at the end of the east wing) are severely corroded and should be replaced.			X	<div>

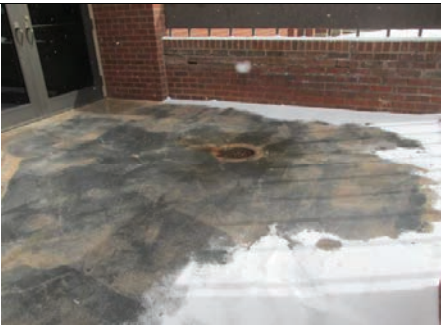
<p>↑Exterior landing at library entrance</p>

S-3	The exterior landing slab at the entrance to the library has cracks in it and signs of water intrusion are evident on the surface of the soffit below. Further investigation is required to determine the condition of the landing structure and what repairs will be required.			X	<div>

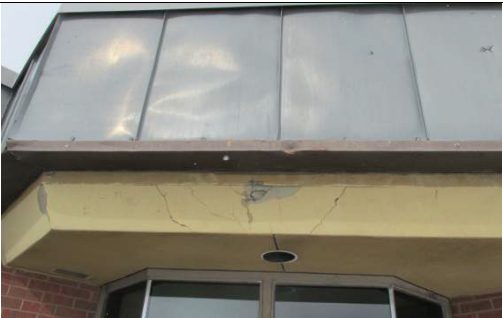
S-4	The soffits at the loading dock area have been damaged. Repair may be necessary to prevent water intrusion.	X
