2023 MASTER PLAN UPDATE

4 2023 MASTER PLAN UPDATE Lake County School District

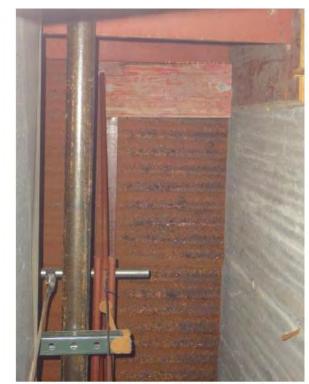
Photo 4: Rust on 2nd floor deck
