Lake County School District Board of Education Sept. 14, 2021 5:00 pm Regular Meeting Location: District Office-Room 11 & via Zoom

School Facility Condition Report

Lake County R-1

Lake County MS

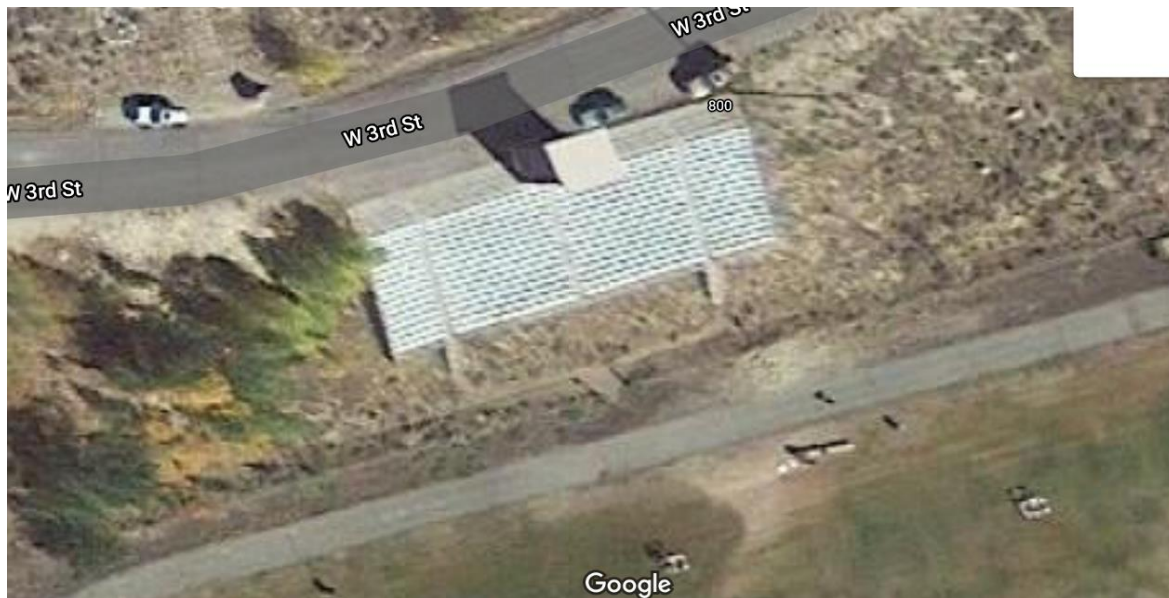
The Federico Field grandstands were originally built in 1962 and are 384 square feet. They are wood bleachers on a steel support structure. The grandstands have now deteriorated and are not structurally safe. They need to be removed and disposed of.

After completion of the stairs, we will remove or expand the existing fencing surrounding the grandstand. We will then brace the damaged structural support and begin removal of all aluminum bleacher components by hand. Once aluminum is removed, we will begin demolition of the announcers booth at the top of the grandstand utilizing the mini excavator. All debris will be staged and loaded out at the flat area adjacent to W. 3rd St near the top of the Grandstands. When the announcers booth is complete, we will begin demolition of the concrete support structure of the grandstand. We will start at the top and work down, moving debris to the top of the hill as we go. After demolition is complete, we will dispose of all site debris utilizing side dump trailers.

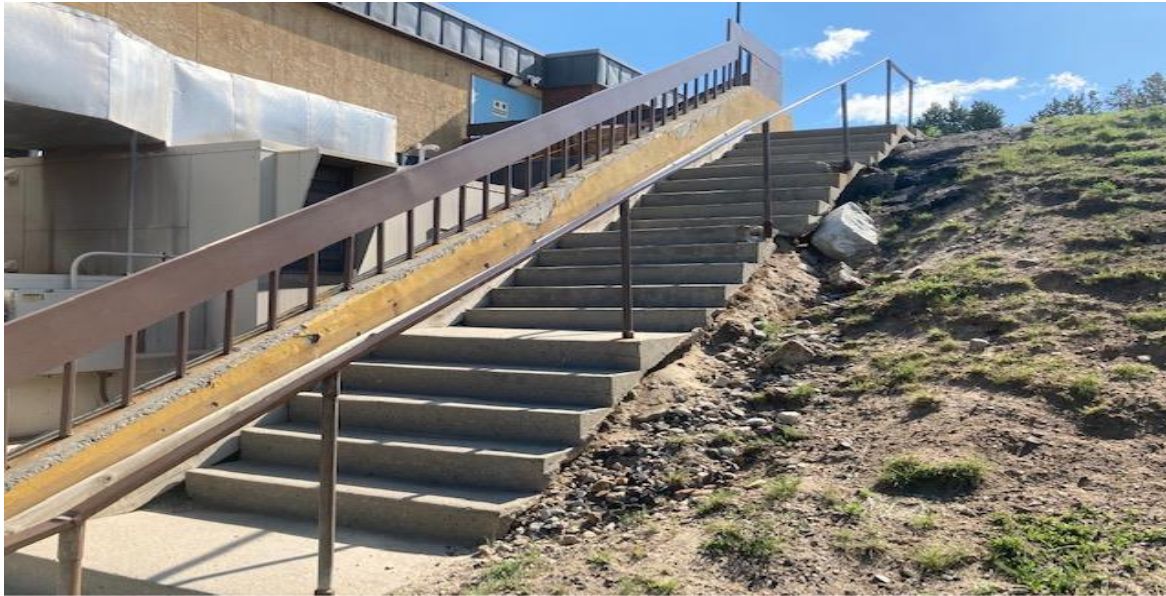
Lake County Intermediate School was built in 1976 and is 142,600 square feet. The three story steel structure, steel framing and decking, non-load bearing exterior masonry, stucco, and

metal panels, slab on grade and composite deck. The stairs are on the south side of the building

1. Demolition and disposal of the set of stairs located on the south side of Lake County Intermediate School Care will be taken not to impact the adjacent retaining wall. Vintage will work with the C.O.O. and maintenance department to determine what to do with the remaining railing above the retaining wall.
2. Disconnect Utilities and demolish/dispose of the announcer box at the top of the Federico Field grandstand
3. Removal and salvage of aluminum bleachers.
4. Demolition and disposal of the structurally unsafe concrete support structure.
5. Return existing terrain to grade at both locations

Vintage Environmental will have all utilities disconnected at any required location. Once utility disconnects are complete and verified, we will begin by safely demolishing the stair set at Lake County Intermediate School. We will utilize a mini-excavator equipped with a jackhammer attachment to perform the demolition. Beginning at the top and working down, the stair set will be pulled away from the retaining wall as it is demolished. Care will be taken not to damage the retaining wall or attached railing. The railing on the south side of the stairs will be removed with the stairs. All debris will be disposed of in a side dump truck. We will return the underlying hill to grade as it appears the underlying substrate has gradually washed out from below the stairs.

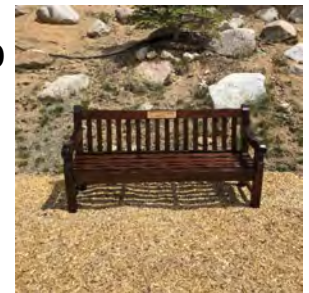
Site Furnishings - Wood Bench

Current Age:	5 years	Year Installed:	2016
Exp. Use. Life:	30 years	Obs. Yrs. Rem:	25 years
Quantity:	1 Each	Unit Cost:	\$998.69
Insp. Date:	7/21/21	Inspector:	Tim Cissell

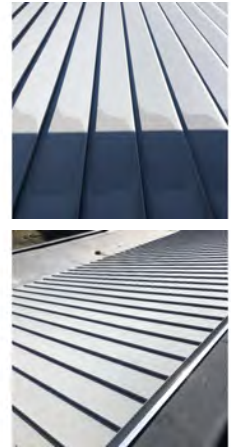
Metal Roofing

Current Age:	44 years	Year Installed:	1977
Exp. Use. Life:	65 years	Obs. Yrs. Rem:	21 years
Quantity:	24,973 SF	Unit Cost:	\$18.39
Insp. Date:	7/21/21	Inspector:	Tim Cissell
