Lake County School District  
Learning Beyond Walls

# 2019 MASTER PLAN

FEBRUARY 15, 2019

## 2019 MASTER PLAN

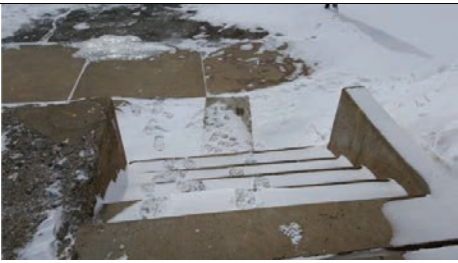
A-2	Stairs from lower parking to entry door have no handrails. Installation of ADA handrails recommended. Further review of concrete condition to be included in civil assessment report.			X

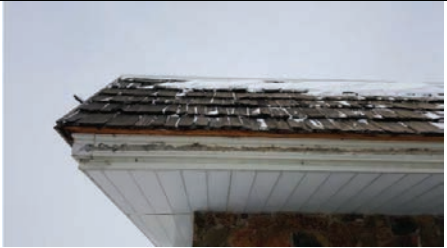
A-4	Cedar shingles at front entry are past their useful life and may be contributing to water and structural damage. Further investigation of condition recommended, as well as replacement of roof. Note any roof replacement at this building will require upgrading the insulative and structural requirements to meet current code.			X

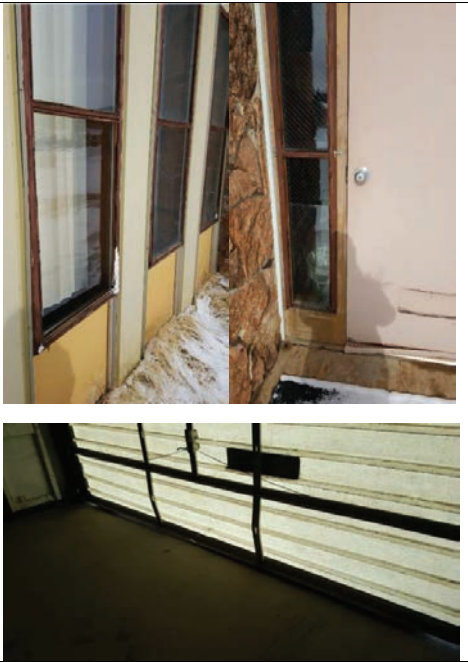
A-5	Deteriorating and damaged frames and sealant noted at exterior windows. Replacement of all windows and man doors recommended. Further			X	
treanorhl.com

review of overhead doors required to determine if observed damage was impacting function.

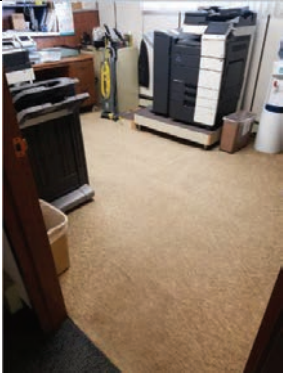
A-9	Carpeting throughout offices appears to be in serviceable condition. If structural repairs are required at the floor slab, replacement of the carpet will likely be necessary.	X

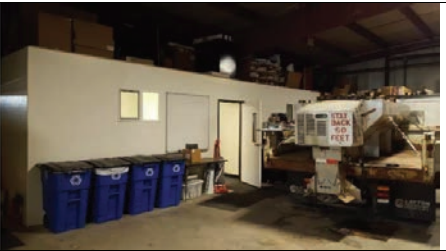
A-12	There does not appear to be a proper fire barrier separation between the garage area with gas-fueled vehicles and the office area. Recommend remediation of existing walls and doors.

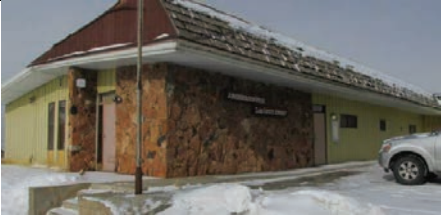
DISC. ITEM #	OBSERVATION / ISSUE / ITEM DESCRIPTION	PRIORITY LEVEL			PHOTOS
		LOW	MED	HIGH	
S-1	The wood shingles on the east building elevation have weathered significantly. Repair is recommended to prevent moisture intrusion. The soffit below the shingled roof dips and is not entirely level. This could be an indication of structural distress. Further investigation is recommended to determine if repairs are required.		X

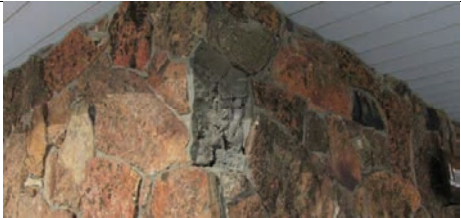
S-3	A piece of stone is missing from the veneer at the southeast corner of the building. The surrounding stone appears to be firmly adhered so a repair would be for visual reasons.	X

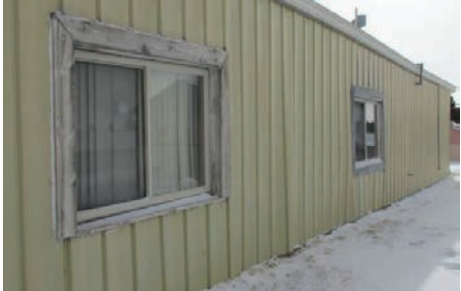
S-4	The exterior siding is dented and bent in several locations around the perimeter of the building and the sealant around the windows has deteriorated. Repair of the siding and replacement of the sealant may be necessary to prevent water intrusion.	X

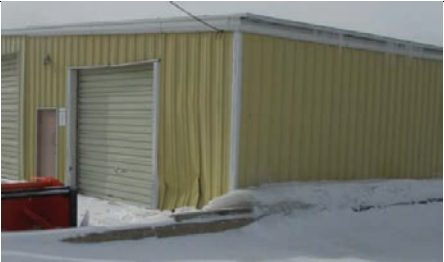
DISC. ITEM #	OBSERVATION / ISSUE / ITEM DESCRIPTION	PRIORITY LEVEL			PHOTOS
		LOW	MED	HIGH	
S-5	The exterior wall at the northeast corner of the building is badly dented; however, the metal building column in the corner appears to be undamaged. Repair of the wall is recommended to prevent water intrusion.	X

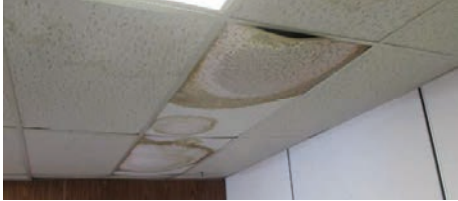
DISC. ITEM #	OBSERVATION / ISSUE / ITEM DESCRIPTION	PRIORITY LEVEL			PHOTOS
		LOW	MED	HIGH	
S-8	Multiple roof leaks occur above the offices and conference room as evidenced by stained ceiling tiles and water filled catch buckets placed above and below the ceilings. It is recommended that the roof leaks be repaired and that the metal roof framing be inspected for signs of corrosion and other weather-related deterioration.		X

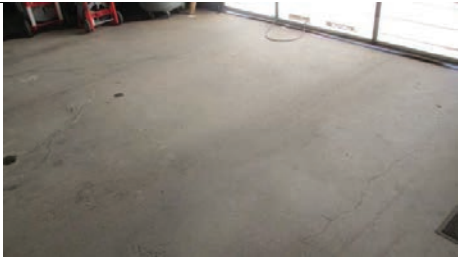
S-9	Minor cracks occur in the slab-on-grade in the maintenance garage bays. The cracks are of the type that would normally be expected for slabs-on-grade and are not a structural concern.	X

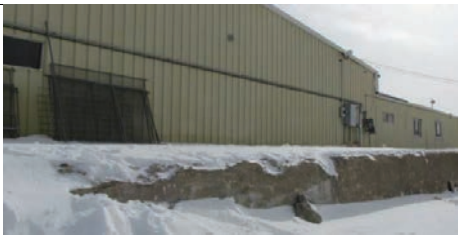
S-10	The top of the concrete retaining walls has deteriorated and spalled off in some locations. The spalling is unsightly but it does not appear to have compromised the structural integrity of the walls. Repairs and or replacement of the walls will eventually be required as they continue to deteriorate.	X

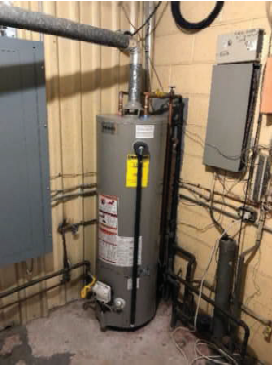
DISC. ITEM #	OBSERVATION / ISSUE / ITEM DESCRIPTION	PRIORITY LEVEL			PHOTOS
		LOW	MED	HIGH	
MP-4	Domestic Water Heater in good condition.	X

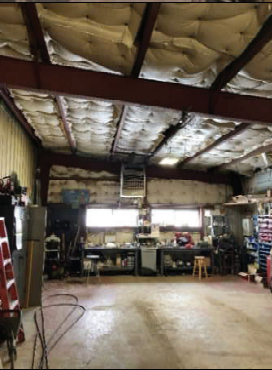
MP-5	Maintenance Bay Unit Heater in serviceable condition.		X

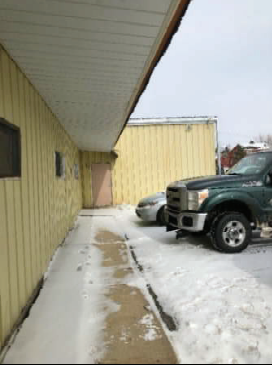
DISC. ITEM #	OBSERVATION / ISSUE / ITEM DESCRIPTION	PRIORITY LEVEL			PHOTOS
		LOW	MED	HIGH	
E-3	Existing fixtures maybe damaged due to leak in the ceiling space.			X	 
E-4	Exterior fixture seems to be broken and not utilized.		X

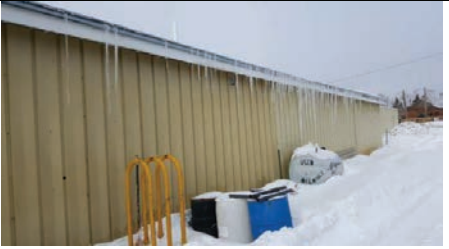
DISC. ITEM #	OBSERVATION / ISSUE / ITEM DESCRIPTION	PRIORITY LEVEL			PHOTOS
		LOW	MED	HIGH	
A-1	Heat loss through the roof is causing significant ice damming on a portion of the east side of the building. Recommend review of integrity of roof panels in this location, as well as the implementation of a roof mounted snow melt system.		X

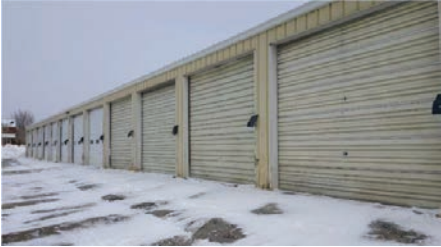
DISC. ITEM #	OBSERVATION / ISSUE / ITEM DESCRIPTION	PRIORITY LEVEL			PHOTOS
		LOW	MED	HIGH	
A-3	Some of the original garage doors were replaced at some point with newer insulated doors. Recommend replacement of remaining doors.		X

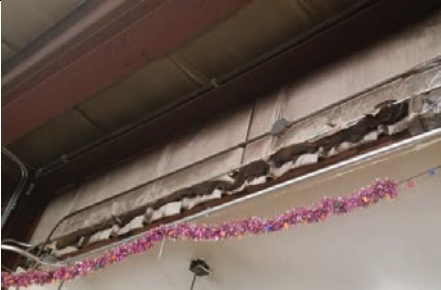
A-4	There are a few miscellaneous areas where insulation repair is recommended.	X

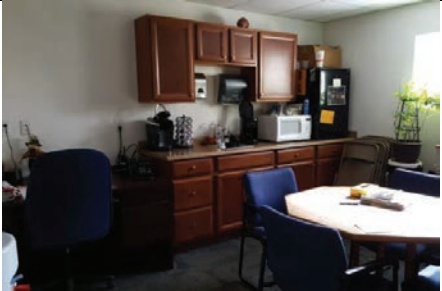
DISC. ITEM #	OBSERVATION / ISSUE / ITEM DESCRIPTION	PRIORITY LEVEL			PHOTOS
		LOW	MED	HIGH	
A-5	Staff lounge is not currently ADA compliant; recommend replacement of cabinetry to allow universal use.	X

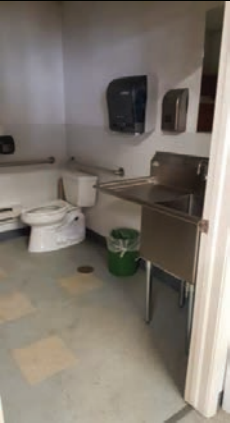
A-6	Staff restroom is partially ADA compliant. Recommend sink replacement and relocation of toilet accessories to meet the requirements.	X

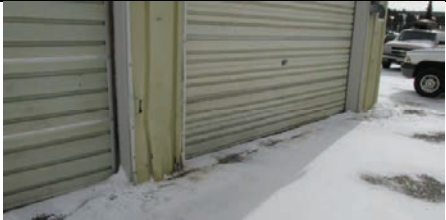
DISC. ITEM #	OBSERVATION / ISSUE / ITEM DESCRIPTION	PRIORITY LEVEL			PHOTOS
		LOW	MED	HIGH	
S-1	The exterior siding is dented and damaged in several locations around the perimeter of the building, particularly at the jambs of the overhead doors. The damage appears to be non-structural; however, repairs may be required to prevent water intrusion.	X

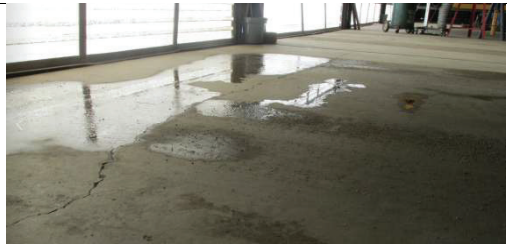
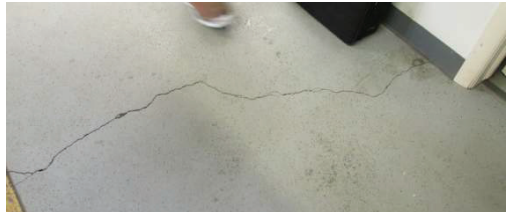
S-3	Minor cracks occur in the slab-on-grade in the maintenance garage bays. The cracks are of the type that would normally be expected for slabs-on-grade and are not a structural concern.	X

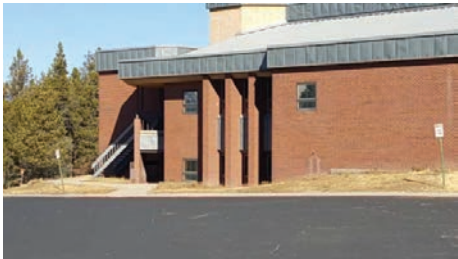
DISC. ITEM #	OBSERVATION / ISSUE / ITEM DESCRIPTION	PRIORITY LEVEL			PHOTOS
		LOW	MED	HIGH	
A-4	Standing seam roofing and exterior fascia is original to the building and at the end of its useful life. Recommend replacement.

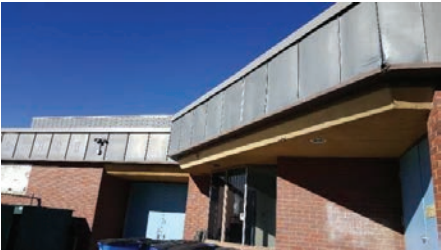
DISC. ITEM #	OBSERVATION / ISSUE / ITEM DESCRIPTION	PRIORITY LEVEL			PHOTOS
		LOW	MED	HIGH	
A-5	Exterior soffits exhibit signs of water damage due to water from adjacent fascia. Recommend replacement of these soffits in conjunction with replacement of standing seam roofing.

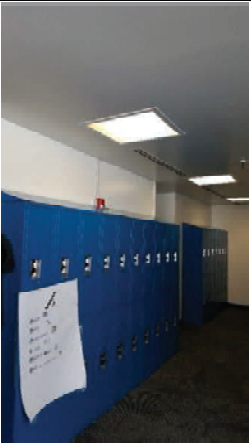
DISC. ITEM #	OBSERVATION / ISSUE / ITEM DESCRIPTION	PRIORITY LEVEL			PHOTOS
		LOW	MED	HIGH	
A-9	Doors between the swimming pool and locker rooms are not fully secured to limit access to the school. Recommend providing magnetic security locks as shown on the attached Supplemental Exhibit.				
A-10	Lockers remain in corridors of buildings from original construction but are unused. In some instances, there is conflict with the fire alarm system. Recommend removal of lockers at time of flooring replacement.

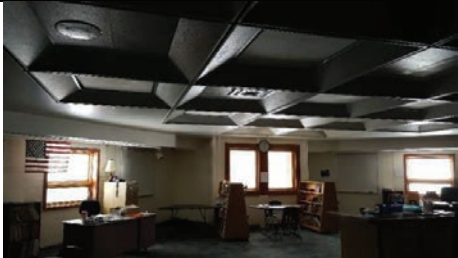
DISC. ITEM #	OBSERVATION / ISSUE / ITEM DESCRIPTION	PRIORITY LEVEL			PHOTOS
		LOW	MED	HIGH	
A-14	Many areas of ceiling in the building are original, and show signs of damage and age. Recommend new ceilings throughout for both aesthetic and acoustic improvements.

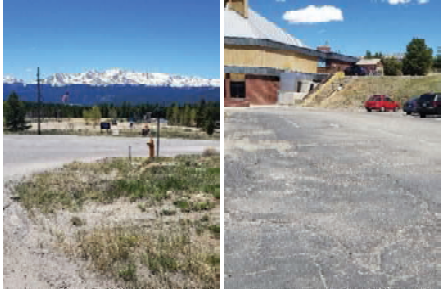
DISC. ITEM #	OBSERVATION / ISSUE / ITEM DESCRIPTION	PRIORITY LEVEL			PHOTOS
		LOW	MED	HIGH	
C-1	Asphalt drives and parking lots have reached the end of their useful life. Recommend replacement.

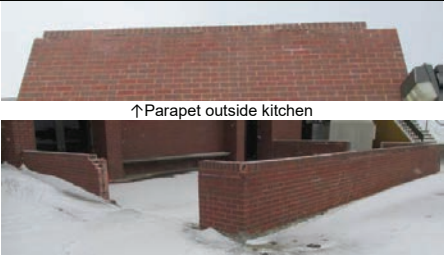
DISC. ITEM #	OBSERVATION / ISSUE / ITEM DESCRIPTION	PRIORITY LEVEL			PHOTOS
		LOW	MED	HIGH	
S-1	The exterior brick walls generally appear to be in good condition for the age of the building. There are some areas, however, where weathered mortar joints or damaged brick should be replaced and treated with a penetrating surface sealer for visual reasons and to maintain the weather-resistant characteristics of the wall system. See photos for representative locations.		X

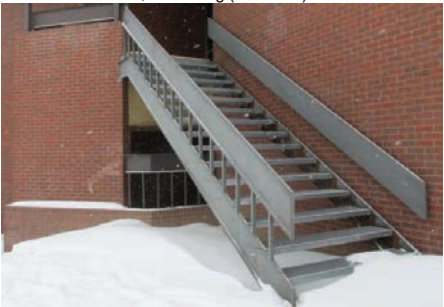
<p>↑West wing (east side)</p></div>
-----	--	--	--	---	---

S-2	The stringers for the four exterior steel stairs (two at the end of the west wing and two at the end of the east wing) are severely corroded and should be replaced.			X	<div>

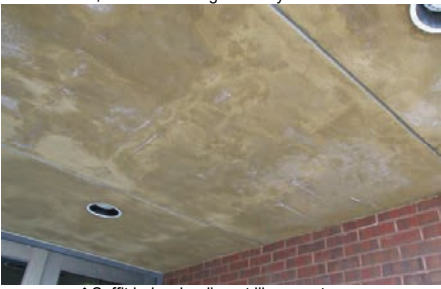
<p>↑Soffit below landing at library entrance</p></div>
-----	---	--	--	---	--

S-3	The exterior landing slab at the entrance to the library has cracks in it and signs of water intrusion are evident on the surface of the soffit below. Further investigation is required to determine the condition of the landing structure and what repairs will be required.			X	<div>

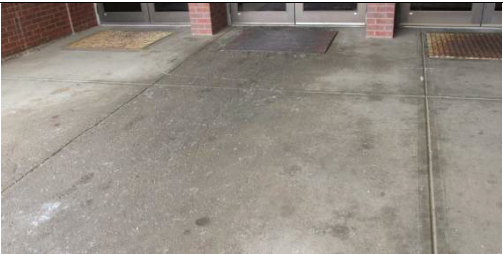
<p>↑ Flatwork at main entrance</p>

S-5	Concrete at the entrances (flatwork and steps) and loading dock is deteriorating and should be replaced.	X			<div>

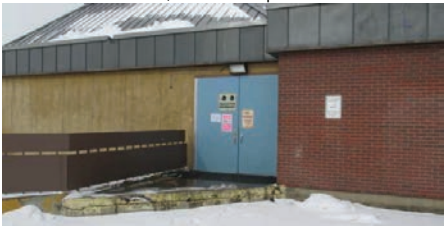
<p>↑ Loading dock</p></div>
--	--	--	--	--	--

S-4	The soffits at the loading dock area have been damaged. Repair may be necessary to prevent water intrusion.	X

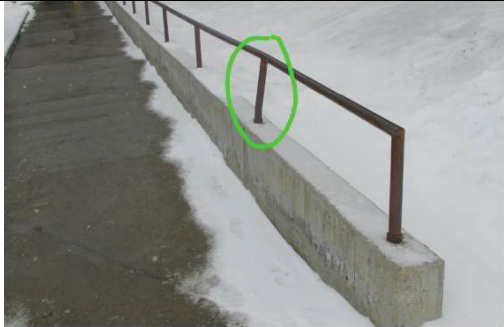
<p>↑Railing at main entrance</p>

<div>Page 8 of 8 Lake County School District Structural Facility Assessment – LAKE COUNTY INTERMEDIATE SCHOOL Project #: ED0480.0003.00 Issue Date: 08/13/2018</div> <div>TREANORHL</div>					
S-6	The exterior steel railings appear to be in serviceable condition except that one of the railing posts at the main entrance is bent and the bases of some of the railing posts at the mechanical well stair are rusting. If the bent post is straightened for visual reasons, care should be taken to not damage the concrete wall. Removal of the rust and coating with a rust-inhibiting primer and paint is recommended. Repair of cracked concrete at the base of the rusting posts is also recommended.	X			<div>

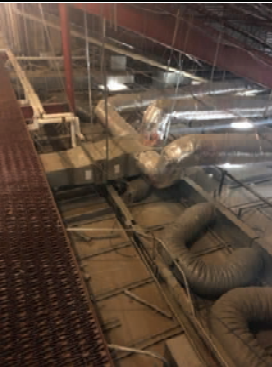
DISC. ITEM #	OBSERVATION / ISSUE / ITEM DESCRIPTION	PRIORITY LEVEL			PHOTOS
		LOW	MED	HIGH	
MP-3	Existing reheat coils with associated catwalk access.	X

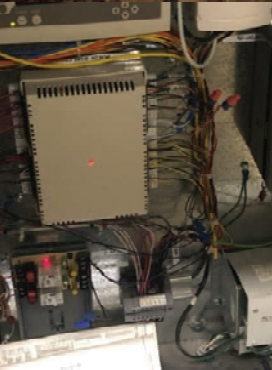
MP-4	Typical existing electronic control panel.		X

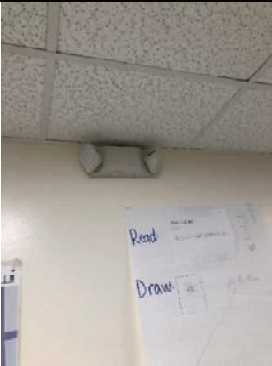
DISC. ITEM #	OBSERVATION / ISSUE / ITEM DESCRIPTION	PRIORITY LEVEL			PHOTOS
		LOW	MED	HIGH	
E-3	Existing battery packs were provided throughout interior path of egress. Exterior emergency fixtures would need to be provided on all exterior egress doors since it is required by code.		X

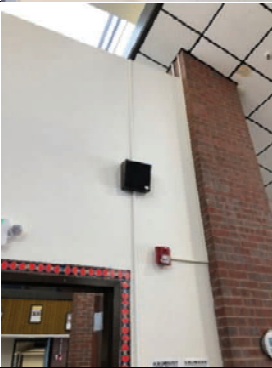
E-4	Existing horn/strobes would need to be replaced with new speaker strobes to accommodate voice evacuation system, if modification is required for fire alarm system.		X

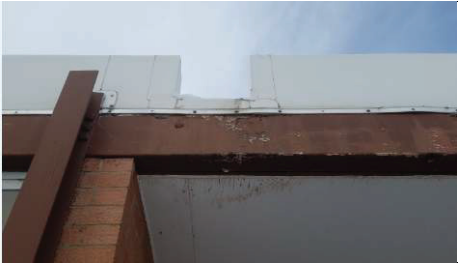
A-2	Roof scuppers along the perimeter of the building lack proper metal flashing drip edges, and as such have contributed to water damage at fascias and soffits. It is recommended that metal flashing be installed as part of the re-roofing, and fascias and soffits repaired or replaced.		X

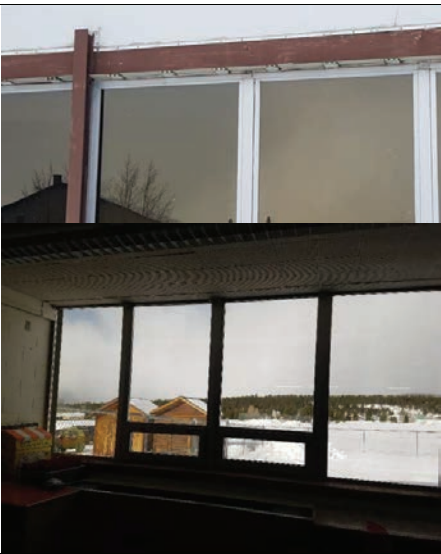
DISC. ITEM #	OBSERVATION / ISSUE / ITEM DESCRIPTION	PRIORITY LEVEL			PHOTOS
		LOW	MED	HIGH	
A-3	Aluminum windows appear to be original to the building, with areas of condensation noted. It is recommended that all windows are replaced with new high performance aluminum windows and glazing.			X

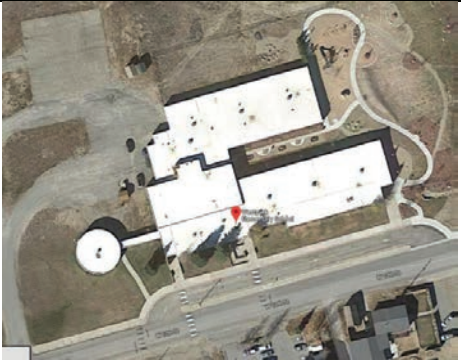
DISC. ITEM #	OBSERVATION / ISSUE / ITEM DESCRIPTION	PRIORITY LEVEL			PHOTOS
		LOW	MED	HIGH	
A-4	There is no ADA signed parking and paths on site. Recommend installation of a minimum of 2 ADA parking stalls adjacent to the main entry.		X

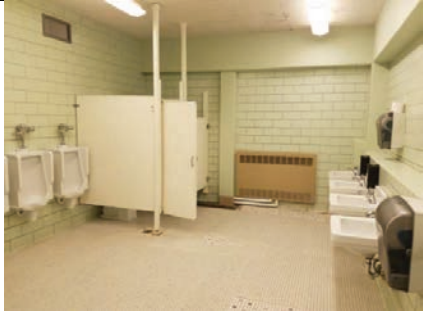
A-5	Multi fixture restrooms in the building are not ADA accessible. In addition, the fixtures and partitions are beyond their useful life. It is recommended that the restrooms are remodeled to incorporate full accessibility requirements.		X

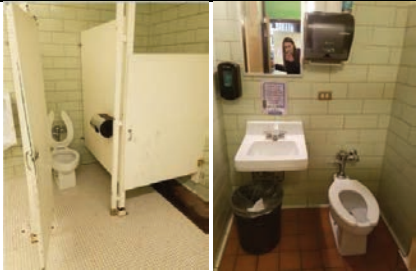
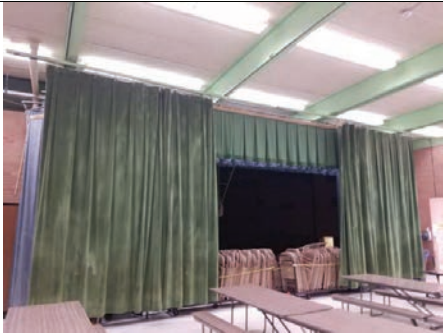
A-6	The stage curtains show signs of wear and tear, and are beyond their useful life and should be replaced. In addition, no safety barrier exists between the cafeteria and the edge of stage. Recommend providing a folding acoustic partition between the stage and gym.		X

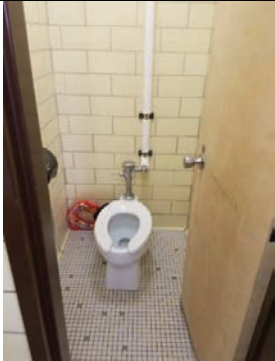
A-7	All classrooms appear to have the proper panic function lever type locks; however, other areas existing where non ADA hardware is in use. Recommend replacing all door knobs with levers.		X

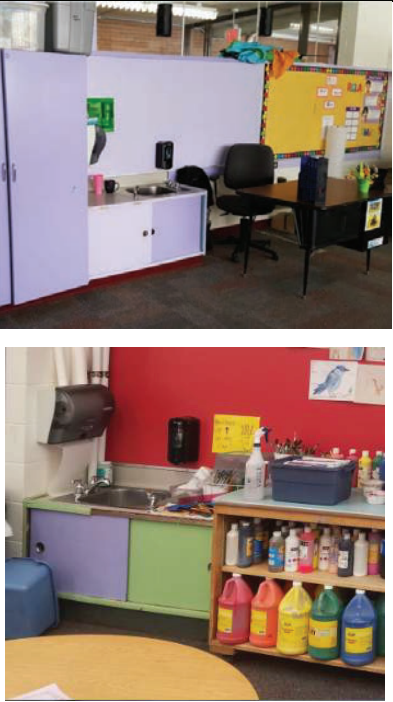
DISC. ITEM #	OBSERVATION / ISSUE / ITEM DESCRIPTION	PRIORITY LEVEL			PHOTOS
		LOW	MED	HIGH	
A-8	Casework is original to the building, and there are several areas where the plastic laminate is damaged. In addition, there are many areas where it is not ADA accessible. It is recommended that all casework in the building is replaced.			X

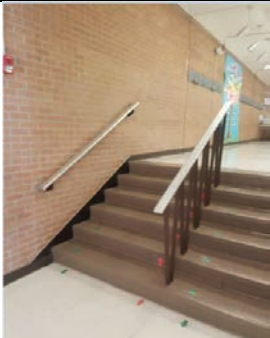
DISC. ITEM #	OBSERVATION / ISSUE / ITEM DESCRIPTION	PRIORITY LEVEL			PHOTOS
		LOW	MED	HIGH	
A-10	Handrails do not meet current accessibility requirements. It is recommended that these be replaced.		X

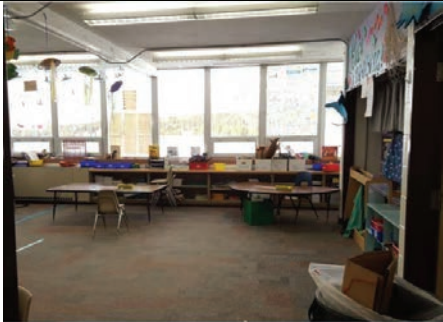
A-11	Carpeting throughout building is still in serviceable condition, however it is nearing the end of its life cycle. Replacement throughout recommended.		X

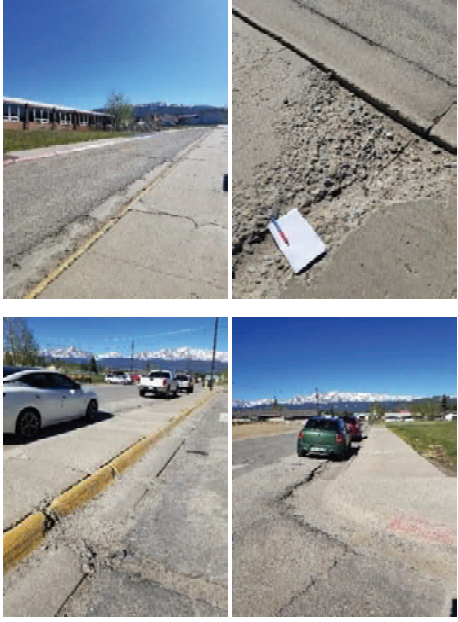
DISC. ITEM #	OBSERVATION / ISSUE / ITEM DESCRIPTION	PRIORITY LEVEL			PHOTOS
		LOW	MED	HIGH	
C-2	Drop-off drive lane, parking lane, concrete island, and concrete walks along Right-of-Ways are in very poor condition and do not appear to conform to current ADA code. Recommend regrading and replacement.

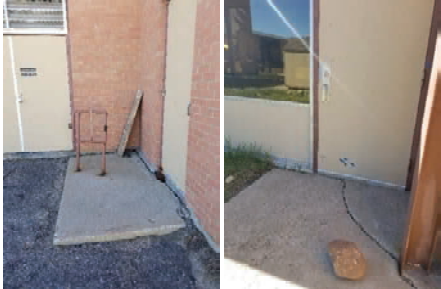
DISC. ITEM #	OBSERVATION / ISSUE / ITEM DESCRIPTION	PRIORITY LEVEL			PHOTOS
		LOW	MED	HIGH	
C-3	Concrete stoops at several doors have experienced movement or damage and are out of conformance with current code. Recommend selective replacement.

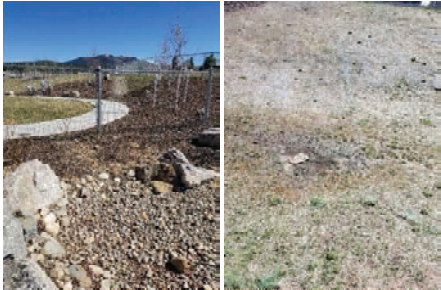
C-4	Playground drainage was noted to not function as intended. Small ponding occurs in softscape and at the installed dry well. Recommend remove and replace with positive drainage away from low points.

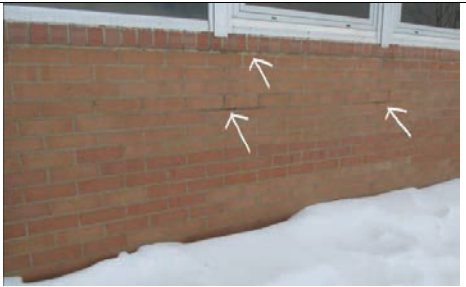
S-2	The exterior brick walls generally appear to be in good condition for the age of the building. There are a few isolated areas where weathered mortar joints or damaged brick could be repaired for visual reasons and to maintain the weather-resistant characteristics of the wall system.	X

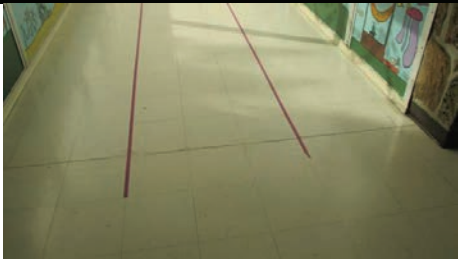
DISC. ITEM #	OBSERVATION / ISSUE / ITEM DESCRIPTION	PRIORITY LEVEL			PHOTOS
		LOW	MED	HIGH	
S-5	Signs of interior slab-on-grade movement were not observed except for some minor separation of the vinyl floor covering in a few isolated locations, possibly due to slab contraction.	X

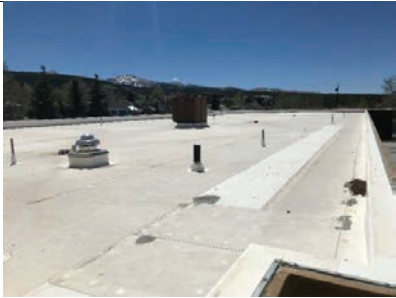
DISC. ITEM #	OBSERVATION / ISSUE / ITEM DESCRIPTION	PRIORITY LEVEL			PHOTOS
		LOW	MED	HIGH	
A-2	Some portions of the building were reroofed in 1997 with TPO membrane. This membrane has exceeded its life span, and should be replaced. Overflow scuppers or interior overflow drains should be added at time of reroof.

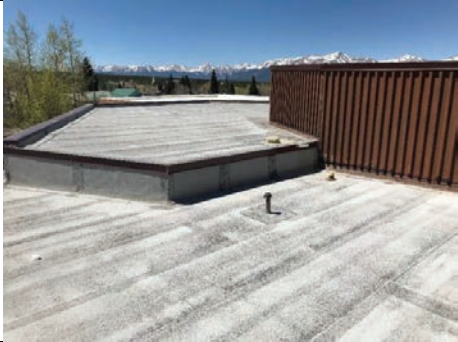
A-3	Areas of built-up roofing that were not replaced in 1997 still remain. Recommend replacement with new roofing membrane.

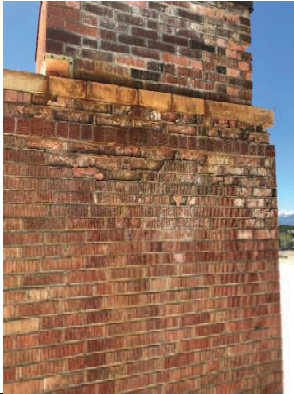
DISC. ITEM #	OBSERVATION / ISSUE / ITEM DESCRIPTION	PRIORITY LEVEL			PHOTOS
		LOW	MED	HIGH	
A-4	Masonry on existing chimney (not-in-use) is in disrepair. Recommend dismantling and capping, and replacing remaining masonry below.

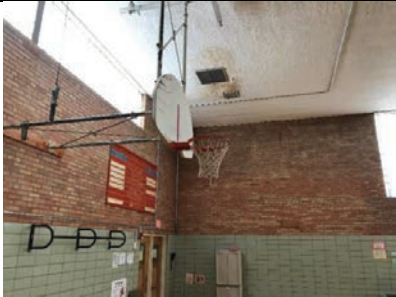
DISC. ITEM #	OBSERVATION / ISSUE / ITEM DESCRIPTION	PRIORITY LEVEL			PHOTOS
		LOW	MED	HIGH	
A-5	Water staining at the gym ceiling is evident. Reroofing may help to address; refinishing ceiling is recommended.

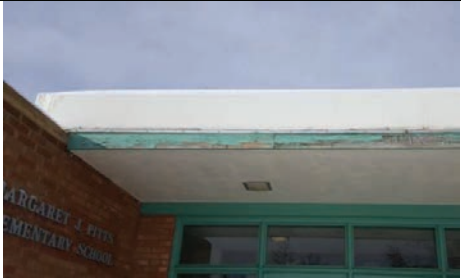
A-6	Exterior fascias have considerable deterioration and should be replaced. Recommend installation of sheet metal flashing with drip edge as part of reroof work to limit future water damage.

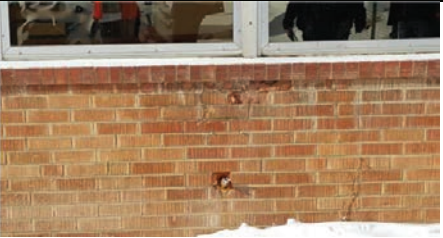
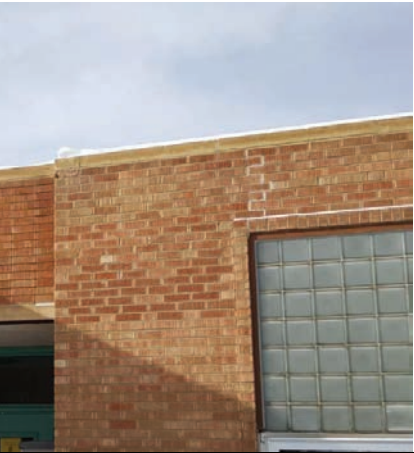
DISC. ITEM #	OBSERVATION / ISSUE / ITEM DESCRIPTION	PRIORITY LEVEL			PHOTOS
		LOW	MED	HIGH	
A-7	Areas of damage to exterior brick noted. These areas should be replaced/retooled.

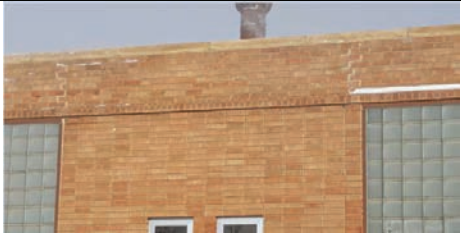
A-8	Cast stone parapet cap should be replaced with sheet metal flashing as part of reroofing.

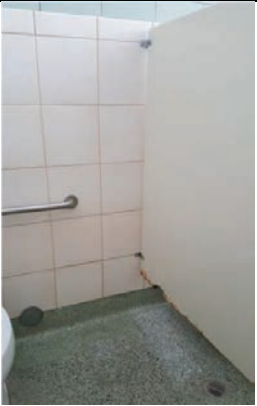
DISC. ITEM #	OBSERVATION / ISSUE / ITEM DESCRIPTION	PRIORITY LEVEL			PHOTOS
		LOW	MED	HIGH	
A-11	Toilet partitions are beyond their useful life and should be replaced.

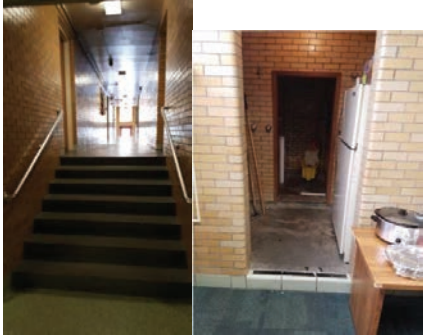
DISC. ITEM #	OBSERVATION / ISSUE / ITEM DESCRIPTION	PRIORITY LEVEL			PHOTOS
		LOW	MED	HIGH	
A-12	Limited areas of the building are not ADA accessible.

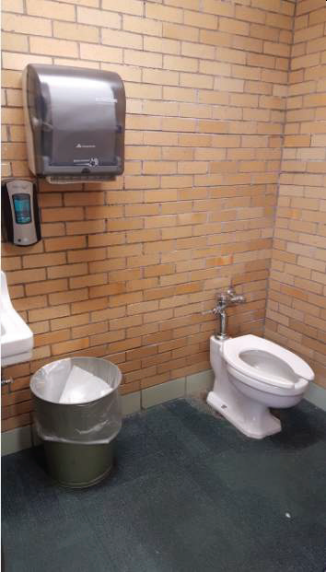
DISC. ITEM #	OBSERVATION / ISSUE / ITEM DESCRIPTION	PRIORITY LEVEL			PHOTOS
		LOW	MED	HIGH	
A-14	There are non ADA accessible restrooms that should be renovated to meet requirements. In addition, restroom flooring should be replaced as part of that work.

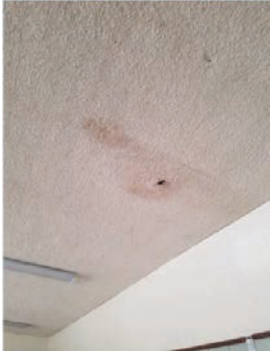
DISC. ITEM #	OBSERVATION / ISSUE / ITEM DESCRIPTION	PRIORITY LEVEL			PHOTOS
		LOW	MED	HIGH	
A-15	Areas of water damage noted at ceiling in cafeteria. Source of damage should be investigated and ceiling repaired.

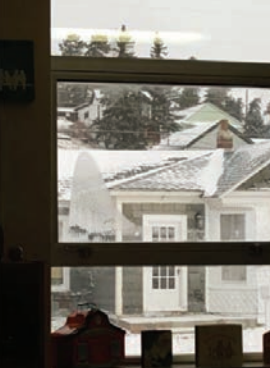
A-16	Aluminum windows are beyond their useful life, and various areas of condensation were noted. Recommend all windows be replaced with new high performance aluminum windows and glazing.

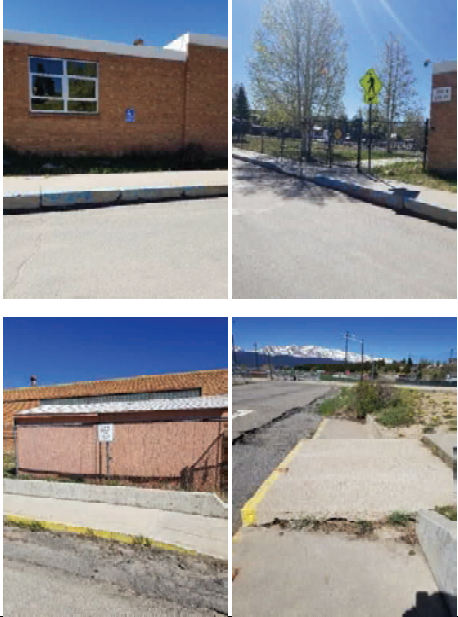
DISC. ITEM #	OBSERVATION / ISSUE / ITEM DESCRIPTION	PRIORITY LEVEL			PHOTOS
		LOW	MED	HIGH	
C-2	The building has no ADA accessible parking, drop-off, or accessible routes to the right-of-way that conform with current codes. Existing parking stalls have no accessible ramps. Existing routes have gates without ADA door openers. Recommend replacing site walks.

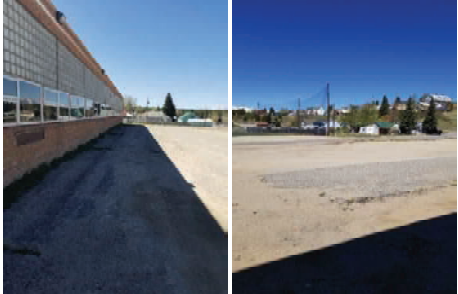
DISC. ITEM #	OBSERVATION / ISSUE / ITEM DESCRIPTION	PRIORITY LEVEL			PHOTOS
		LOW	MED	HIGH	
C-5	Asphalt portion of parking lot is at end of useful life. Recommend full replacement.

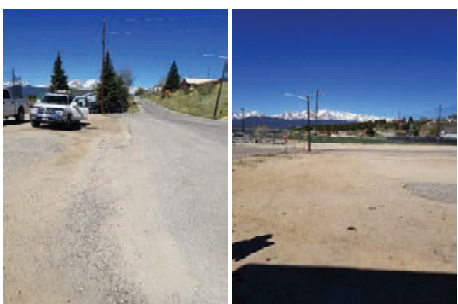
C-6	Existing gravel parking lot is not stabilized and causes erosion and tracking onto Town roads. Recommend regrading and routine maintenance.

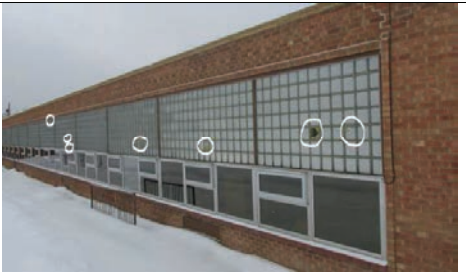
S-2	<p>The sealant around the windows has deteriorated in some locations. Removal and replacement of the deteriorated sealant may be necessary to prevent water intrusion.</p> <p>The exterior brick walls do not have any control joints and stair step cracks occur commonly in the corners above the glass block areas. It is evident that the cracks have been repaired in the past; however, some of the repairs appear to have deteriorated and should be refreshed with repointing or re-caulking and applying a sealer to prevent water intrusion.</p> <p>The stone parapet cap is weathered and the mortar joints between sections have deteriorated. Repairs should occur to prevent moisture intrusion. In some areas, the roof membrane has been wrapped over the top of the parapet and attached to the brick wall with an exposed termination bar.</p>		X

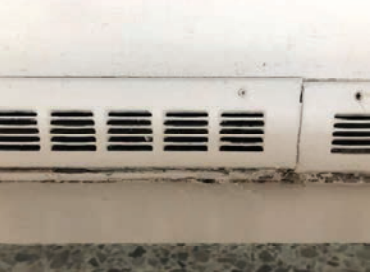
DISC. ITEM #	OBSERVATION / ISSUE / ITEM DESCRIPTION	PRIORITY LEVEL			PHOTOS
		LOW	MED	HIGH	
MP-2	Abandoned baseboard in millwork.			X

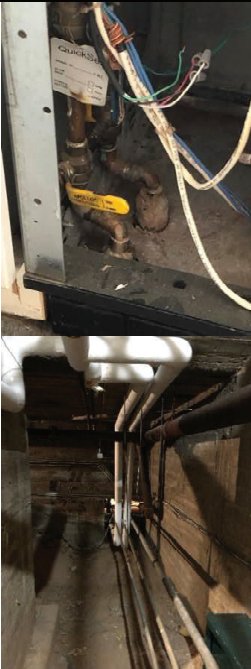
DISC. ITEM #	OBSERVATION / ISSUE / ITEM DESCRIPTION	PRIORITY LEVEL			PHOTOS
		LOW	MED	HIGH	
MP-4	Existing under slab mechanical piping still in service.			X

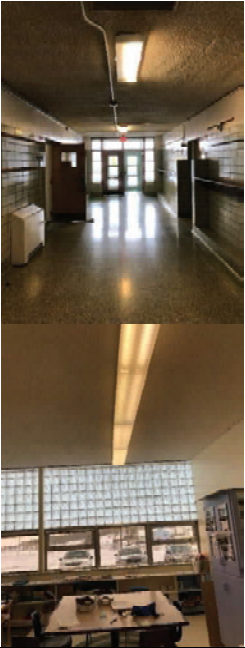
DISC. ITEM #	OBSERVATION / ISSUE / ITEM DESCRIPTION	PRIORITY LEVEL			PHOTOS
		LOW	MED	HIGH	
E-2	Existing linear fluorescent lighting. Corridors seems to be a bit dark. We recommend on replacing fixtures with LED (2x2 or linear).	X

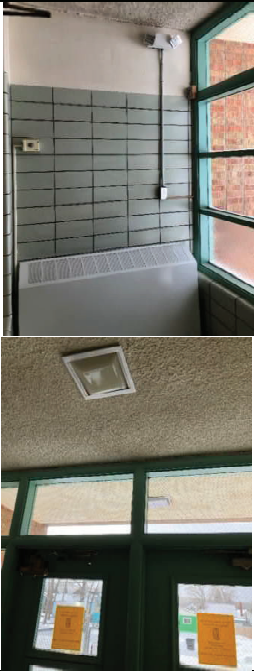
DISC. ITEM #	OBSERVATION / ISSUE / ITEM DESCRIPTION	PRIORITY LEVEL			PHOTOS
		LOW	MED	HIGH	
E-3	Existing battery packs were added throughout interior path of egress. Exterior emergency fixtures would need to be provided on all exterior egress doors since it is required by code.			X

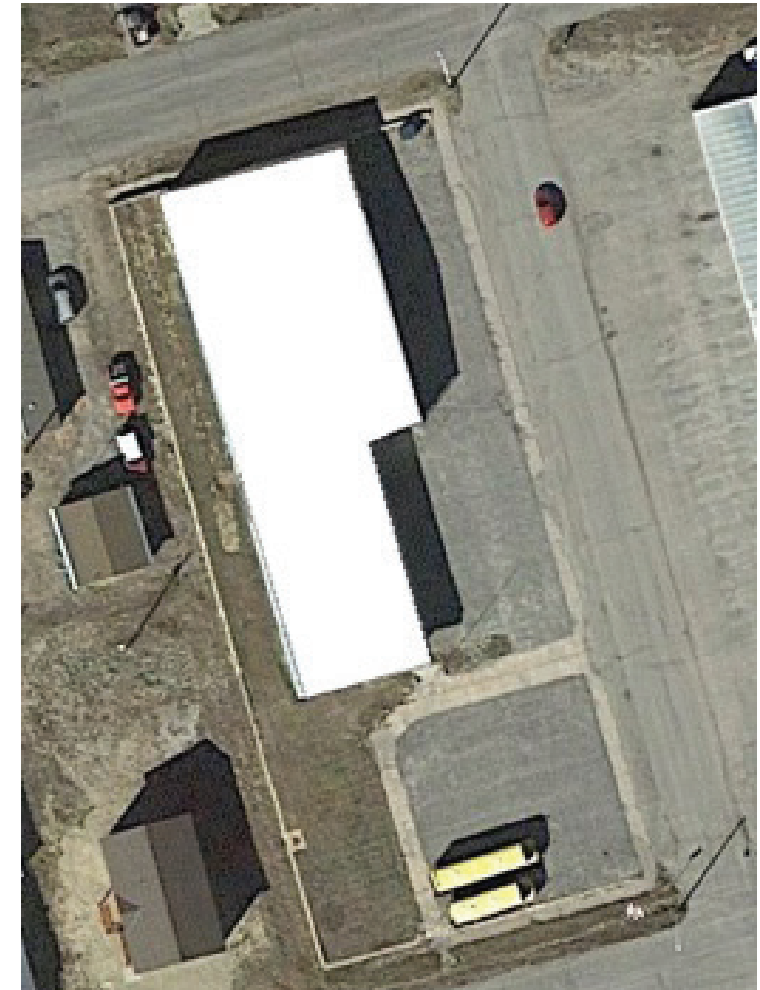
- No ADA parking is available
- Lack of ADA access from public right of way to entry
- Concrete and asphalt paving in poor condition and needs to be replaced
- Areas of grading repair needed to provide positive drainage away from building

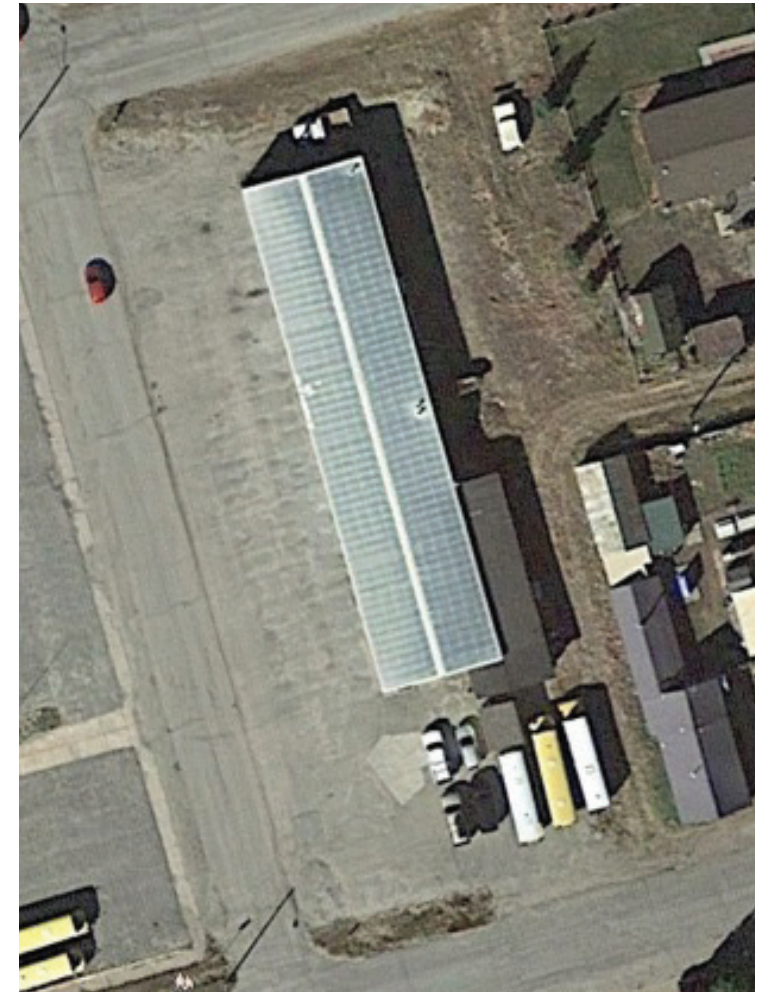
- No ADA parking is available
- Lack of ADA access from public right of way to entry
- Asphalt paving in poor condition and needs to be replaced
- Areas of grading repair needed to provide positive drainage away from building

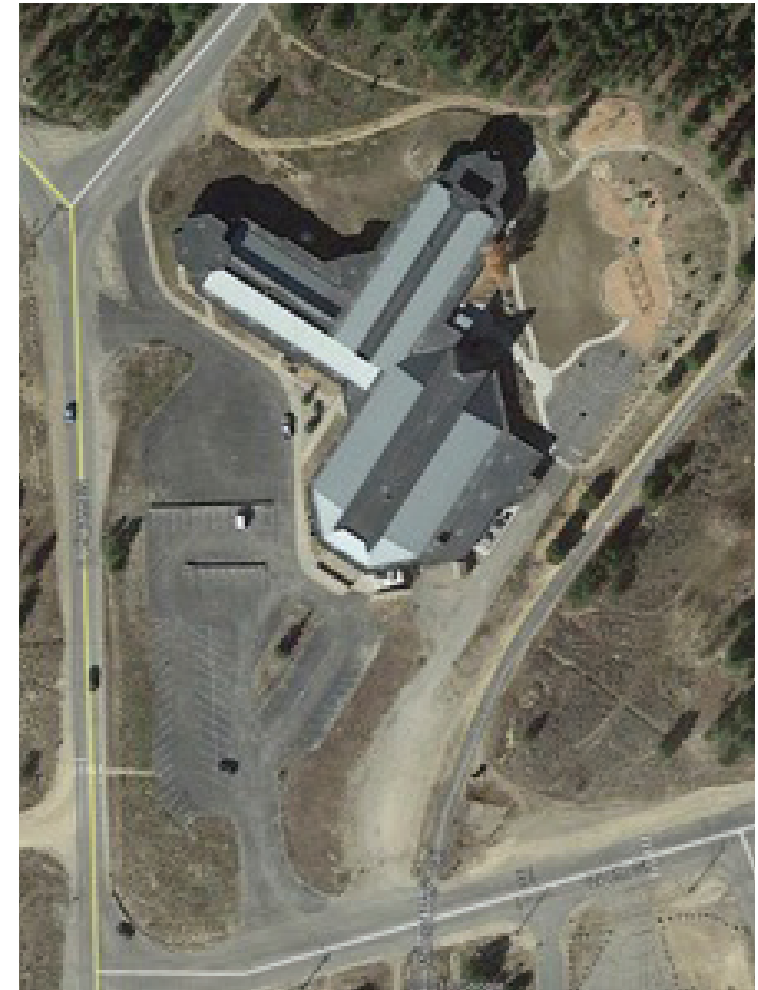
- Exterior stairs serving building entrances and exits are deteriorated and need replacement
- Site does not provide any access that conforms to ADA. ADA parking stalls also require accessible connection to building.
- Asphalt drives and parking lots are deteriorated and need replacement
- Site safety for students needs to be addressed, with provision of separate and clear parent drop off, bus drop off, pedestrian access, and Rec Center access.
- Several slopes across the site have evidence of erosion; repair and erosion control needs to be installed
- Fire hydrants on site appear inaccessible and possibly outdated.
- Areas of grading repair needed to provide positive drainage away from building
- Water and sanitary sewer service lines are at the end of their expected life.

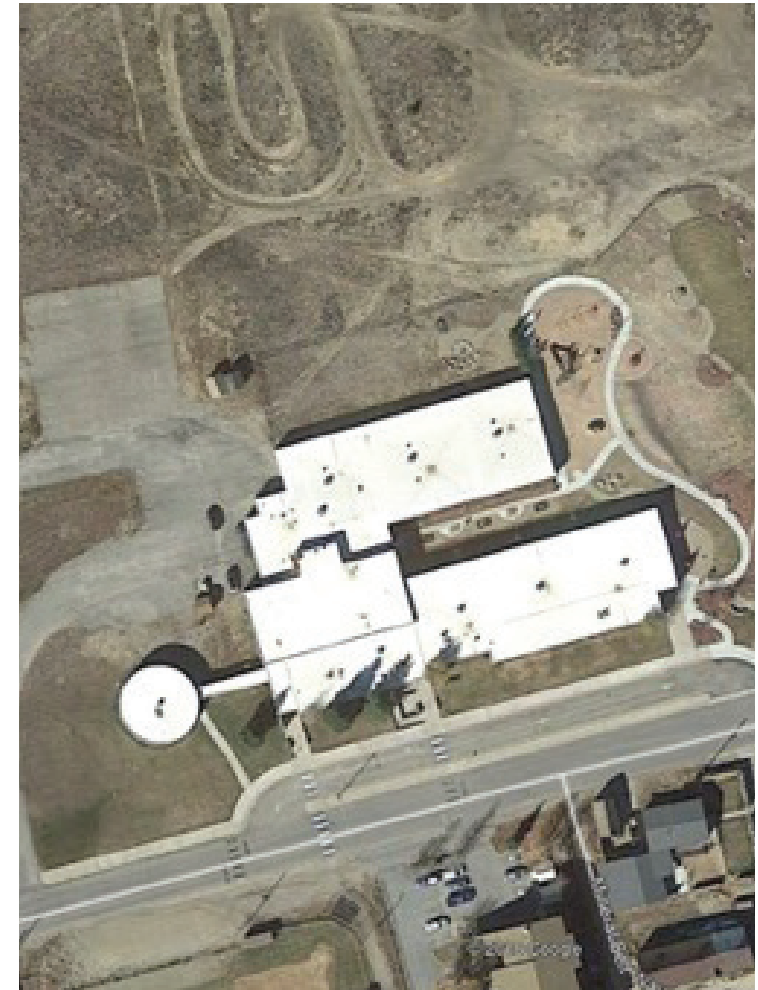
- Site does not provide any access that conforms to ADA. No ADA parking stalls are available.
- Asphalt drives and parking lots, as well as concrete walks and curbs are deteriorated and need replacement.
- Site safety for students needs to be addressed, with provision of separate and clear parent drop off, bus drop off, parking, and pedestrian access.
- Playground drainage not functioning as intended; regrading required to provide positive drainage.
- Water and sanitary sewer service lines are at the end of their expected life.

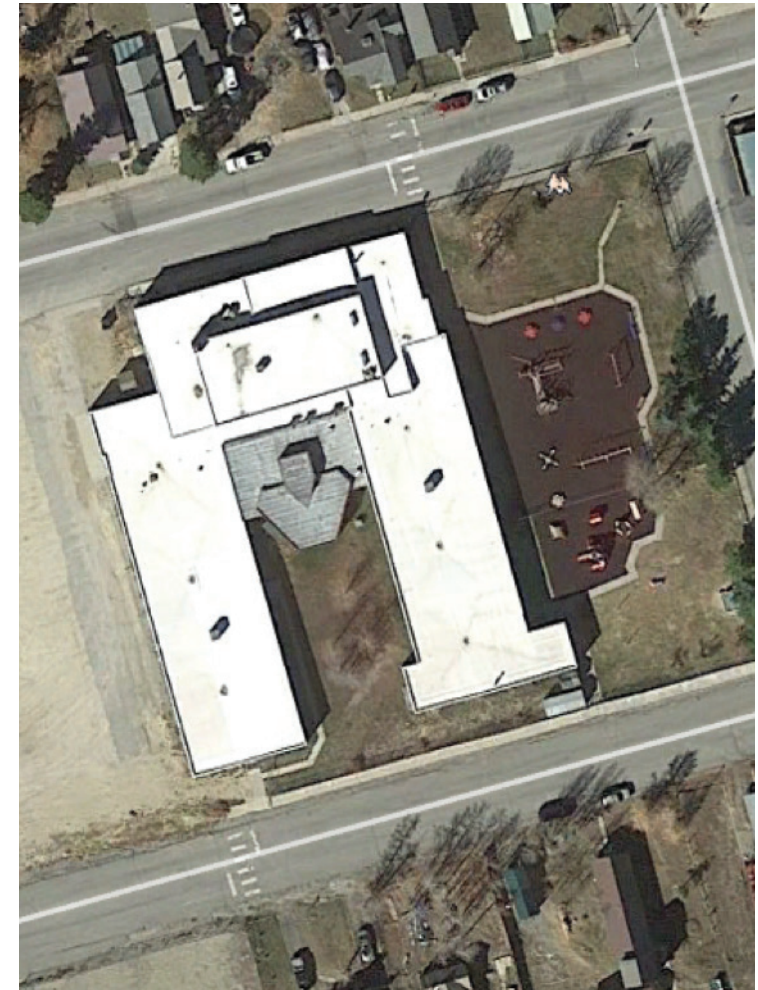
- Site does not provide any access that conforms to ADA. No ADA parking stalls are available.
- Asphalt drives and parking lots, as well as concrete walks and curbs are deteriorated and need replacement.
- Clear entry point for building needs to be provided, with safe parent parking for drop off.
- Grading around the building, primarily on the east side and within the courtyard, does not provide adequate fall away from the building. Site grading and underground drainage improvements required.
- Water and sanitary sewer service lines are at the end of their expected life.

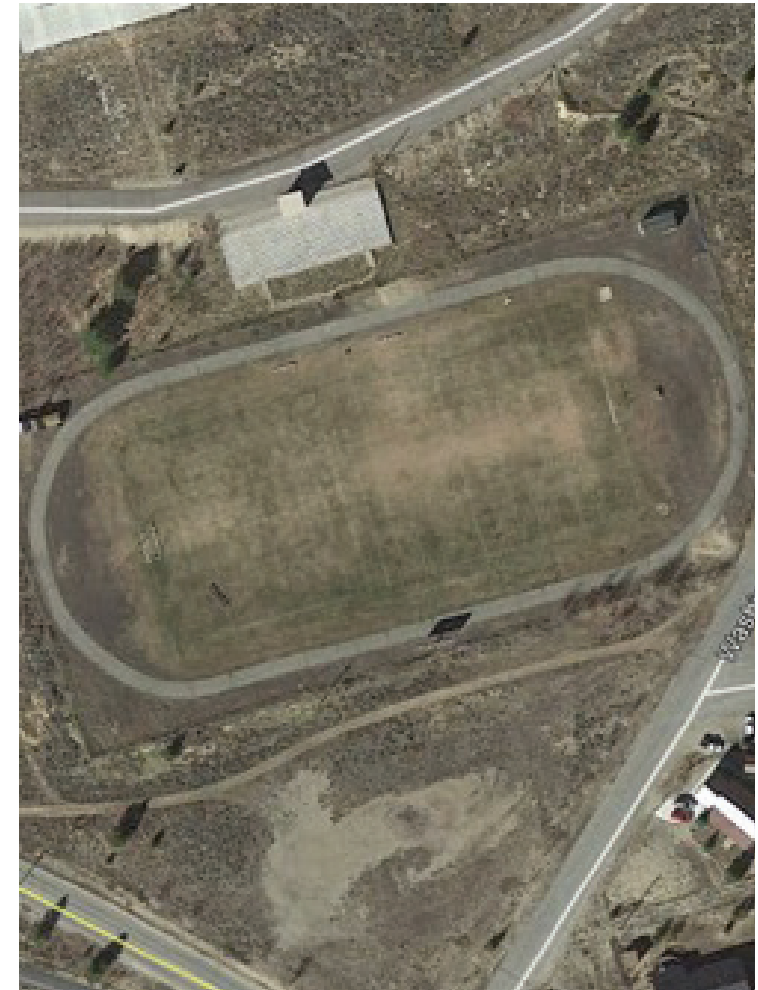
- Poor site drainage has caused deterioration of both the track and field. Recommend regrading around and of track and field area, and installation of underground drainage system or some other stormwater conveyance system.
- Asphalt track is deteriorated and should be replaced.
- Areas of erosion noted on north side of site as it slopes up toward high school. Recommend repair and installation of additional erosion control.
- Bleachers and pressbox are dangerously deteriorated and need to be replaced in their entirety.
- ADA accessible parking and access routes to bleachers need to be provided.
